Pre-development tree survey, (BS5837:2012), Westfield Garden
Centre, Skegby

Mr and Mrs Brouwer, commissioned Dr. Stefan Bodnar to undertake an arboricultural survey (BS5837: 2012) on trees within a development site at Westfield Garden Centre, Skegby. The trees included within the survey and their relationship to the Development Footprint are identified on the drawing in Appendix 2. Photographs of trees involved are included in Appendix 1, together with examples of the trees concerned. BS 5837:2012 includes an assessment of all trees within the development footprint in addition to those near to the site boundary.

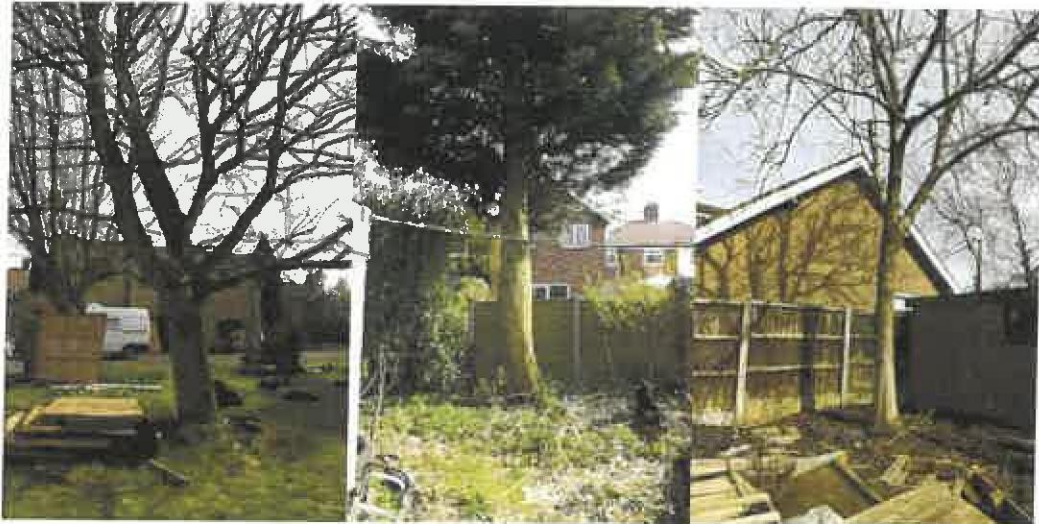
Trees 5, 1 and 2

Trees 3, 3a, 7, 11 and 26 are dead or dying and as such are recommended for removal. Tree 2, although healthy, is recommended for removal due to its location beside a residential building and likely foundation damage as it becomes more developed.

Trees 5, 12 and 14 all attain a B category and should be retained, with tree and root protection zones established.

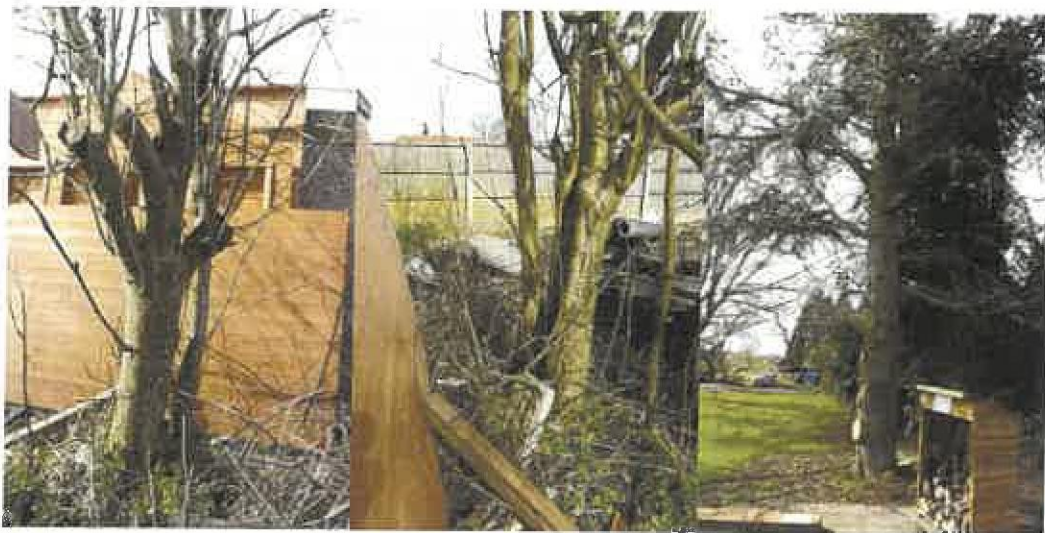
Trees 3, detail of 3 and tree 6

6	Atlas Cedar	790	9.6	290	6	9	6	8	10	Semi-mature	10-20 years	Severe storm damage with loss of apical shoot and damaged limbs. Uneven, poor form. Previous pruning	C1	Formative pruning
7	Cherry	650	7.8	191	6	6	3	2	10	Over-mature	0-10 years	Uneven, poor form. Dead and dying	U	Remove
7a	Acer Leopoldii	620	7.5	177	6	5	7	4	10	Mature	10-20 years	Root and stem damage on driveway side. Lean to NE. Poor form	C1	Formative pruning
8	Leyland Cypress	Multistem	N/A	N/A	2	2	2	2	10	Semi-mature	20-30 years	Max. stem 300 DBH	C1	
9	Cypress	Multistem	N/A	N/A	2	2	2	2	10	Semi-mature	20-30 years	Max. stem 300 DBH	C1	
10	Hawthorn	Multistem	N/A	N/A	2	3	5	2	8	Previous hedge shrub	10-20 years	3 stems from 1.2m, 200, 300, 350	C1	
11	Weeping birch	450	5.4	92	3	2	6	0	10	Over-mature	0-10 years	Stem damage at 2m, deadwood, razor strop fungus, decayed and dying	U	Remove
12	Red oak	600	7.2	163	7	7	7	7	10	Semi-mature	20-30 years	Mature tree, reasonable form	B1

The trees in question consist of a number of trees planted as landscape trees in the late 1960s and early 1970s beside the garden centre, and the remains of a self-set tree line, to the north of the plot. The landscape trees beside the garden centre have suffered some storm damage (in particular tree 6), and a number lean away from the prevailing westerly winds. In addition, accidental damage mainly caused by delivery lorries, root damage and compression along the drive and mowing damage to surface roots are all significant factors in reducing the quality of many of the trees present. Some pruning work has also taken place at varying times. The self set trees along the northern boundary have been partially damaged during previous clearance operations related to the derelict greenhouses that were on the site, a number having stem and root damage.

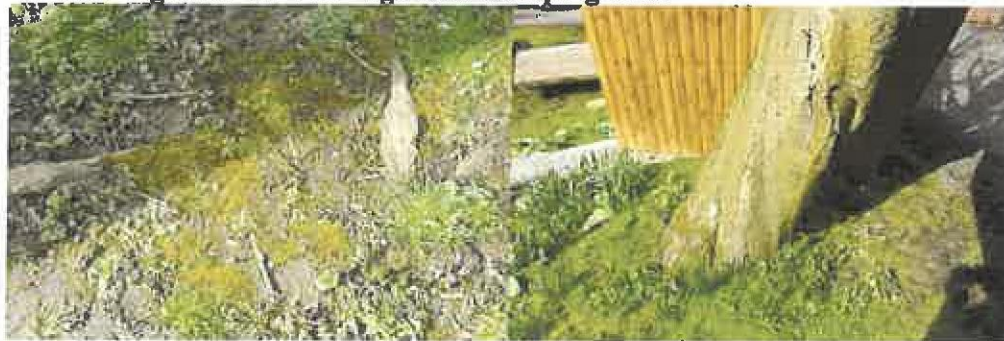
Root damage and stem damage to landscaping trees

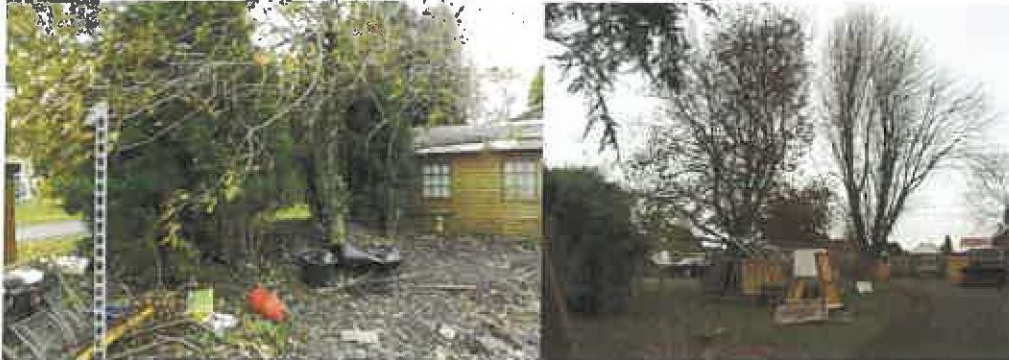
Trees 14 and 15 (first image), trees 4 and 5 (second image)

15	Red horsechestnut	410	4.8	72	4	3	6	3	8	Semi-mature	20-30 years	Some deadwood at fork (1.8m), stem damage. Pruned with reactive growth from pruning. Lean to NE. Poor form	C1	Formative pruning
16	Leyland cypress	300	3.6	41	2	2	2	2	8	Former hedgerow tree. Young.	20-30 years		C1	
17	Leyland cypress	300	3.6	41	2	2	2	2	8	Former hedgerow tree. Young.	20-30 years		C1	
18	Weeping willow	600, 700	15	707	7	3	6	2	8.5	Mature	10-20 years	Two stems from 0.5m. poor form. damaged on southern side. Stems, 600 and 700 DBH. poor form	C1	Formative pruning. Reduce.
19-24	Silver birch group	350 400	4.5	64	3	3	3	3	10	Semi-mature	10-20 years	Self set. mainly twin stems from base. Some with stem and root damage on S. side	C1	
25	Cherry (off-site)	Coppice	7.8	191	3	3	3	3	7	Coppice	10-20 years	3 stems at 220 each	C1	
26	Ash	300	3.6	41	N/A	N/A	N/A	N/A	2.5	Semi-mature	0-5 years	Dead and dying. Snapped at 2.5m, severe stem and root damage.	U
