Tree Condition Report – Fir House, Teversal

On behalf of Julie O'Dowd

Fir House
Buttery Lane
Teversal Village
Nottinghamshire
NG17 3JN

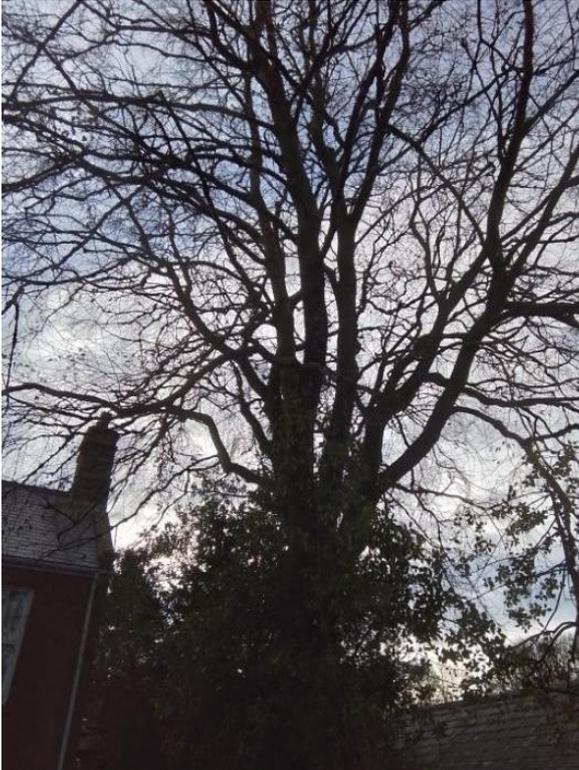
T1 – Beech

This tree is located on the property boundary adjacent Ashfield Cottage.
The tree has extensive growth growing toward the properties. Continued growth and movement from heavy winds will likely cause direct damage to the properties.
In order to abate this future nuisance I would recommend crown lifting to 5m above ground level and pruning to give 3m clearance of the properties.

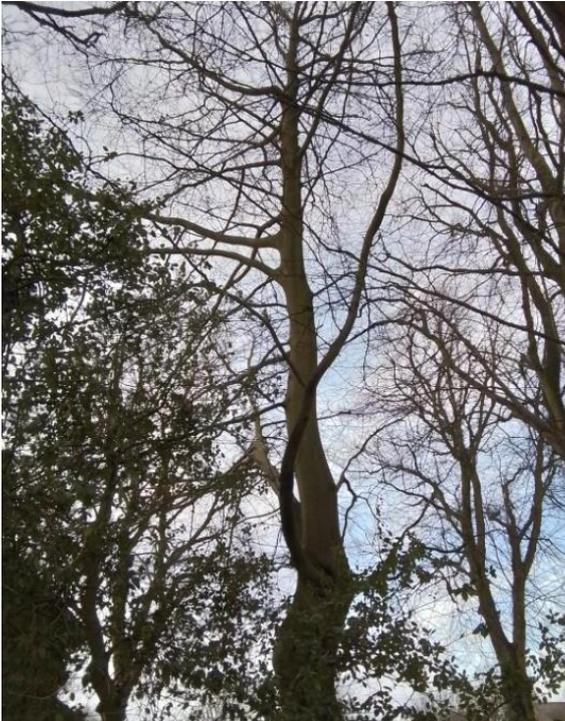
T2 – Beech

This tree also borders Ashfield Cottage and will also likely present a nuisance in the future. I would recommend the same specification as T1, a crown lift to 5m above ground level and pruning to give 3m clearance of the properties.

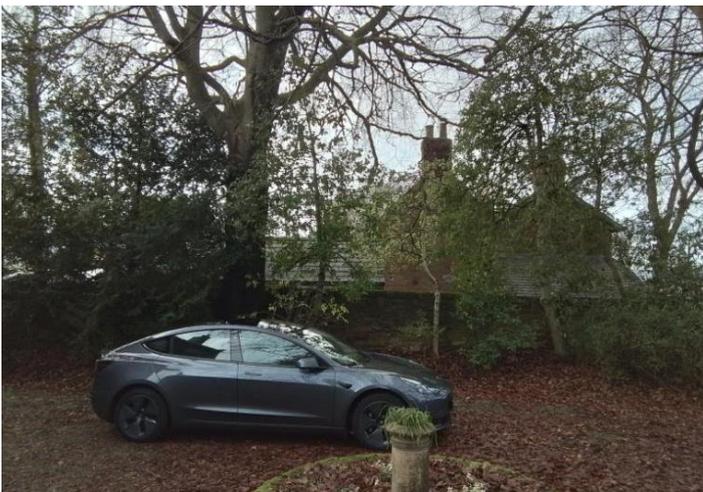
G1 – A mixed species group consisting of; Hollies, 1x young Yew and 1x young Beech.

The group is located adjacent the boundary wall and the secondary thickening process will ultimately cause damage to the structure.

The small Yew within the group is 'leggy' in nature and poses no real amenity value currently.

I would recommend the removal of all Hollies and the small Beech within the group in order to safeguard the historic wall and a crown reduction of the Yew to a height of 2m.

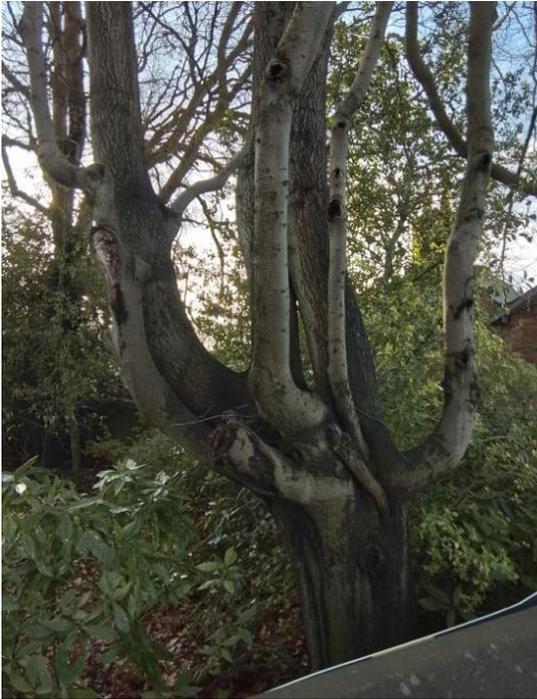
T3 – Beech

This tree is located at the entrance to the property.

The tree has been previously pollarded at a height of 1.5m above ground level. The resultant re-growth features included unions and a growth habit that will ultimately fail following stem growth through the secondary thickening process.

I would recommend the removal of this tree.

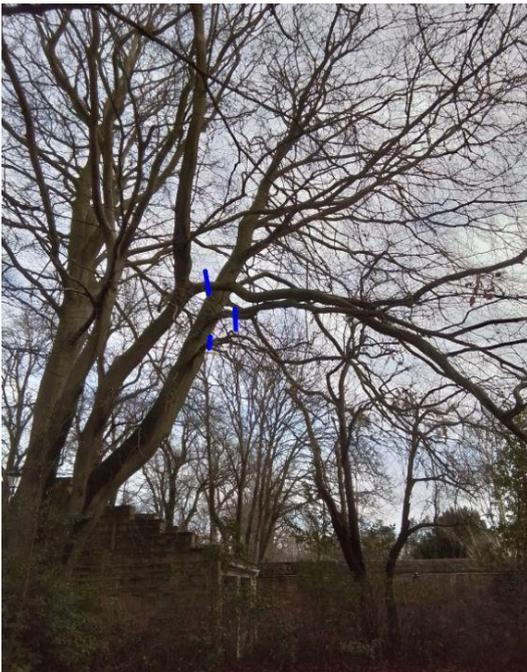
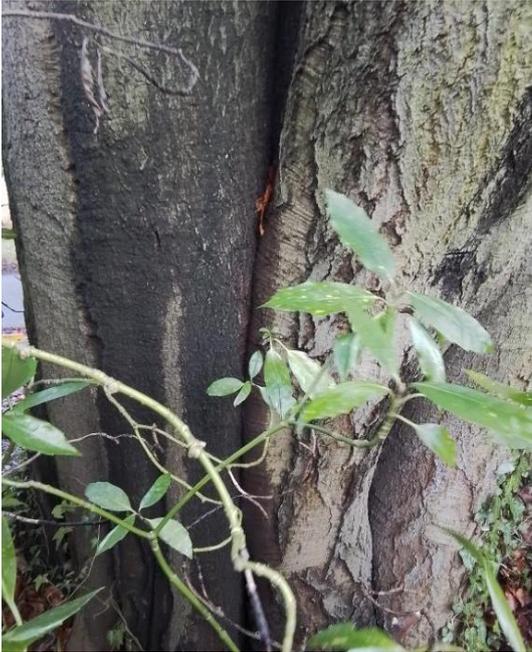
T4 – Beech

This tree is a Mature Beech located at the front of the property beside the garage. It is a twin stemmed tree with the co-dominant stem featuring a substantial included union from ground level and a pronounced phototropic lean toward the property. Given the failures associated with unions of this type, we would look to carry out remedial works to lessen the risk of future failures. I recommend a reduction of the leaning stem by up to 3m and a crown reduction of the remaining tree by no more than 2m in order to maintain a balanced and aesthetic canopy. I would also recommend a crown lift to 5m, the blue dashes in the above photo show some of the larger limbs that would be removed.

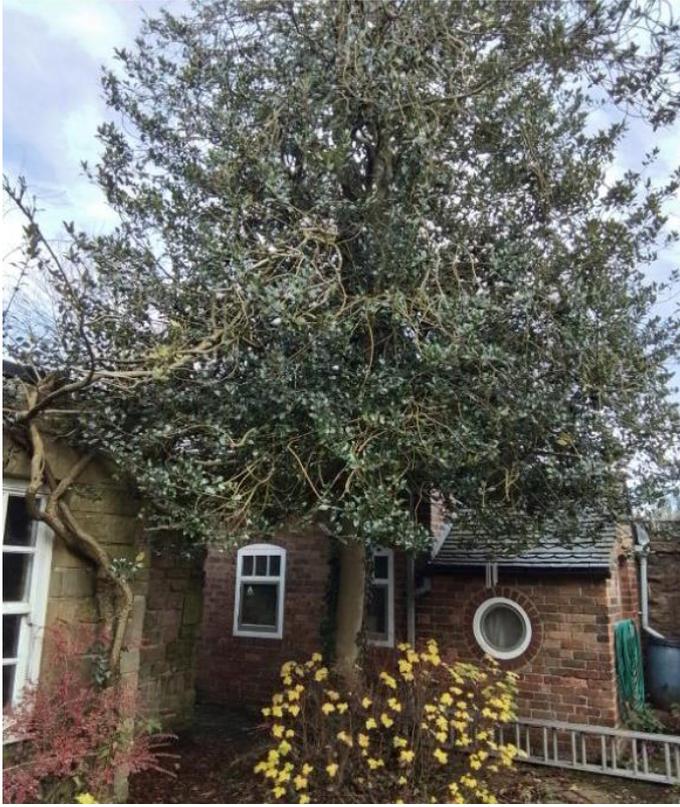
T5 – Holly

This tree is located to the rear of the property adjacent the existing outbuilding. The tree is causing a nuisance through direct damage to the existing slabs around the tree and preventing our clients full enjoyment of their property.

I would recommend removal of this tree.

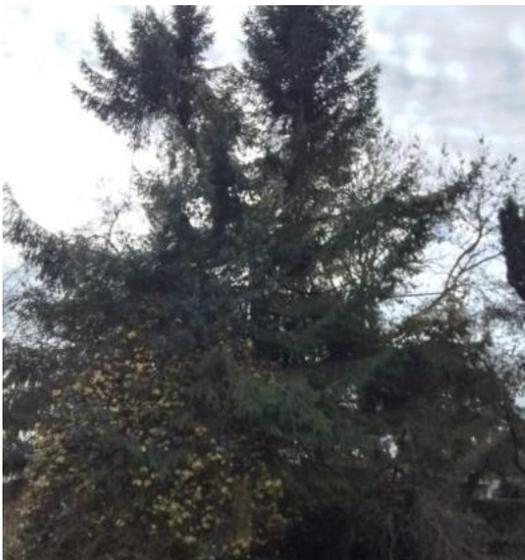
T6 – Spruce

This tree has been topped in the past which has created a canopy which features poor form. Given this lapsed growth from the previous cut points, there is now considerable weighting on the resulting poor unions.

Remove tree.
