Building Survey Report

Address Wilkinsons
1-5 Outram Street
Sutton in Ashfield
NG17 4BX

Prepared for West Notts College
Derby Road
Mansfield
NG18 5BH

Condition Survey Report

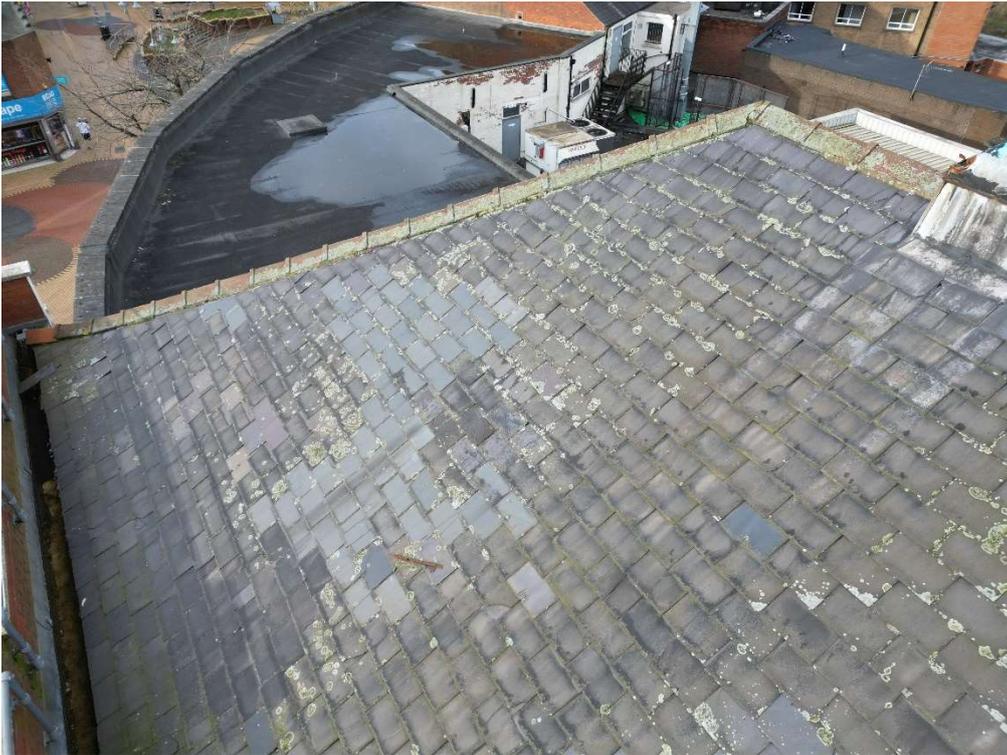
The main pitched roof above the second-floor stock room is in poor condition. Externally a number of slates are showing signs of physical damage with a number of fractured and damaged slates observed, particularly around the ridge line. A number of slipped slates are resting in the valley gutter to the northern and southern elevations (photos 1, 2, 3 and 4). Two holes are present to the northern pitch where slates have slipped (photo 5). A number of replacement tiles were observed, particularly to the southern pitch. The extent of slipped and damaged slates observed and quantity of replacement tiles indicate possibly nail sickness and that the main pitched roof covering has reached the end of its service life and should be replaced.

Photo 1 – Slipped, damaged and replaced slates southern elevation.

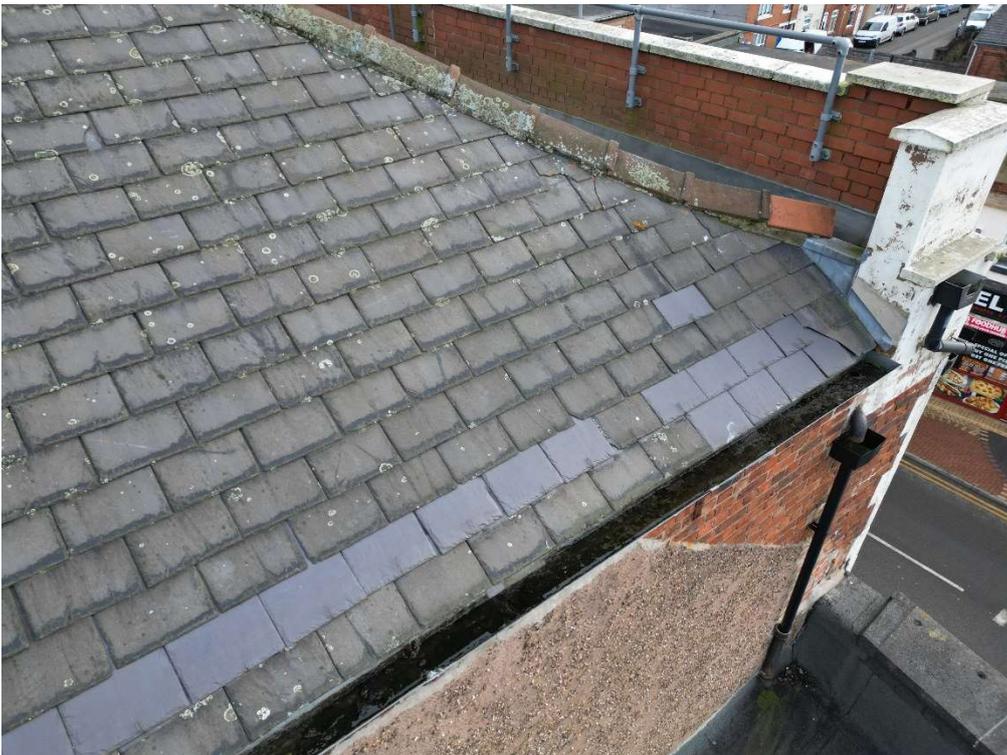
Photo 2 – Damaged and new slate courses, western elevation.

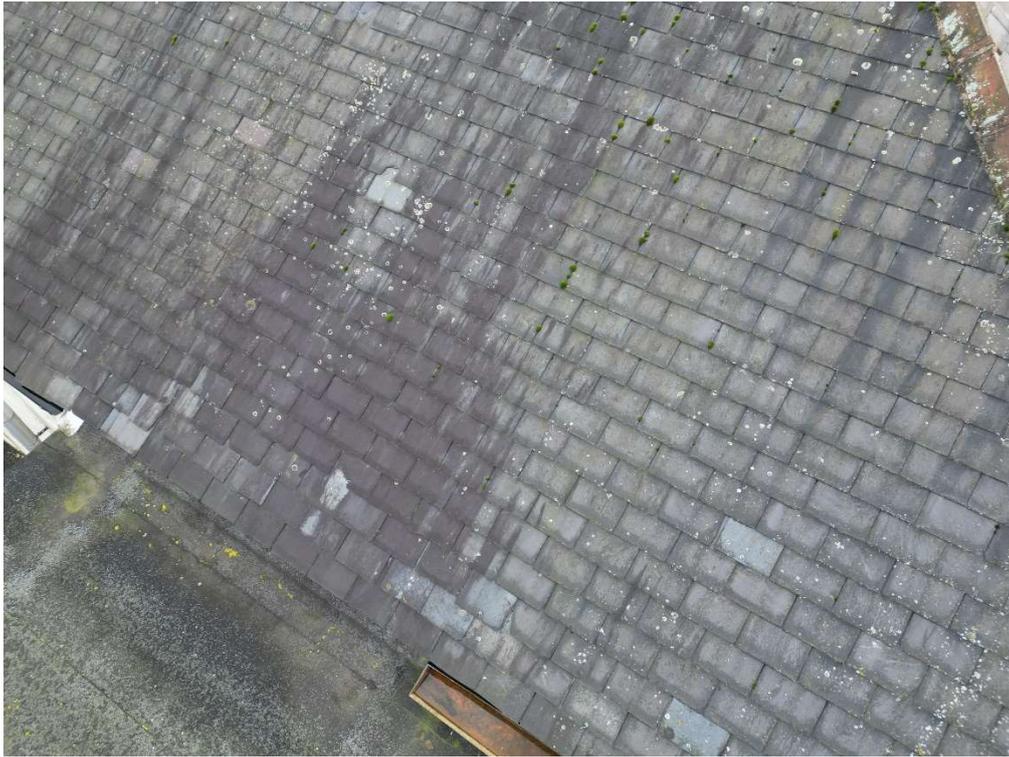
Photo 3 – Damaged and slipped slates, northern elevation.

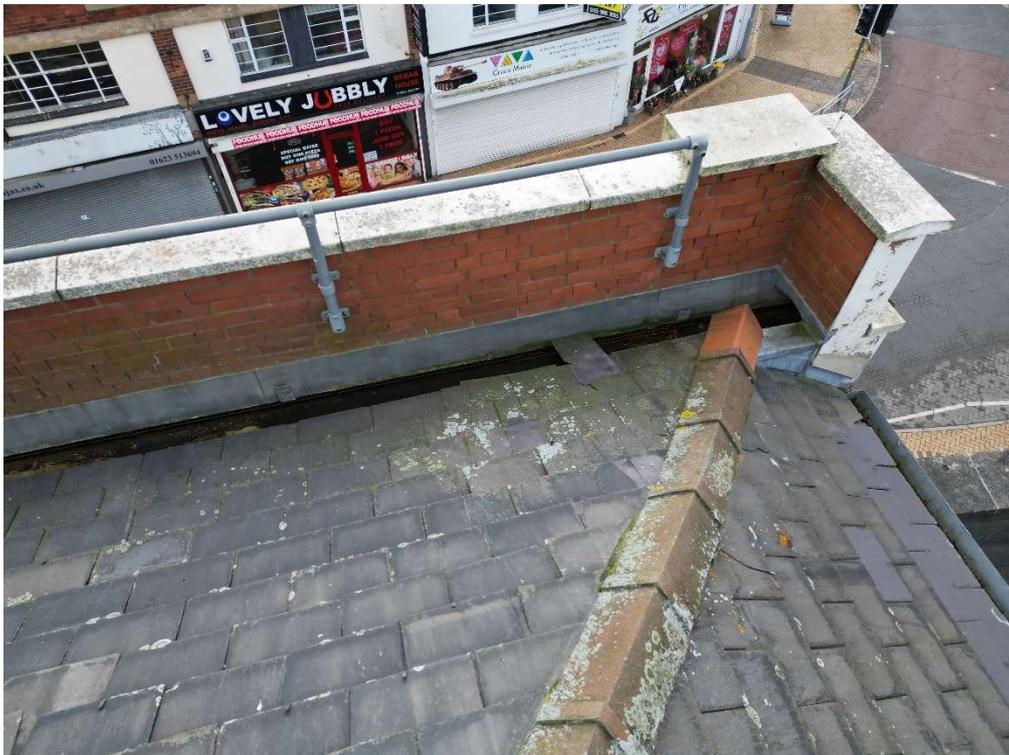
Photo 4 – Slipped slates resting in valley, southern elevation.

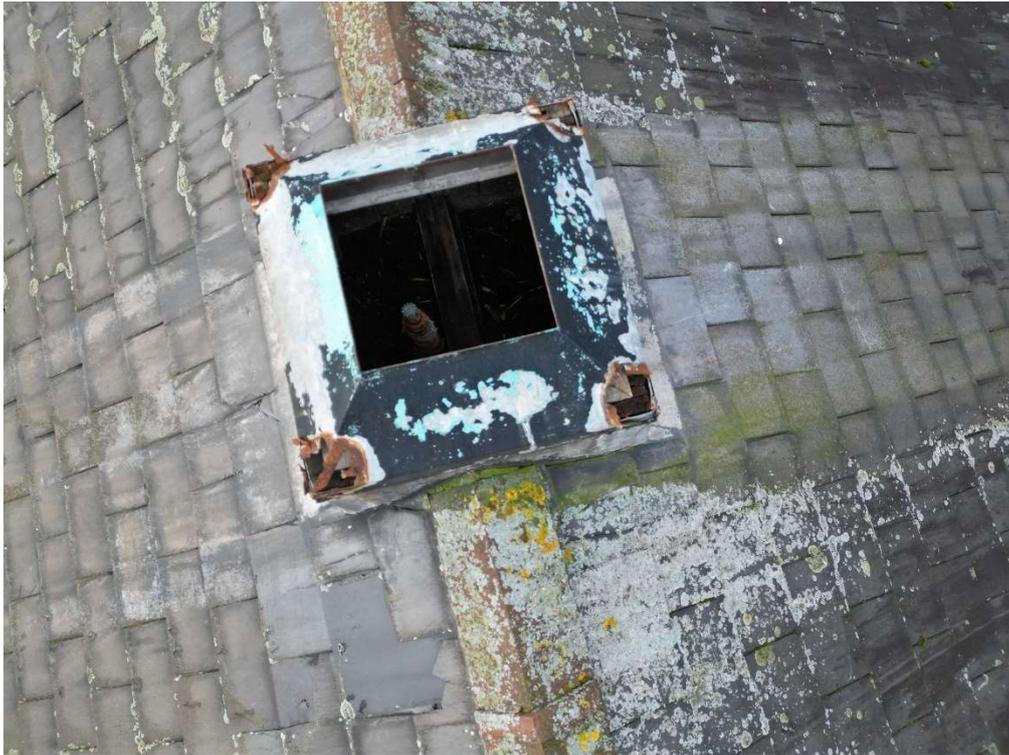
There are two redundant roof vents built into the roof line at the western and eastern ends of the roof. The eastern vent has been capped off with a felt covering. The western vent is heavily corroded with holes at all four corners and a missing cover. Due to its condition the vent will be allowing rainwater to penetrate the building fabric (photos 6 and 7).

Photo 7 – Heavily corroded and defective roof vent, western end of main roof pitch.

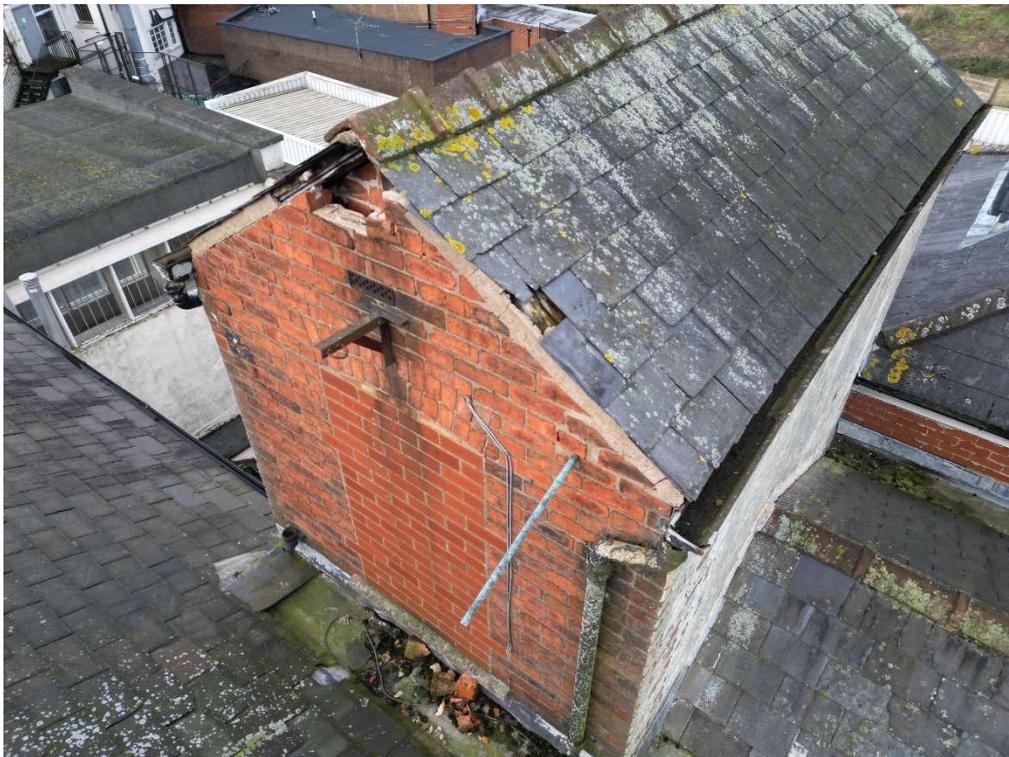
The smaller pitched roofs are in equally poor condition. Slates are missing above the southern gable end wall of the original lift shaft. The missing slates have exposed timber roof trusses. The visible timber elements are severely rotten as a result of continuous water ingress. The roof void in this area could not be accessed however it is reasonable to conclude that other timber elements within the roof have been affected by water ingress. It is advised that these timbers are exposed and inspected prior to undertaking any roof repairs (photo 8). The mortar fillet between the slate roof covering and external walls has also failed and requires replacement.

Photo 8 – Missing slates and exposed roof timbers, original lift shaft (note, brickwork defects discussed later).

As with the main pitched roofs the roof coverings to the smaller pitched roofs have reached the end of their service life, it is recommended that the slate roof coverings are stripped and replaced. Rotten timber roof trusses to the original lift shaft should be renewed. The roof structure above the eastern stairwell should also be inspected during any repairs as this area could not be accessed during the inspection.

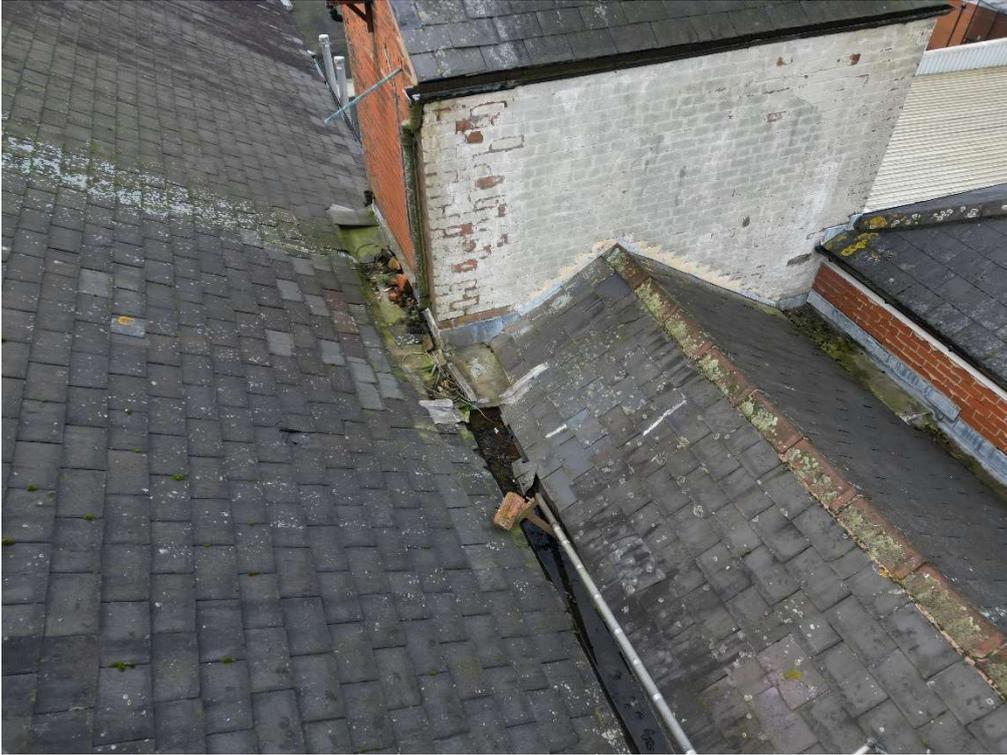
An area of slipped and damaged slates is evident to the southern pitch of the roof above the eastern stairwell. Slipped slates are resting in the gutter at the northern pitch of the eastern stairwell roof (photo 9 and 10). A section of flashing is missing between the lower level eastern stairwell pitched roof and lift shaft. The missing flashing should be replaced.

Photo 9 – Slipped and damaged slates, northern elevation of eastern stairwell roof.

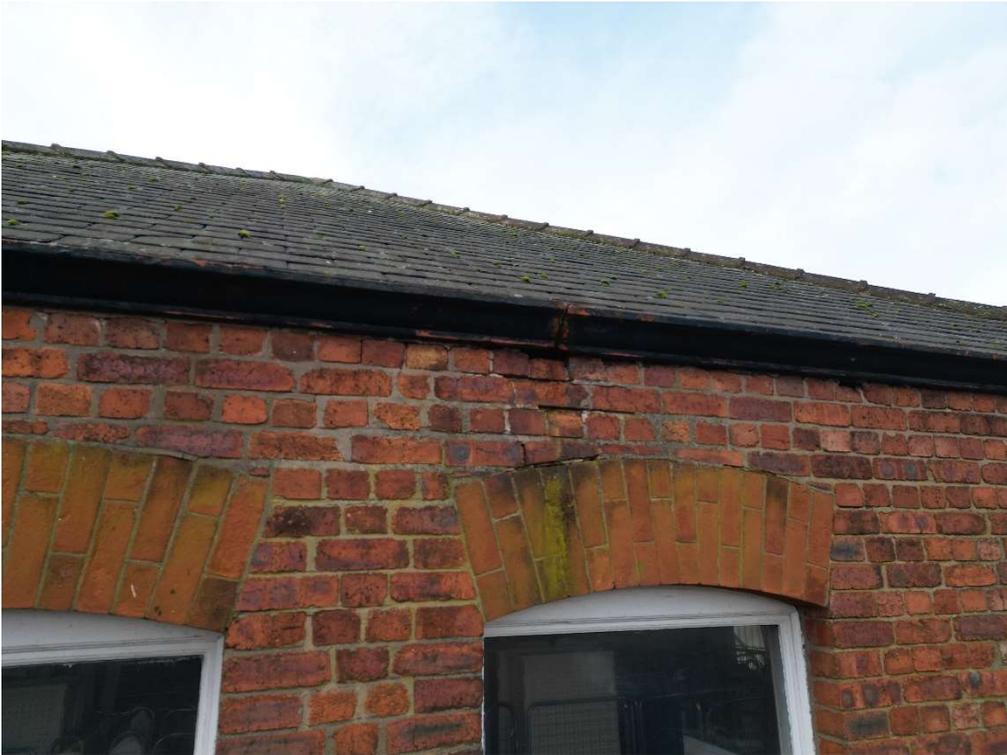
Photo 13 – Open gutter joint and staining, eastern elevation.

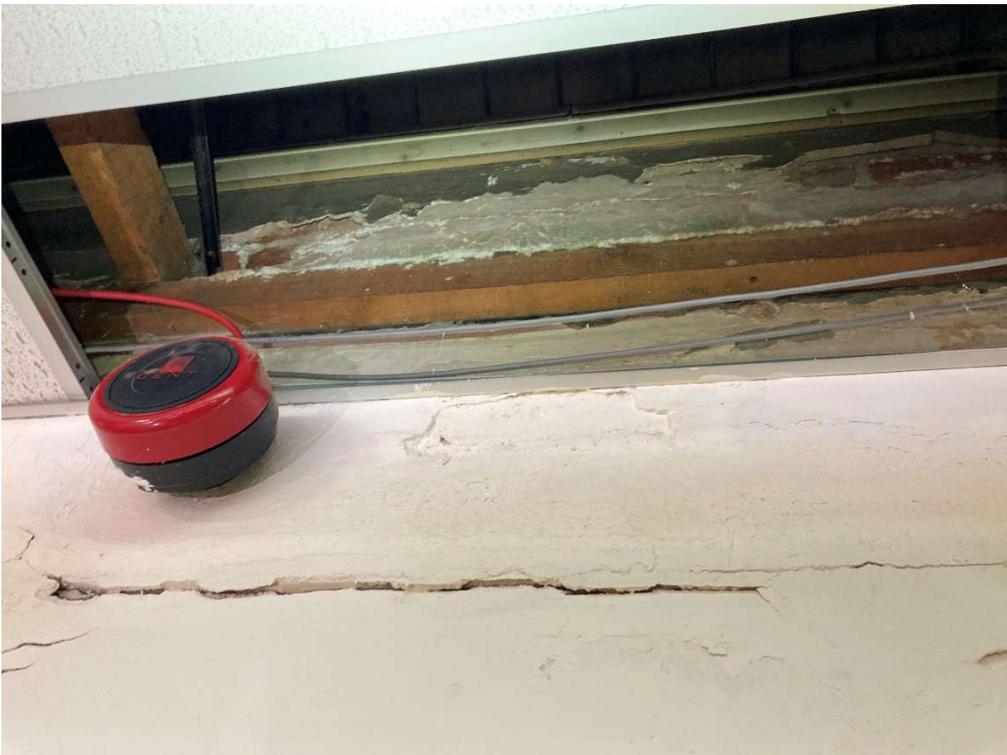
Photo 14 – damp staining above ceiling and fracture to plaster.

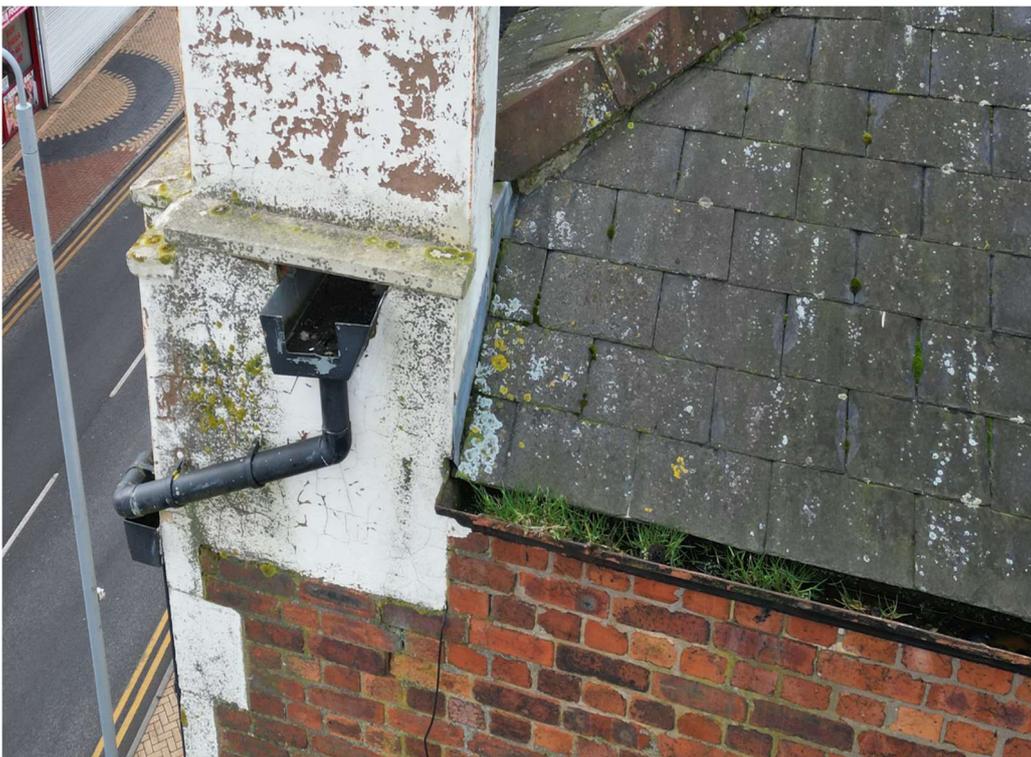
Rainwater goods are predominantly cast iron with some modern uPVC replacements. A number of obstructions were observed including vegetation growth and general debris. Defective and open joints between rainwater goods were observed in a number of locations. The downpipe to the north western corner of the original lift shaft is disconnected from the hopper head and needs to be reattached. All rainwater goods should be cleared, cast iron rainwater goods redecorate and open / displaced joints sealed (photo 16).

Photo 16 – Blocked rainwater goods.

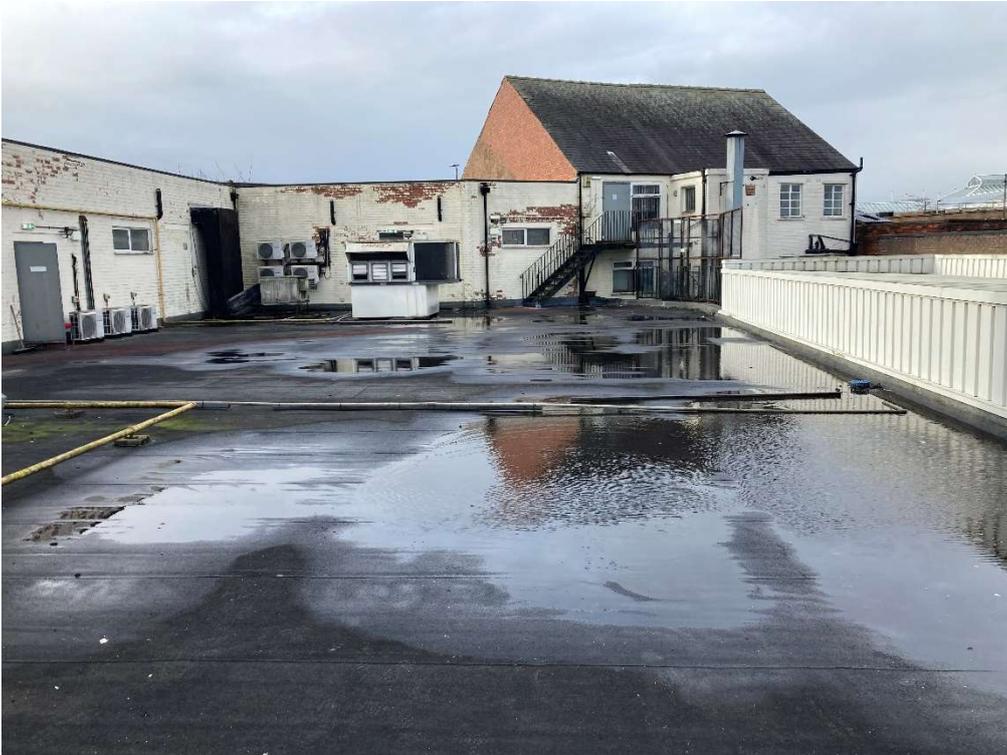
Flat roof coverings are reaching the end of their service life. Significant amounts of standing water are evident to the flat roof at the northern side of the building above the ground floor shop area indicating insufficient roof falls. Standing water will accelerate deterioration of the flat roof coverings (photo 17).

Photo 17 – Standing water to flat roof indicating insufficient falls.

Visible areas of the flat roof decks appear to be in generally good condition with slight spalling and leaching observed at joints between deck panels. The bitumen felt flat roof coverings have reached the end of their service life and will require replacement in the short term. Consideration should be given to stripping the flat roofs and renewing within the next three years.

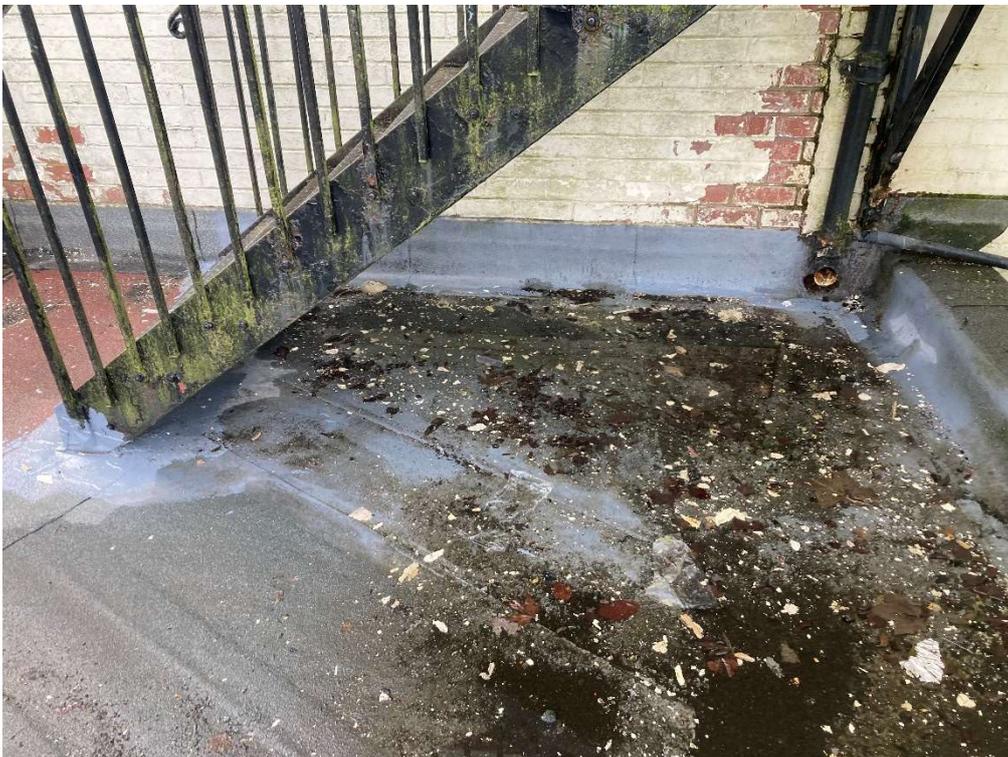
Extensive patch and flash band repairs have been undertaken beneath an external escape stair from a neighbouring property. These repairs indicate past roof defects and water ingress (photo 18). The bitumen felt roof covering is bubbled and ridged in a number of areas. Around the upstands and northern valley gutters these ridges are soft / spongy indicating water ingress between the roof covering and roof deck (photo 19). Evidence of water ingress to the rear of an upstand is also evident at the change in roof level between the original lift shaft and stairwell (photo 20).

Photo 18 – Flash band / patch repairs beneath escape stair.

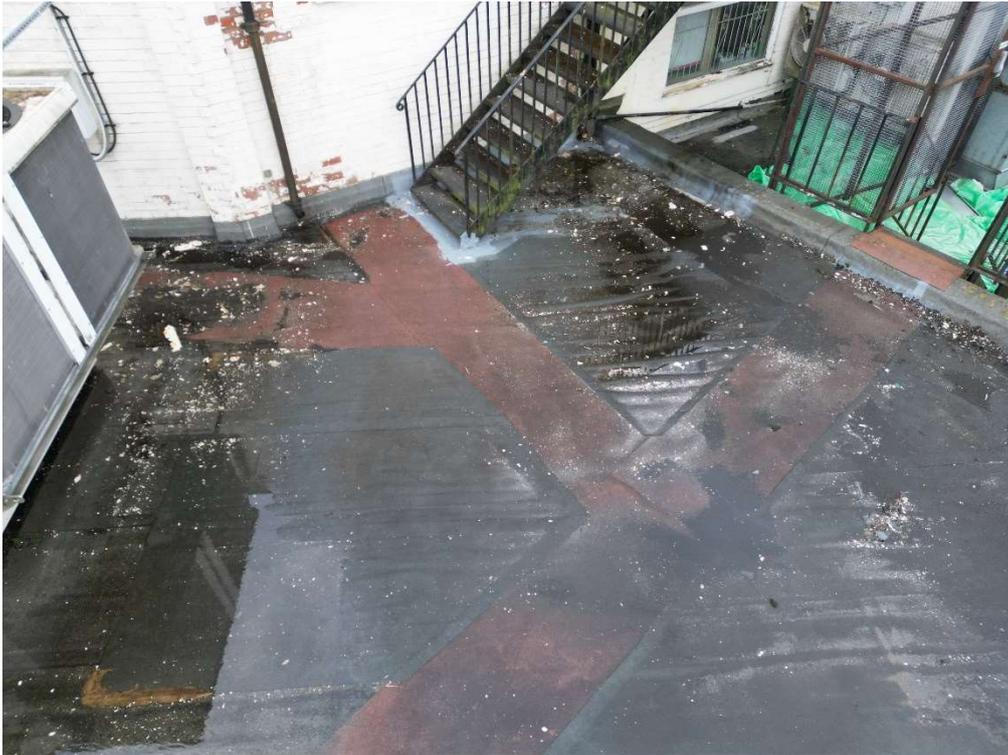
Photo 19 – Ridging to flat roof covering.

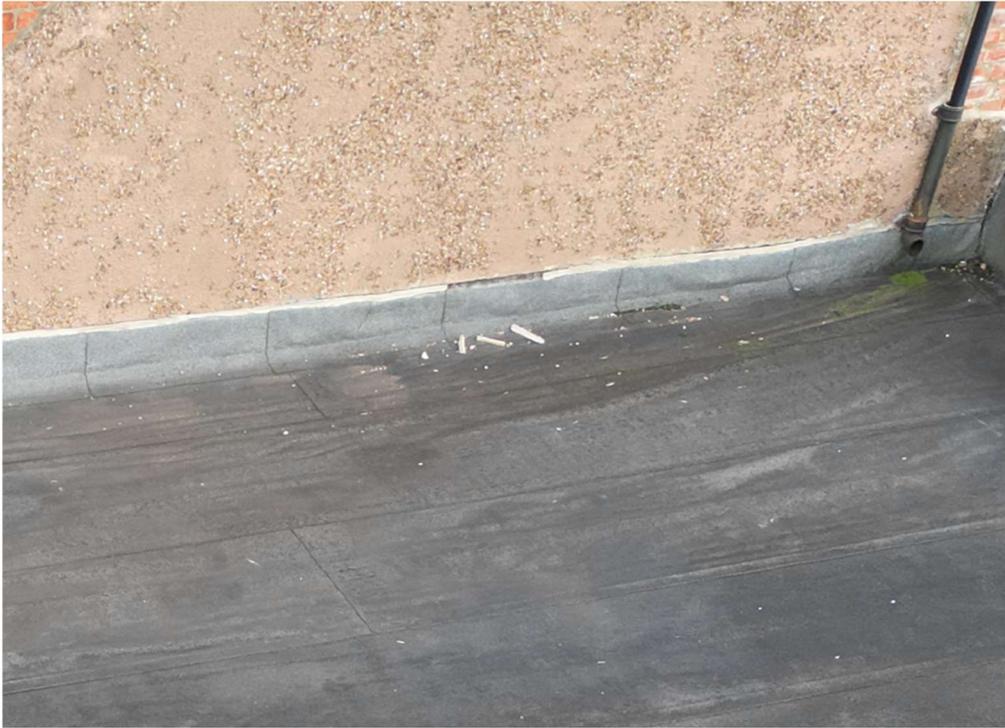
Photo 23 – Damage to mortar fillet above upstand.

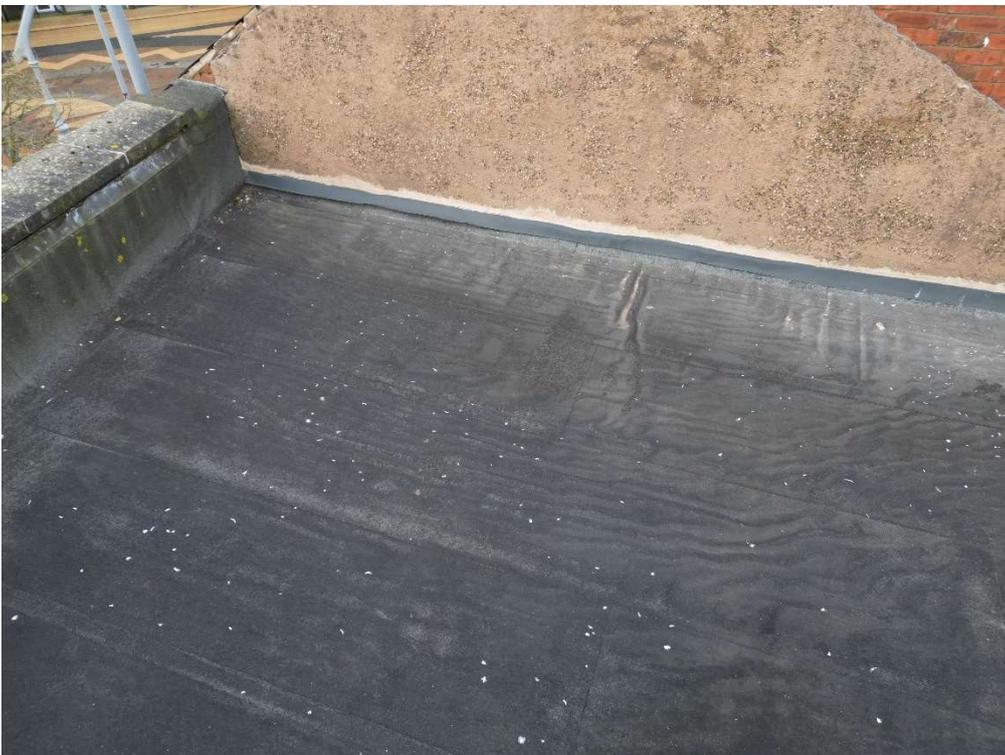
An additional felt upstand has been installed above the original upstand on the western elevation at the joint with the adjoining property party wall. The reason for this additional upstand is unclear but may indicate previous leaks / water ingress. The new upstand is poorly lapped and likely to be ineffective (photo 24).

Photo 24 – Western upstand.

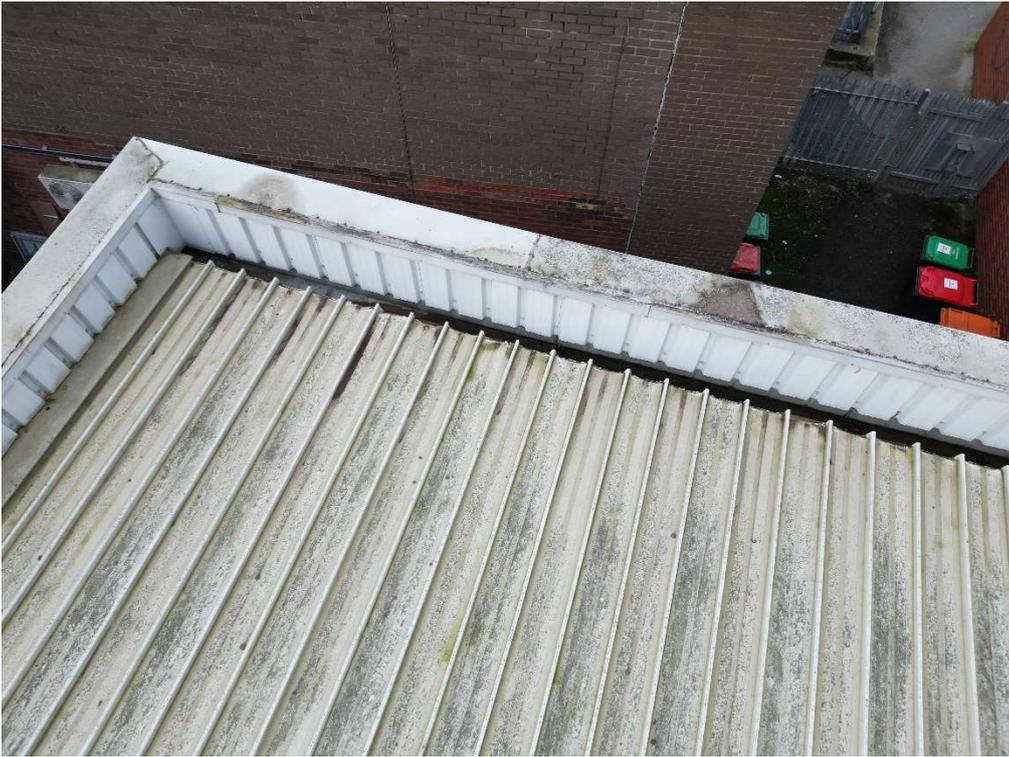
The profiled sheet clad flat roof above the modern extension at the north of the building is in fair condition. There is evidence of extensive cut edge corrosion at the cladding sheet edges (photo 31) and odd corrosion spots to the roof panels (photo 32). The roof should be coated with a giromax or

Photo 31 – Cut edge corrosion.

similar coating to prevent further deterioration. Damp staining to the northern elevation external wall approximately 6.0m from the right hand side of the rear entrance door indicates potential blocked / defective rainwater goods allowing water to penetrate behind the fascia cladding.

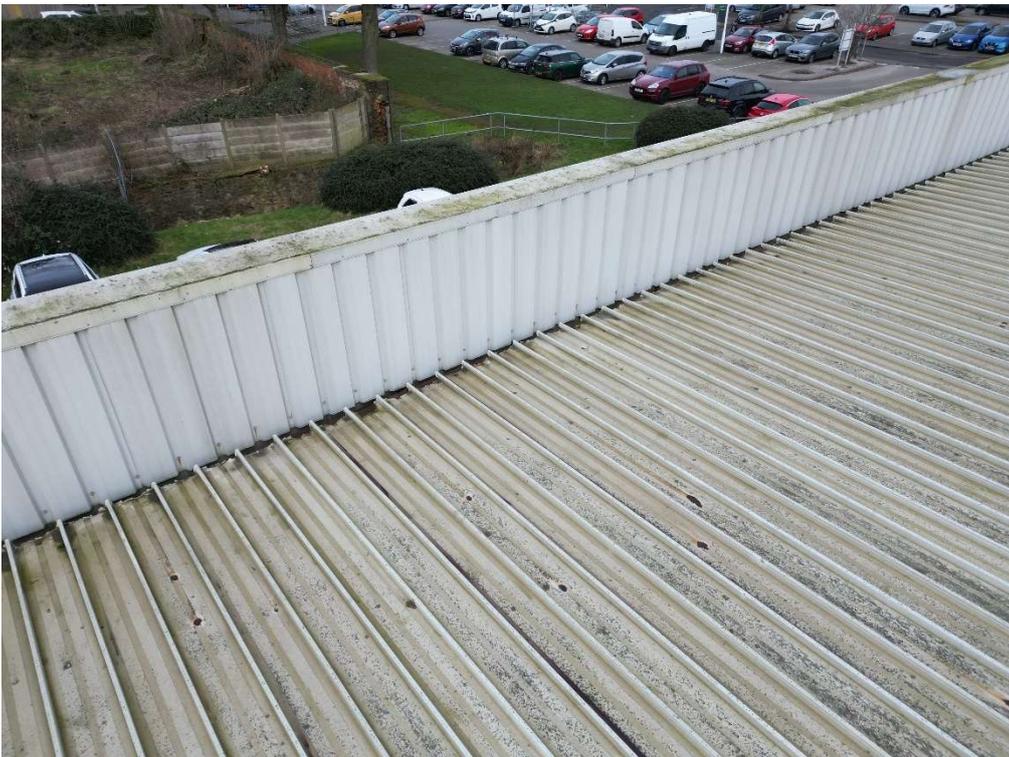
Photo 32 – Corrosion spots to roof covering.

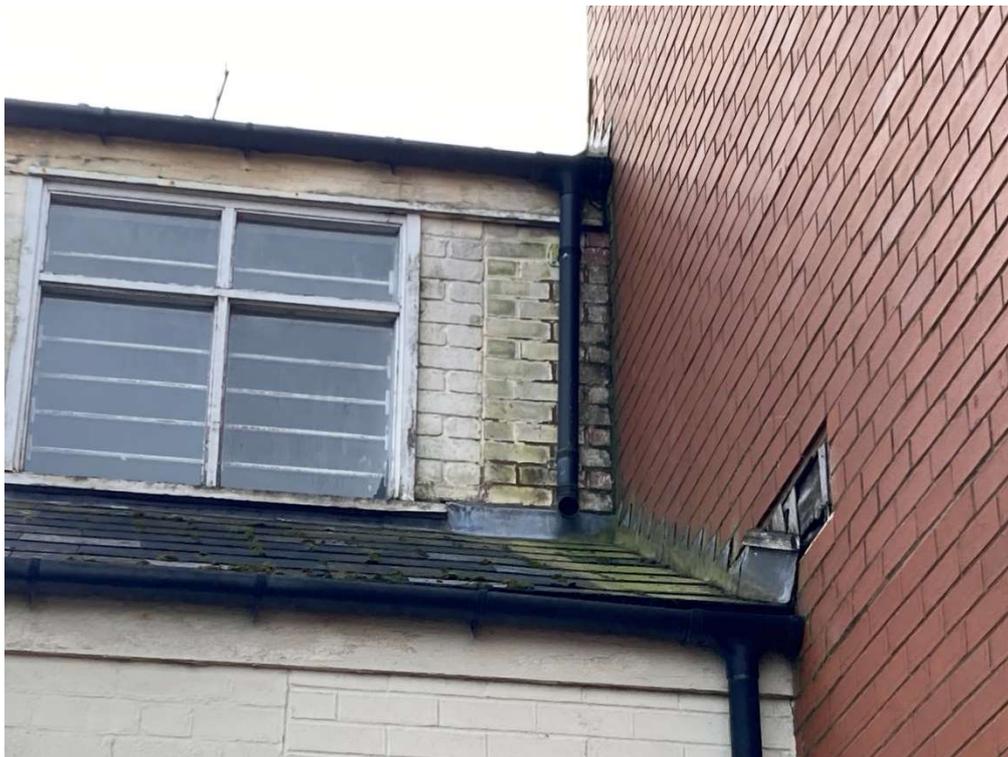
At first floor level some open joints were observed to the right of the eastern stairwell window as a result of defective rainwater goods discussed previously (photo 33). Small areas of open joints and spalling to the face of the brickwork is evident to the external wall section between the original lift shaft and main stairwell, again this is due to defective rainwater goods (photo 34).

Photo 33 – Open brickwork joints due to defective rainwater goods.

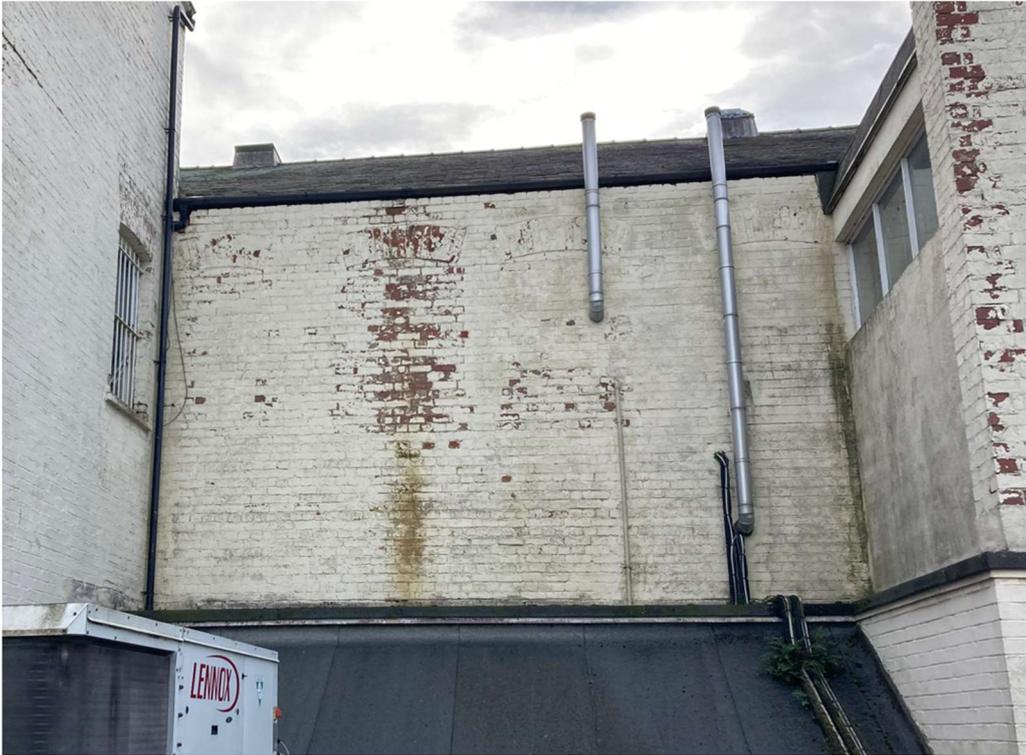
Photo 34 – Spalled brickwork, external wall between original lift shaft and stairwell.

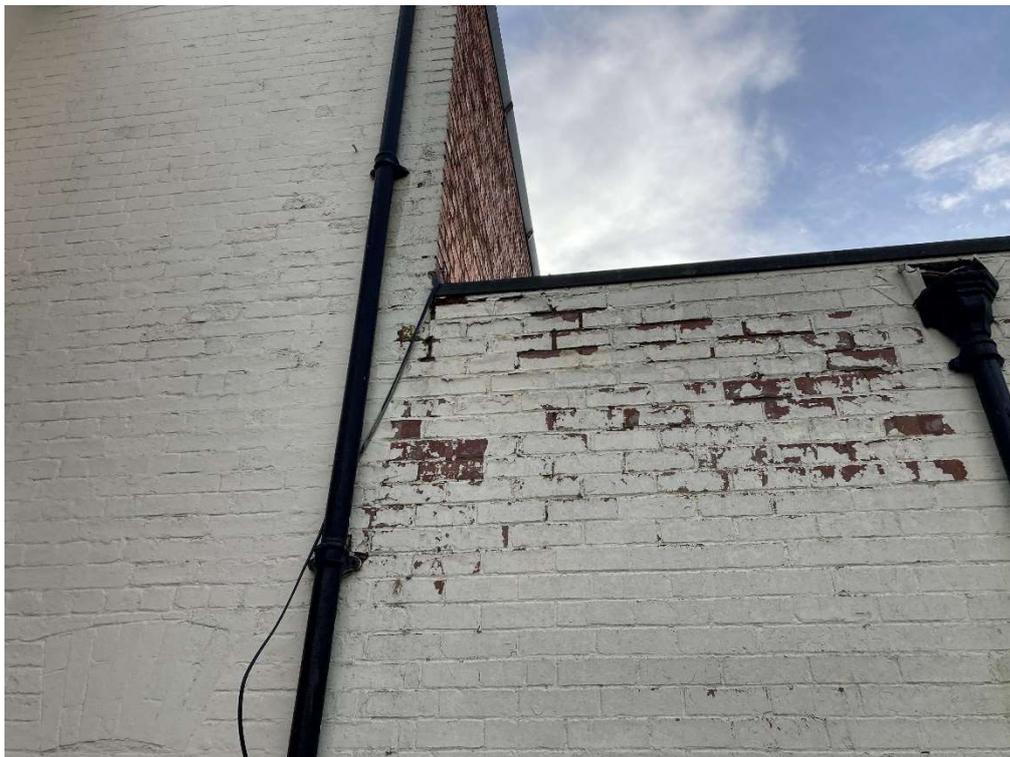
Small areas of spalling and open joints are also evident to the northern external wall above the staff room fire exit doors (photo 35 and 36). Other small areas of surface spalling and open joints are evident throughout the northern external elevation at first and second floor level.

Photo 35 – Spalled brickwork, northern elevation first floor staff room.

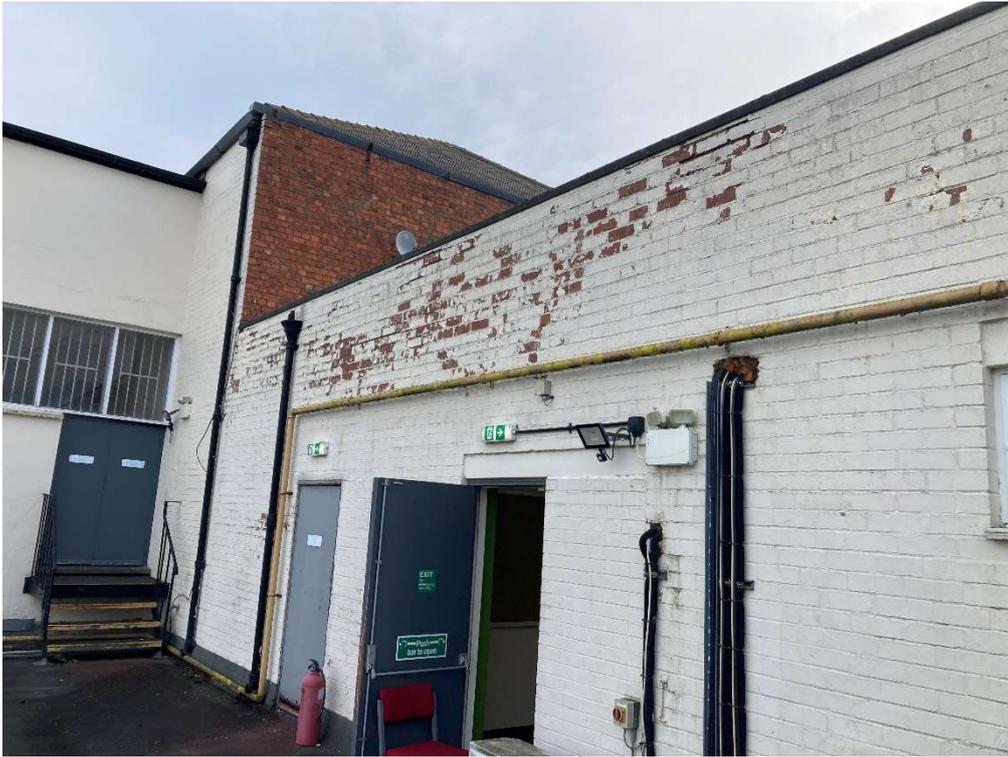
Photo 36 – Open joints above staff room, northern elevation.

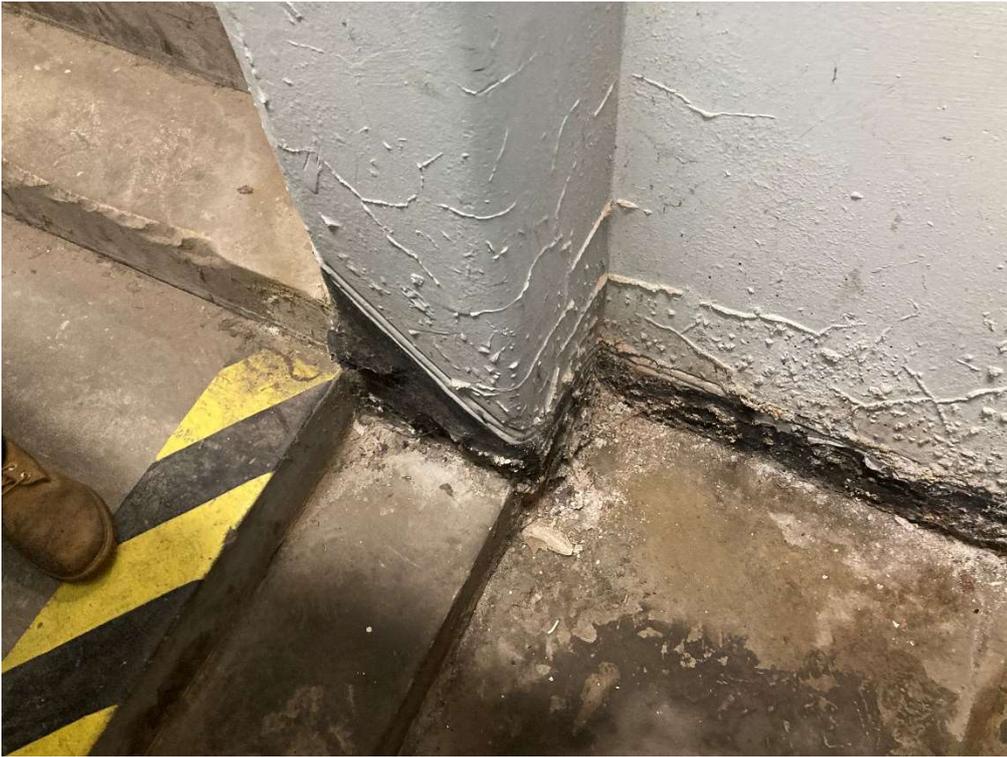
Photo 37 – Rising damp, base of eastern stairwell.

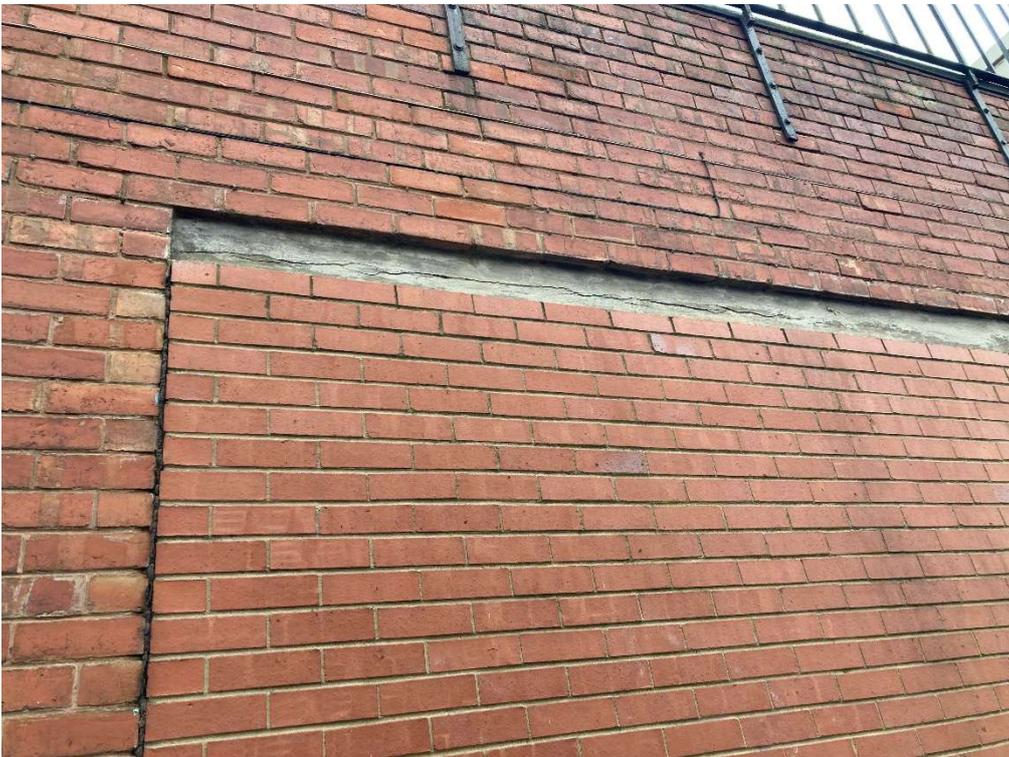
Photo 40 – Fractured lintel above opening.

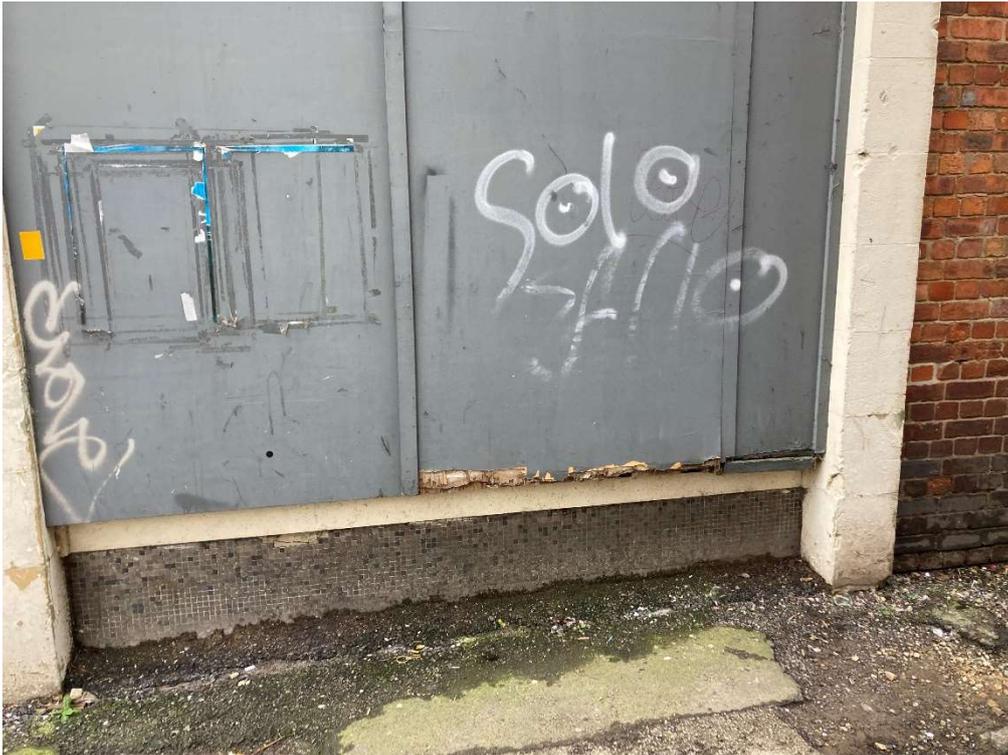
Photo 41 – Rotten timber infill over window.

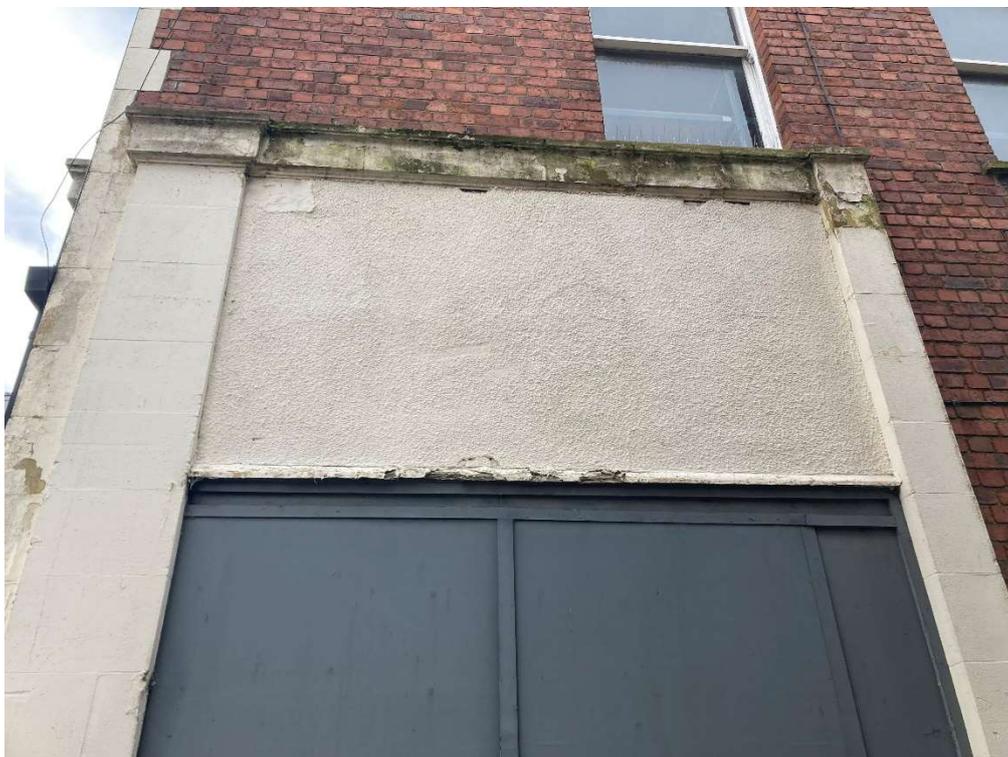
Photo 42 – Deteriorating render above window opening and weathering to masonry surround.

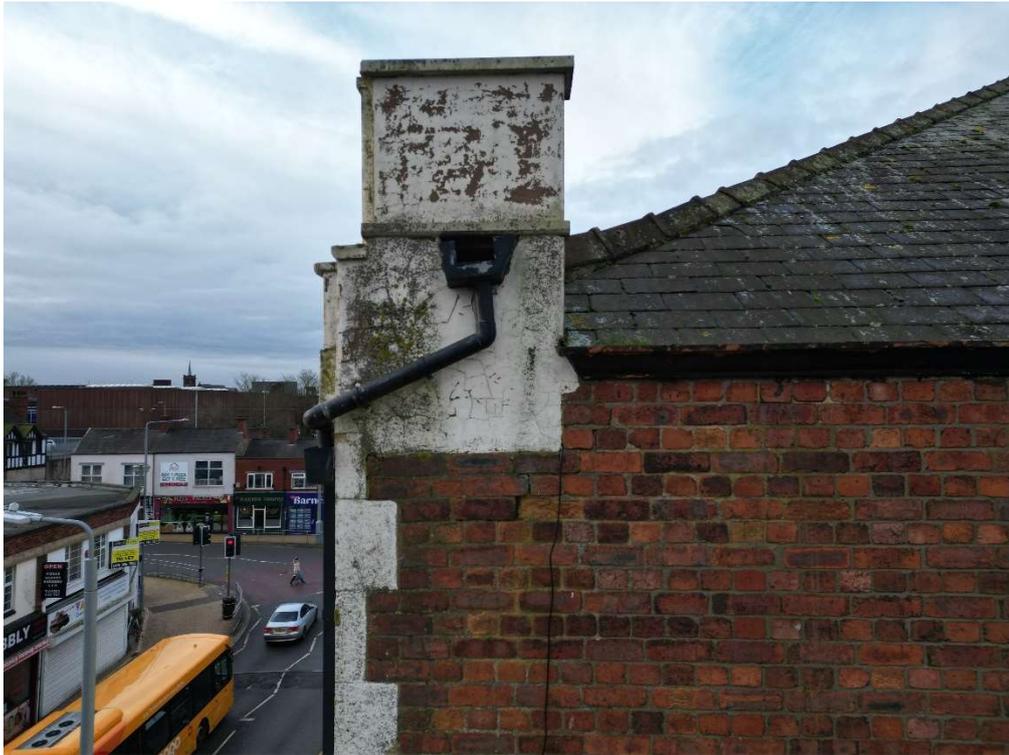
A step fracture is evident at the top southern end of the elevation just below the parapet. The step fracture is open up to 5mm and extends 6nr brick courses. The cause of the fracture is unclear but may indicate slight rotation of the façade / parapet. This should be inspected by a structural engineer at the same time as the façade (see later section). Photo 43.

Photo 43 – Step fracture beneath façade / parapet.

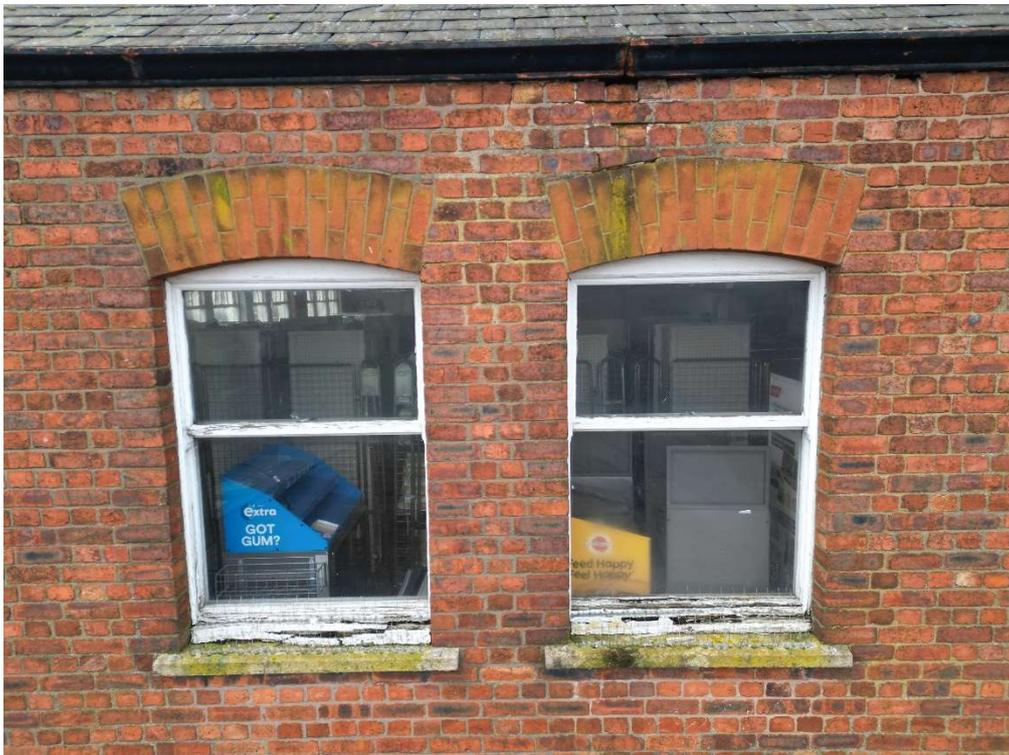
Deep open joints are evident beneath the gutter leak to the centre of the elevation (photo 44). See previous section regarding the gutter defect.

Photo 44 – Small area of deep open joints due to gutter defect.
