Building Survey Report

Address Wilkinsons
1-5 Outram Street
Sutton in Ashfield
NG17 4BX

Prepared for West Notts College
Derby Road
Mansfield
NG18 5BH

Condition Survey Report

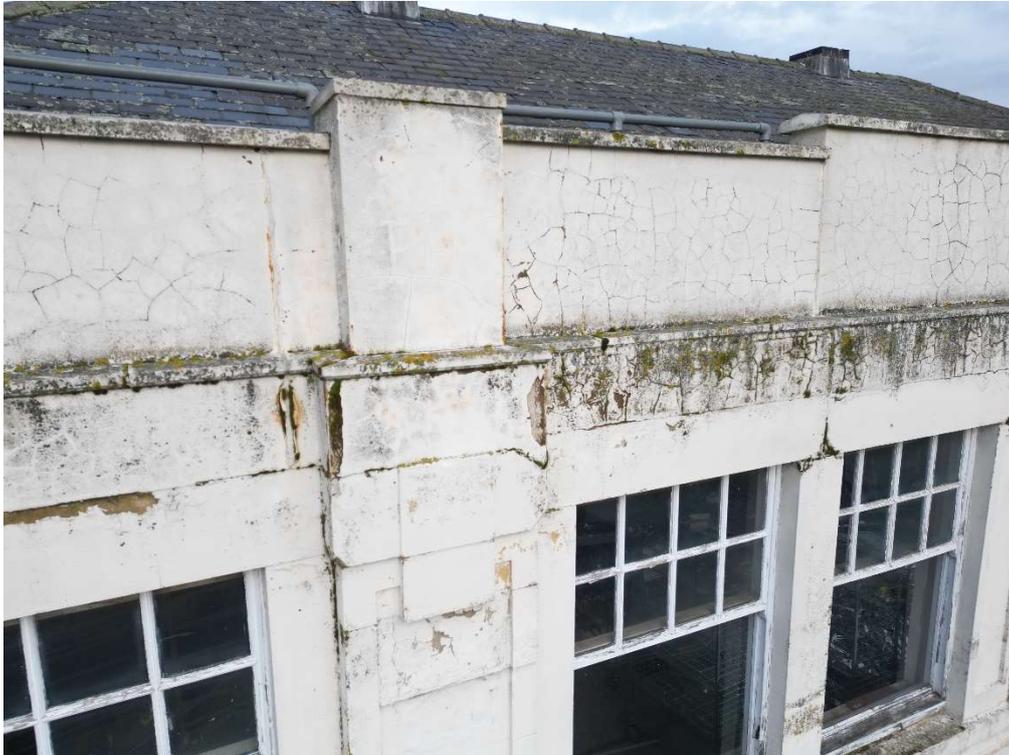
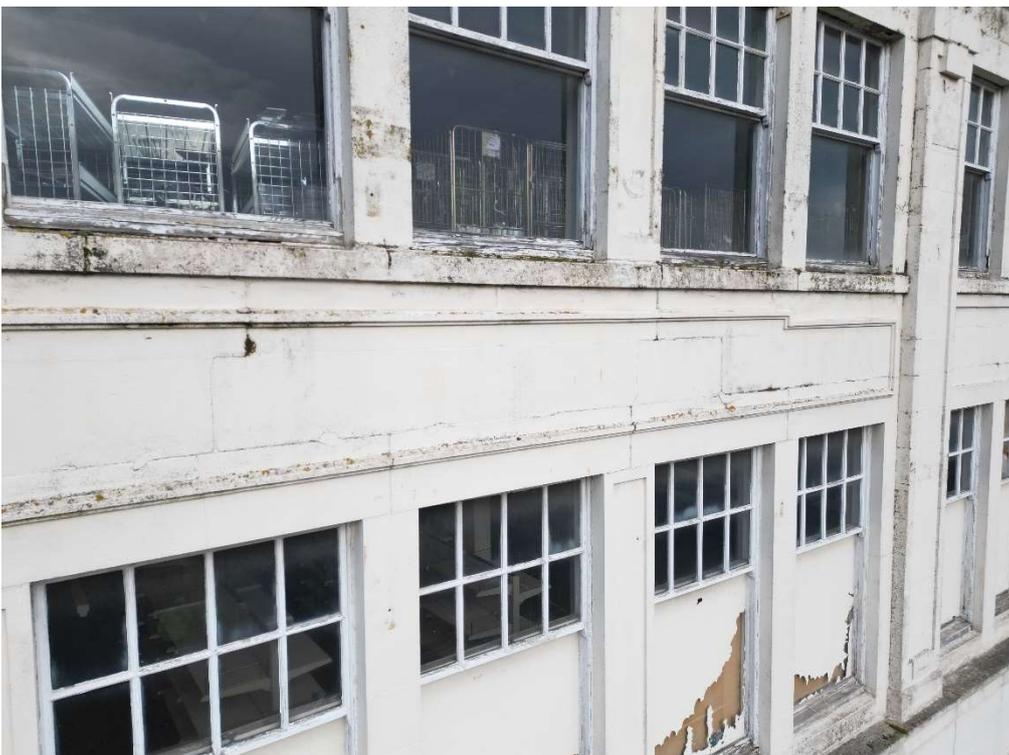
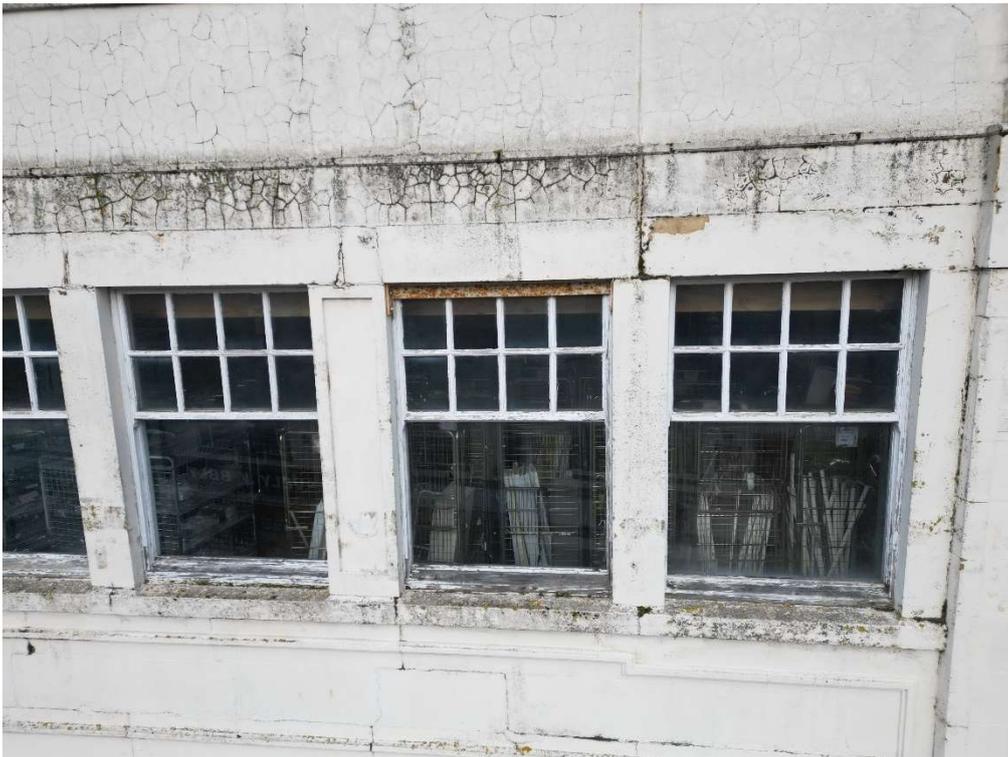
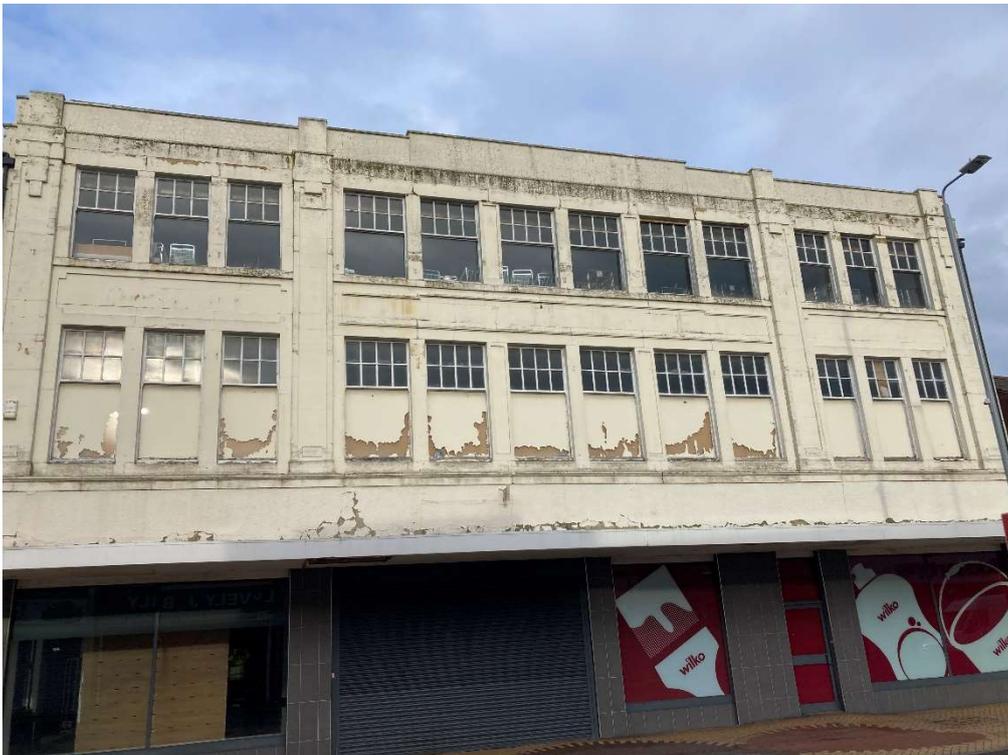
Photo 45 – Failing render to façade parapet.

Photo 46 – Typical fracturing to façade.

Photo 47 – Typical weathering to façade stonework and reinforcement above window opening.

Photo 48 – General view of original façade showing poor condition.

Due to the condition of the original façade it is recommended that a structural engineer is appointed to assess its structural integrity and specify any remedial works required.

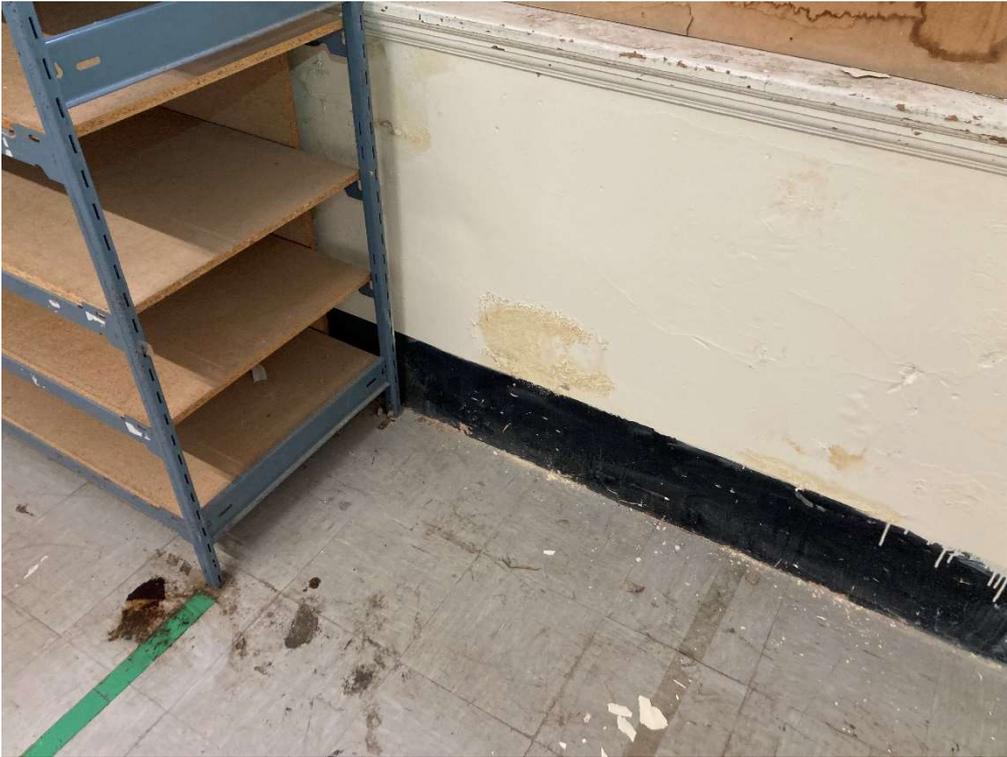
Photo 49 – Damp penetration to internal face of façade at first floor level.

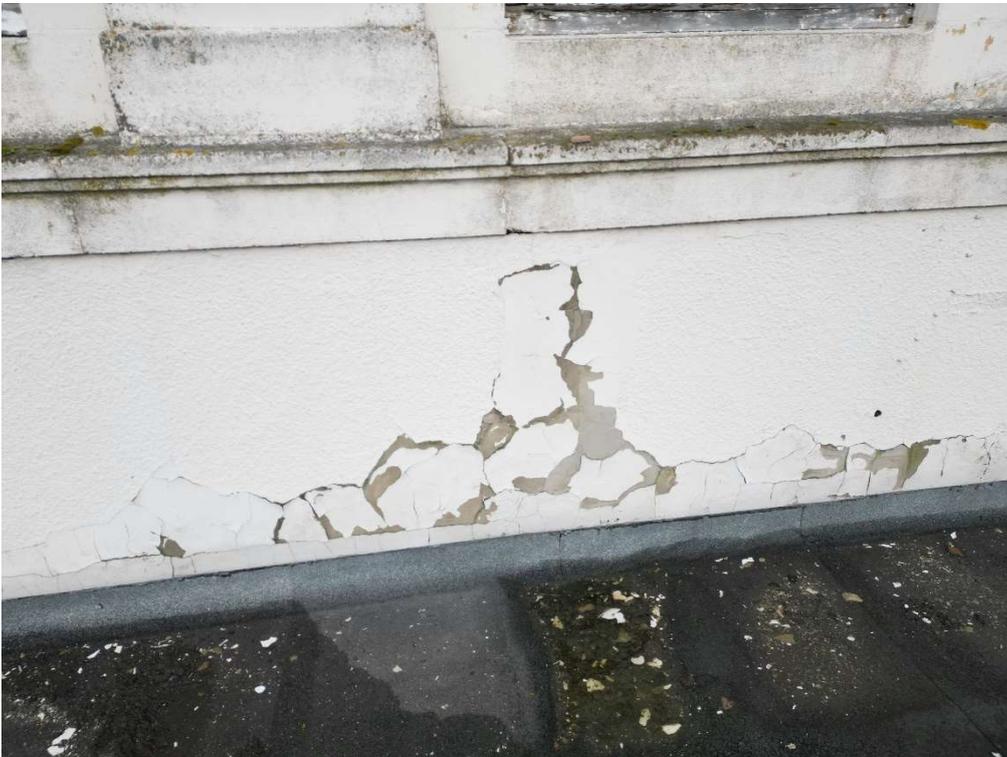
Photo 50 – Damage to render finish above shopfront canopy.

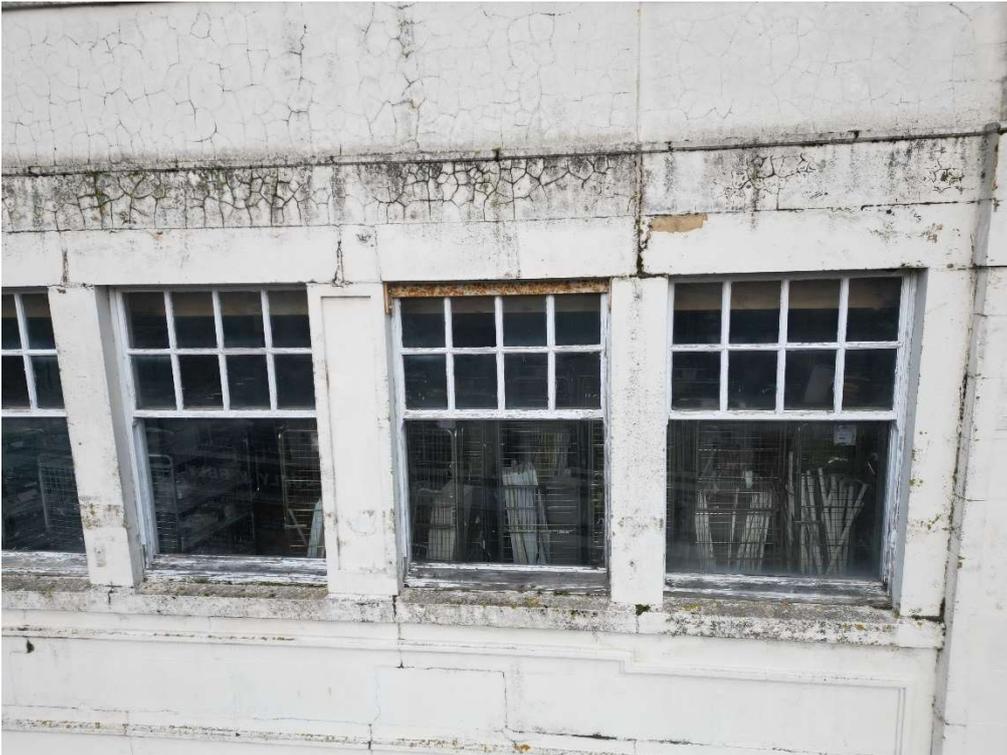
Photo 51 – Steel above window opening. Note condition of lintels and cills.

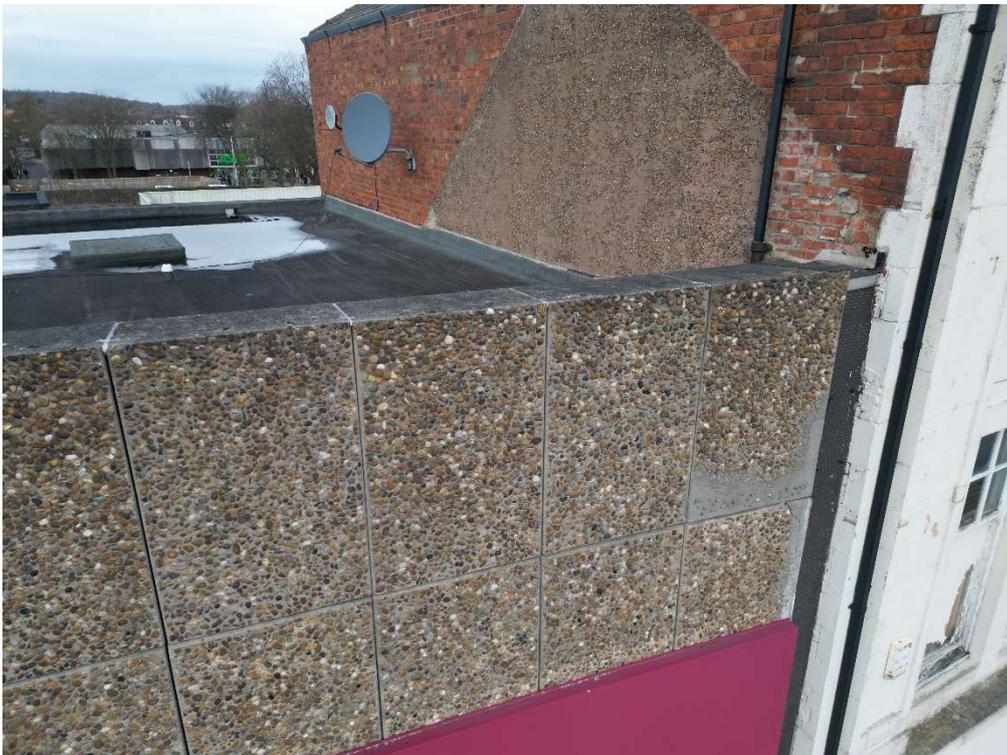
Photo 52 – Patch repairs to concrete cladding panels.

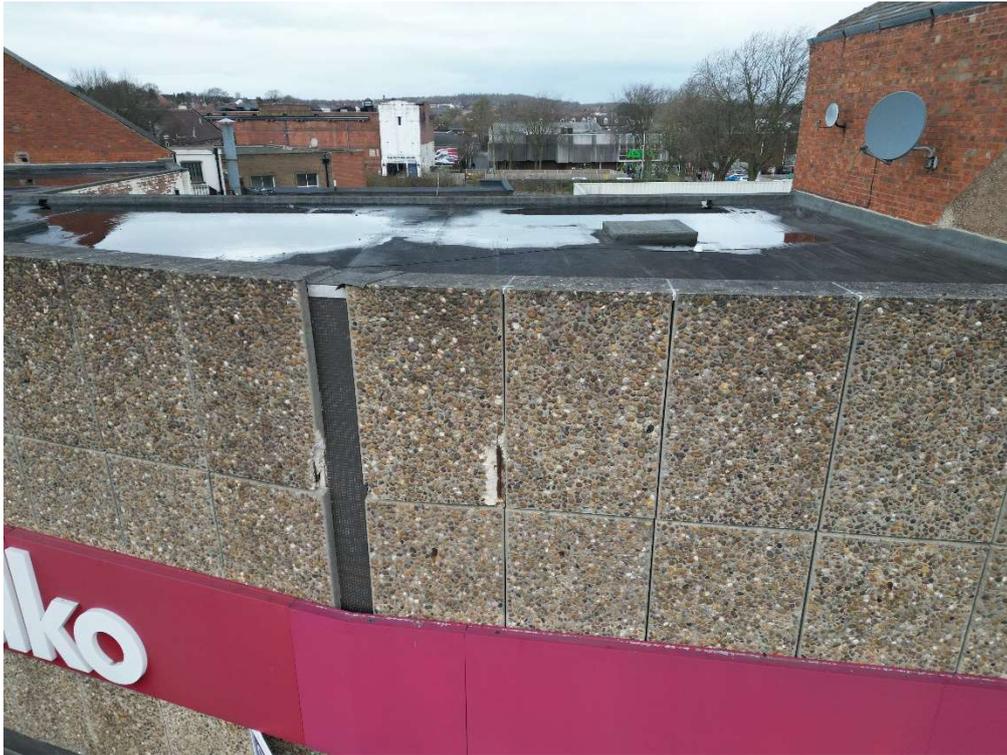
Photo 53 – Spalled cladding panels and exposed reinforcement.

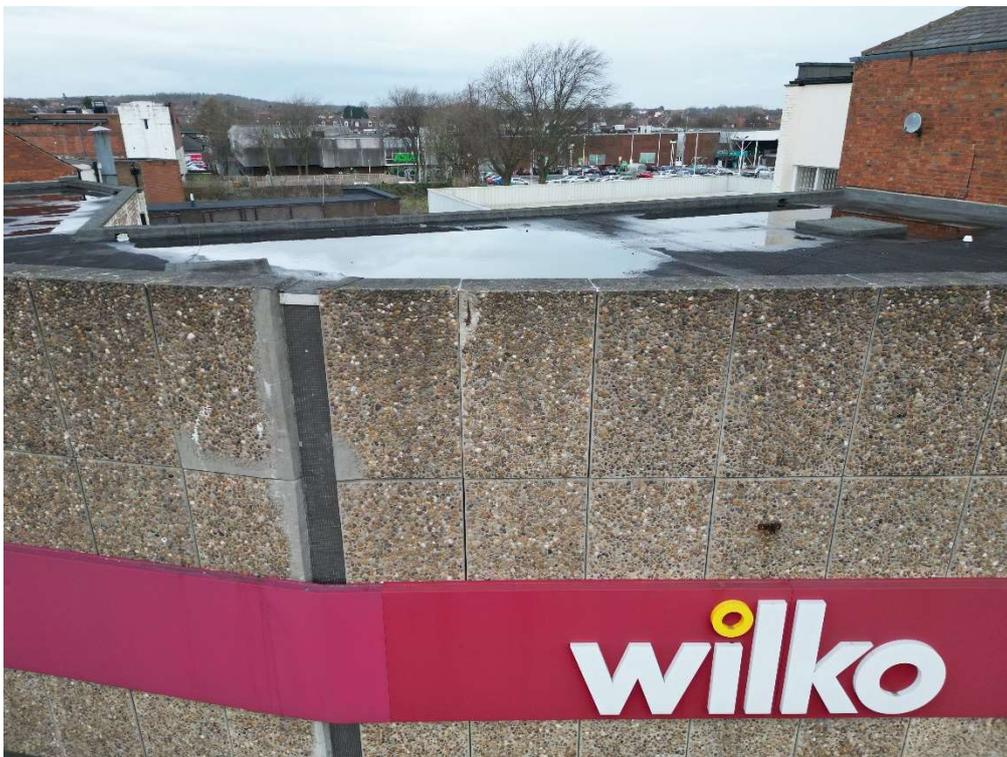
Photo 54 – Patch repaired cladding panels and exposed reinforcement.

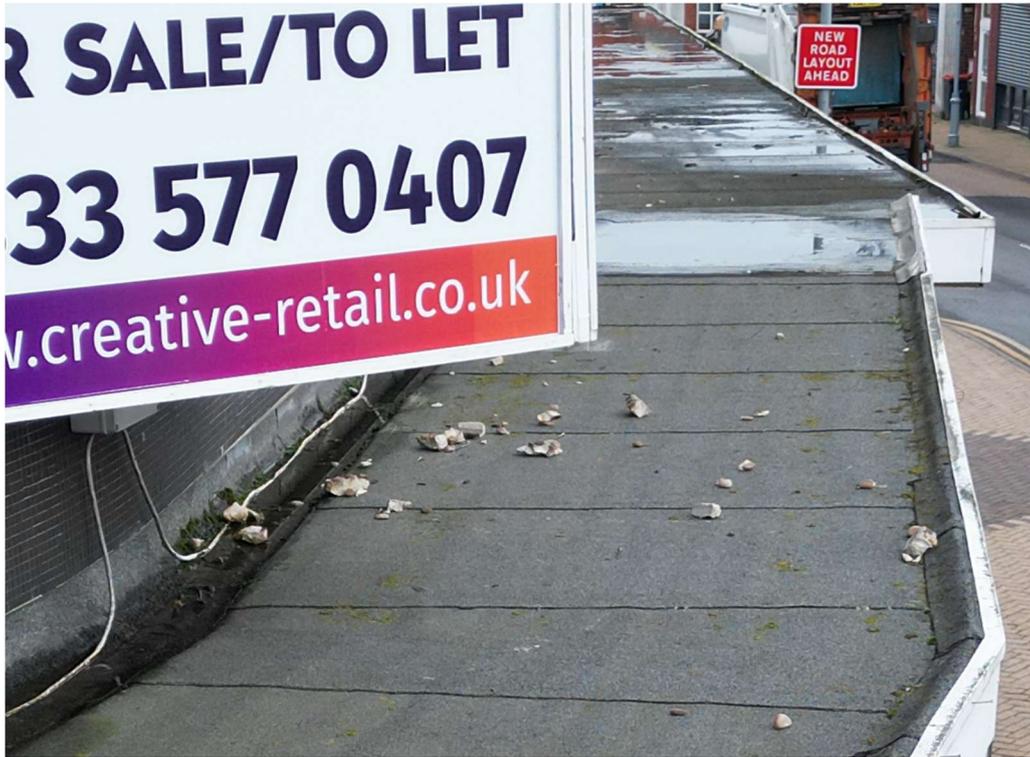
Photo 55 – spalled concrete debris.

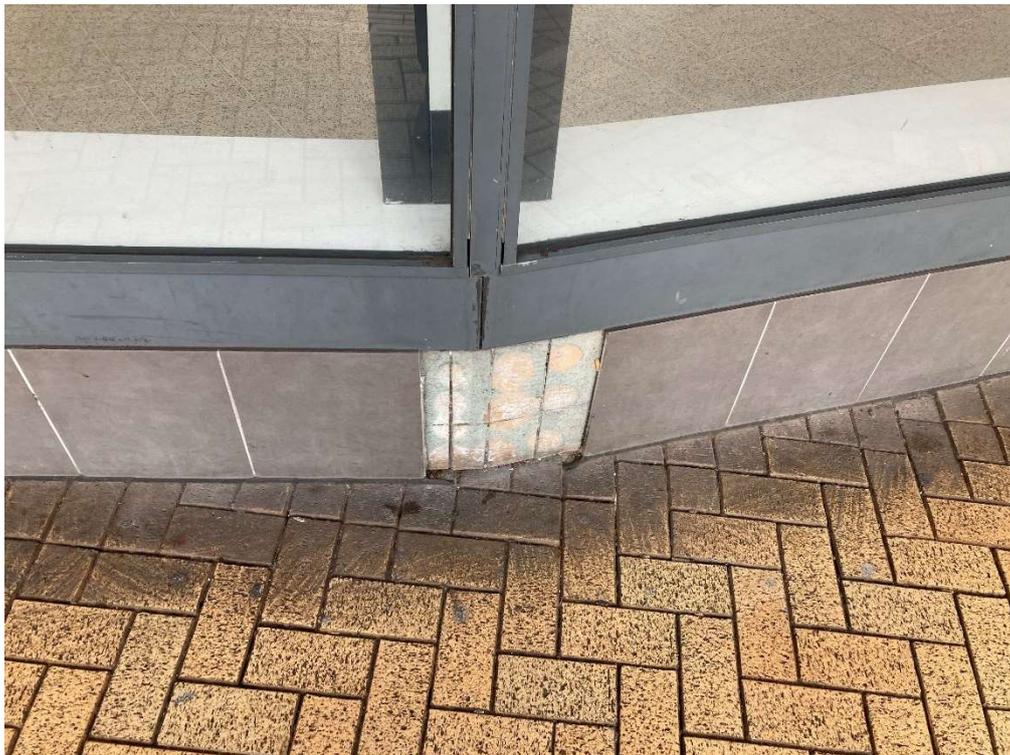
Photo 56 – Missing ceramic tile.

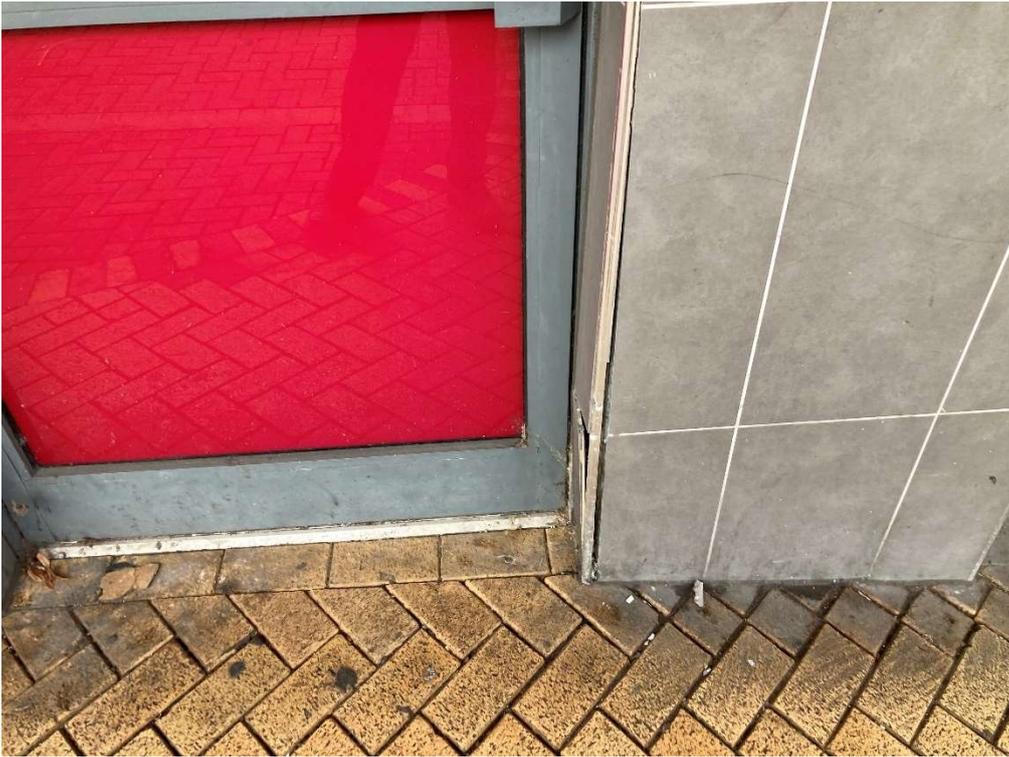
Photo 57 – Damaged / loose ceramic tiles.

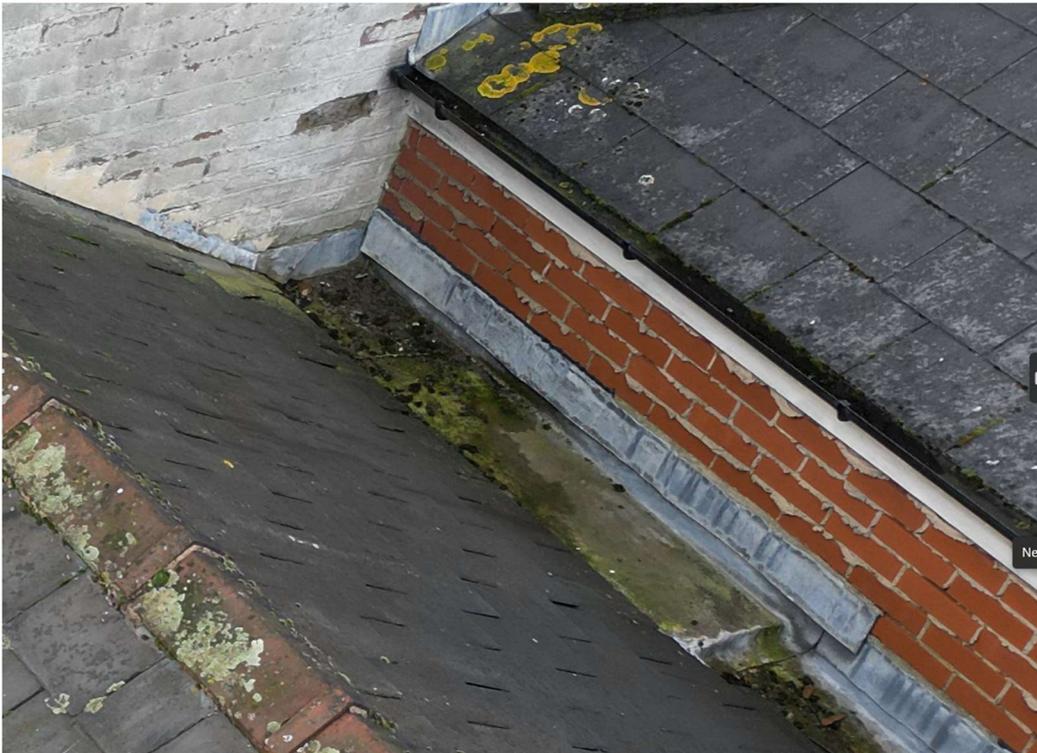
The southern external wall of the new lift shaft has been badly pointed (photo 58) whilst this does not appear to be causing any issues the quality of the pointing is indicative of poor workmanship.

Photo 58 – Poorly pointed wall to northern elevation of lift shaft.

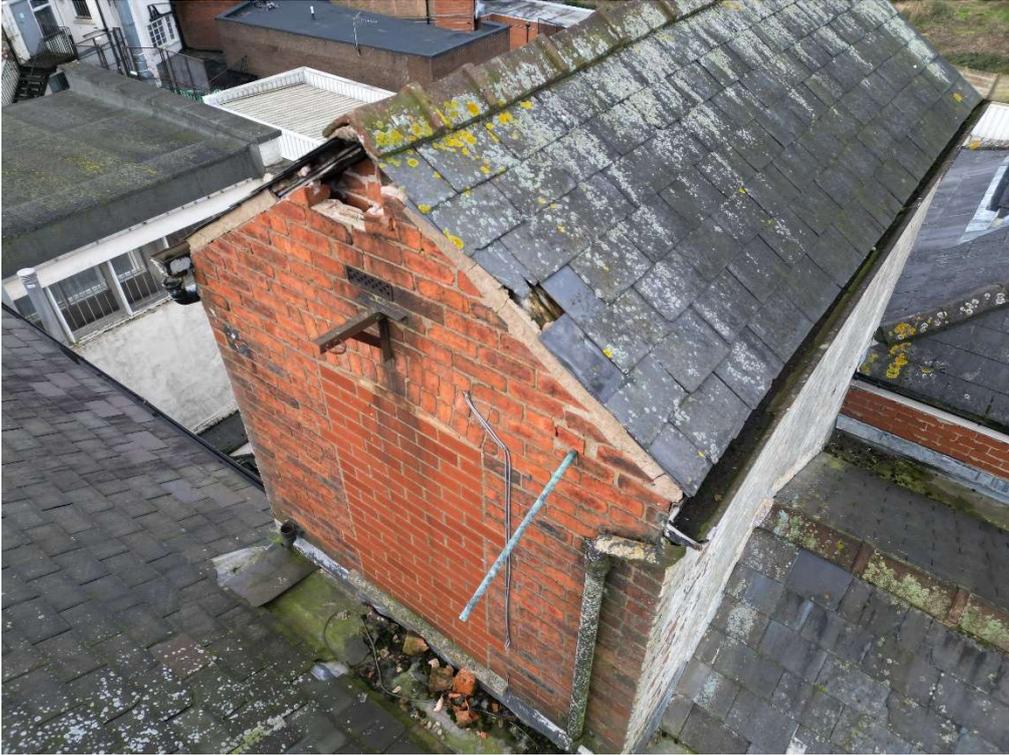
At the rear of the original lift shaft a TV aerial has fallen from the external wall pulling a section of brickwork from the wall. This brickwork should be reinstated.

Photo 59 – Missing brickwork, southern elevation of original lift shaft.

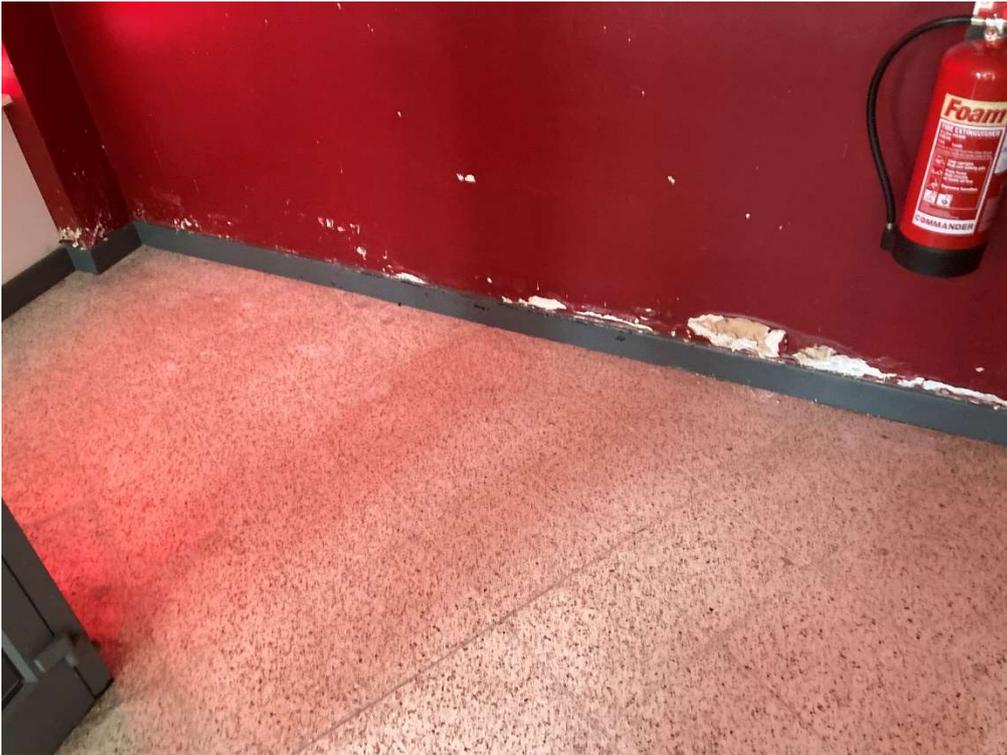
Photo 60 – Rising damp to internal face of wall.

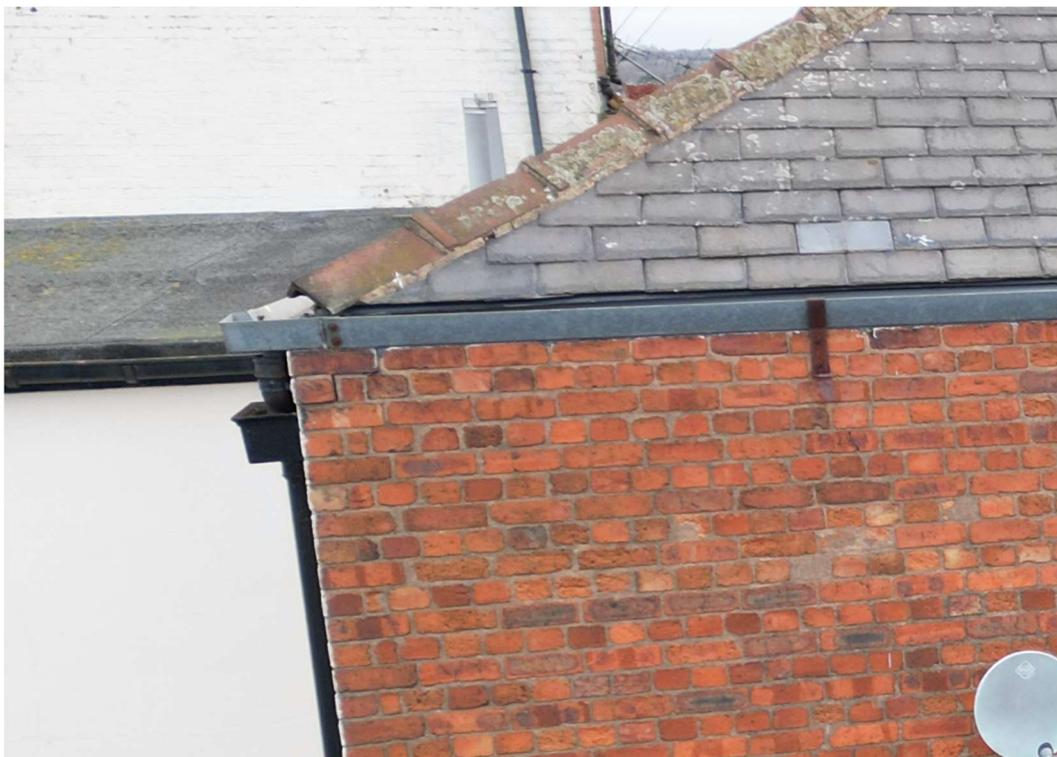
At second floor level the western elevation of the original building appears to be in generally good condition. A small area of loose and displaced brickwork at the left hand side corner requires reinstatement (photo 61).

Photo 61 – Loose / displaced brickwork at LHS corner of eastern elevation.

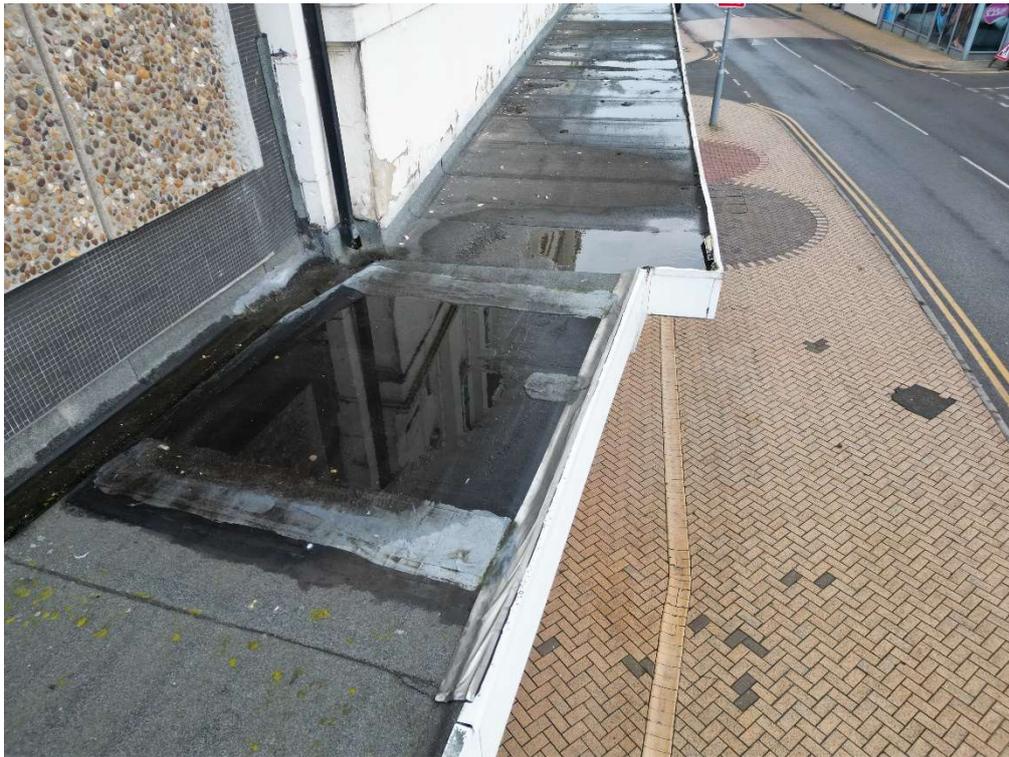
Photo 62 – General view of shopfront canopy roof covering showing patch repairs and inadequate falls.

The canopy should be completely stripped and new roof coverings, fascias and soffits installed. At the same time the structural elements should be inspected and any affected by water ingress replaced.

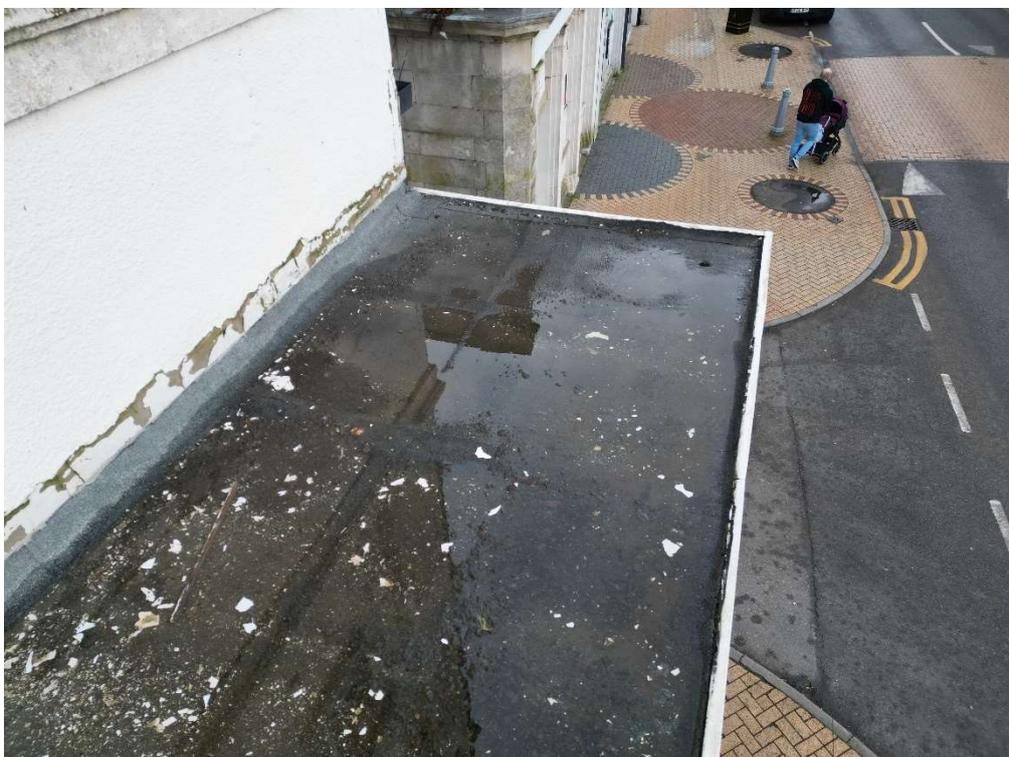
Photo 63 – Further view of canopy roof covering showing inadequate falls and poor condition.

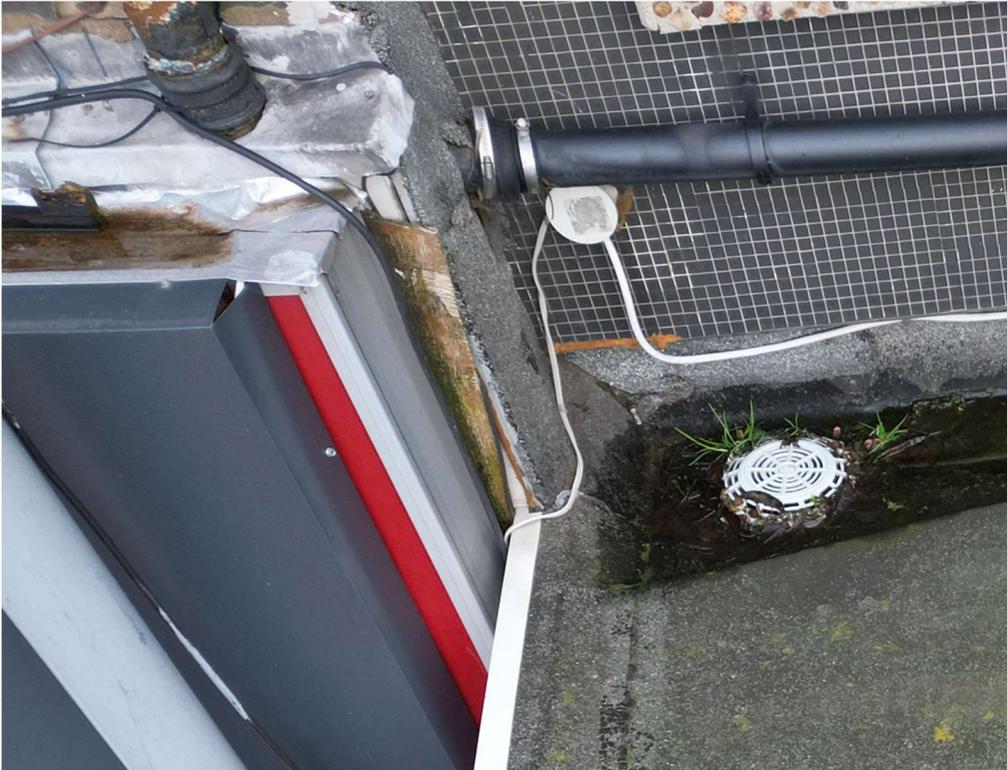
Photo 64 – Poor detailing at joint with adjacent property.

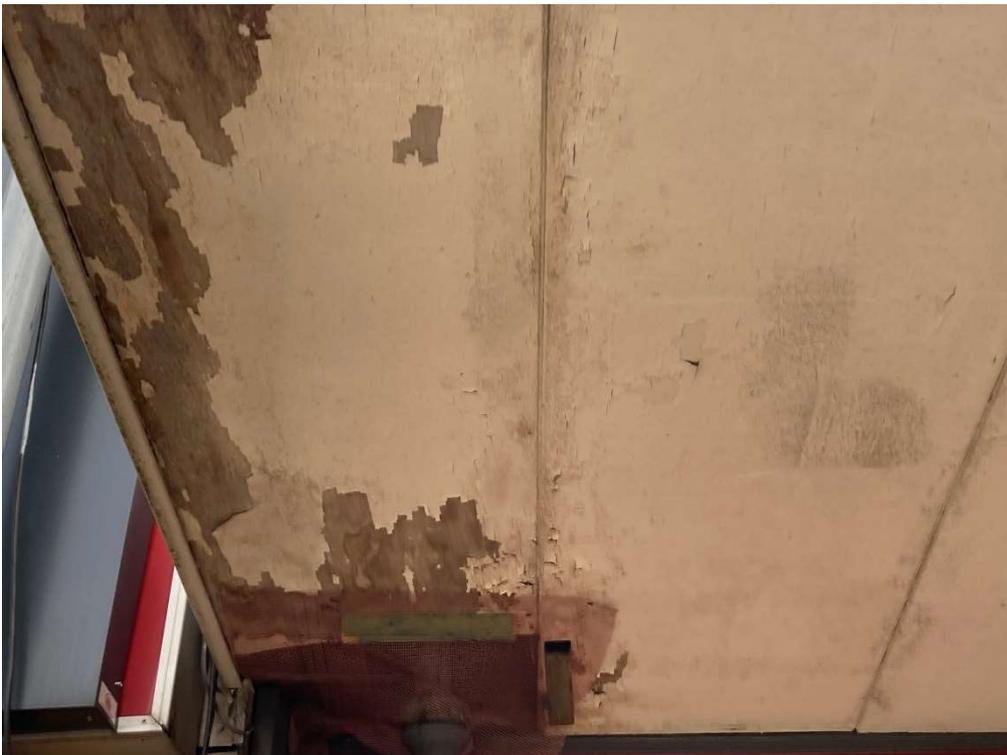
Photo 65 – Damp staining and rot around drainage outlet.

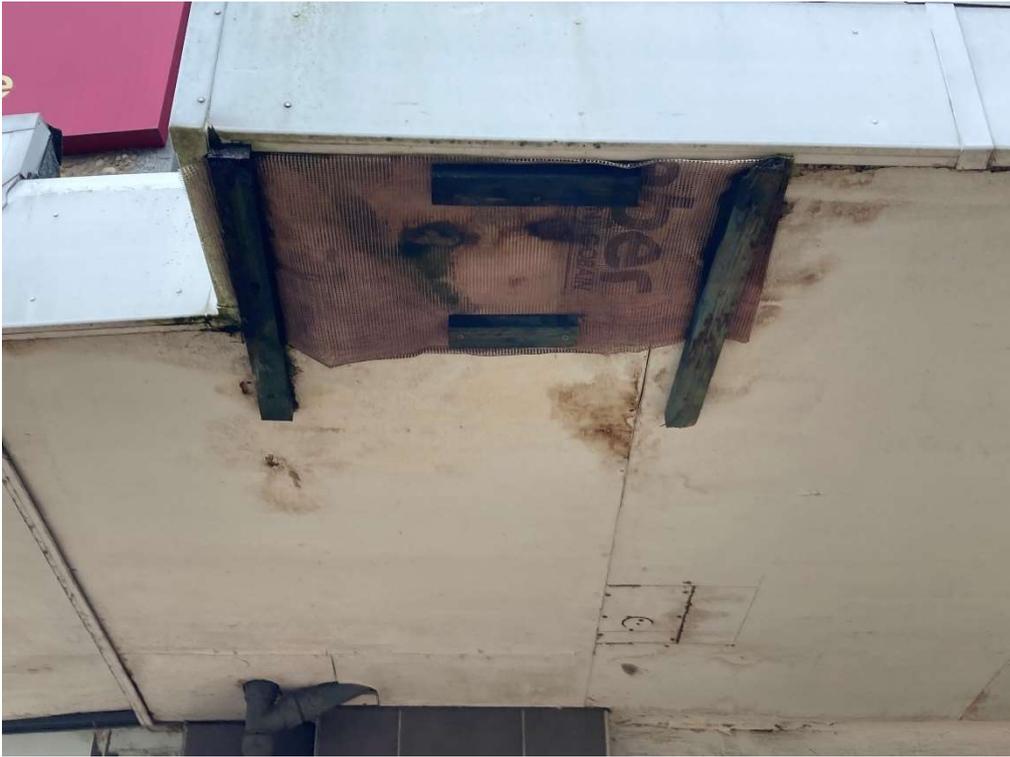
Photo 66 – Rotten and patch repaired canopy soffit.

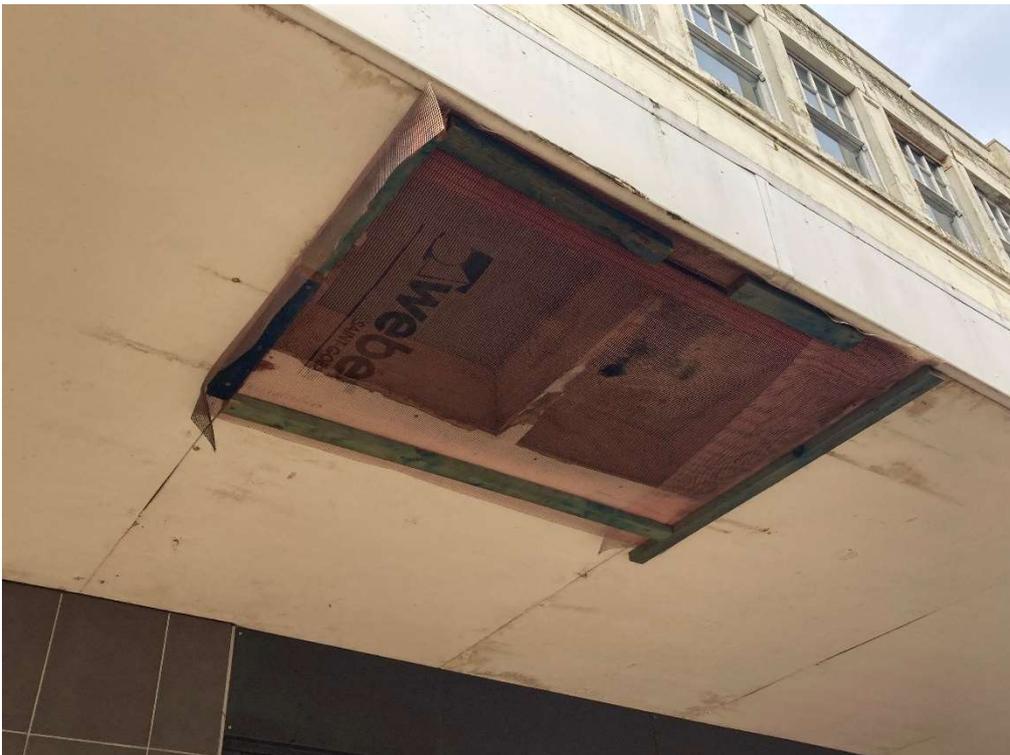
Photo 67 – Section of missing canopy soffit.

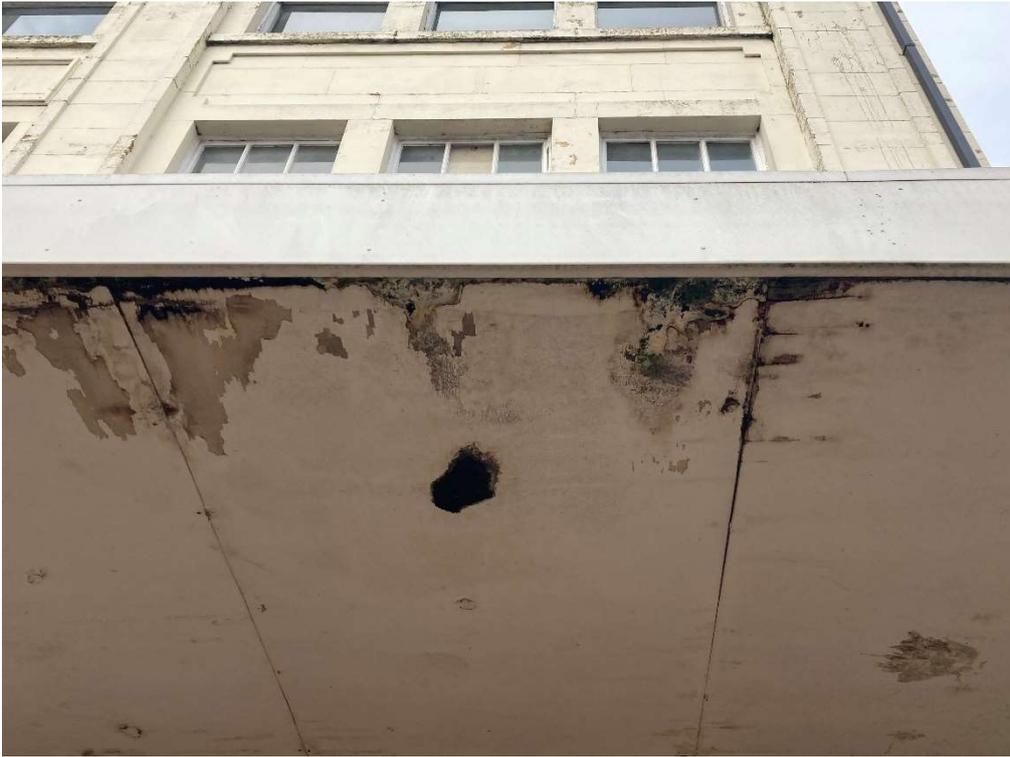
Photo 68 – Rotten canopy soffit.

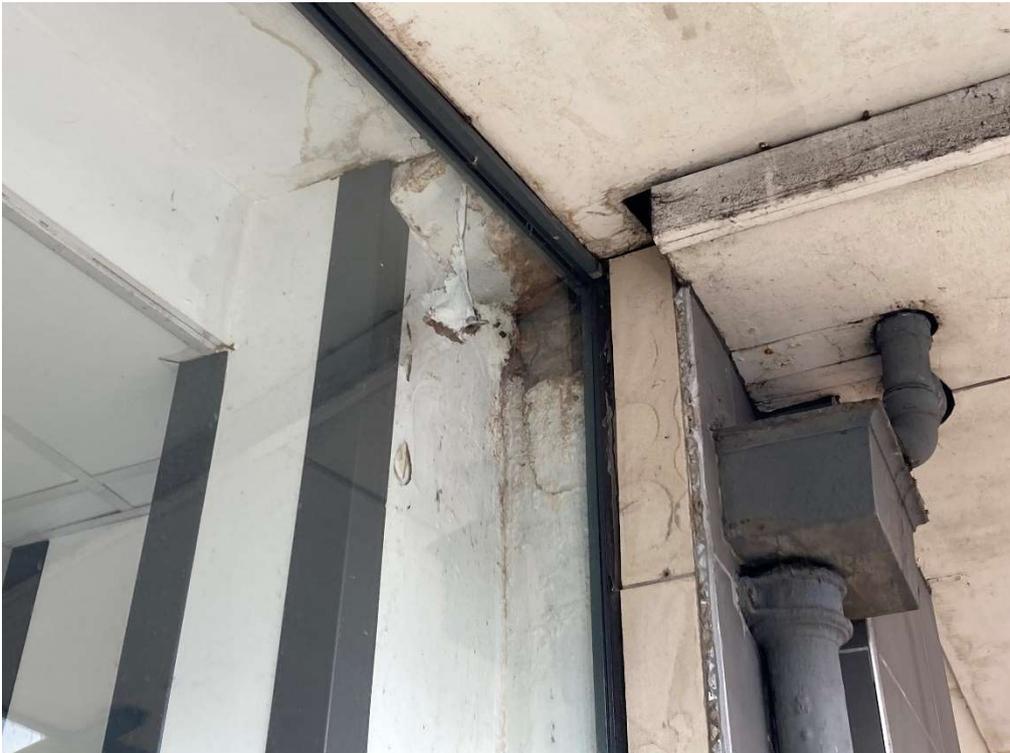
The poor condition of the canopy has allowed water to penetrate the building structure. There is evidence of damp penetration and damage to surface finishes around column heads and above the shopfront windows (photo 69 and 70)

Photo 69 – Damp penetration internally due to canopy defects.

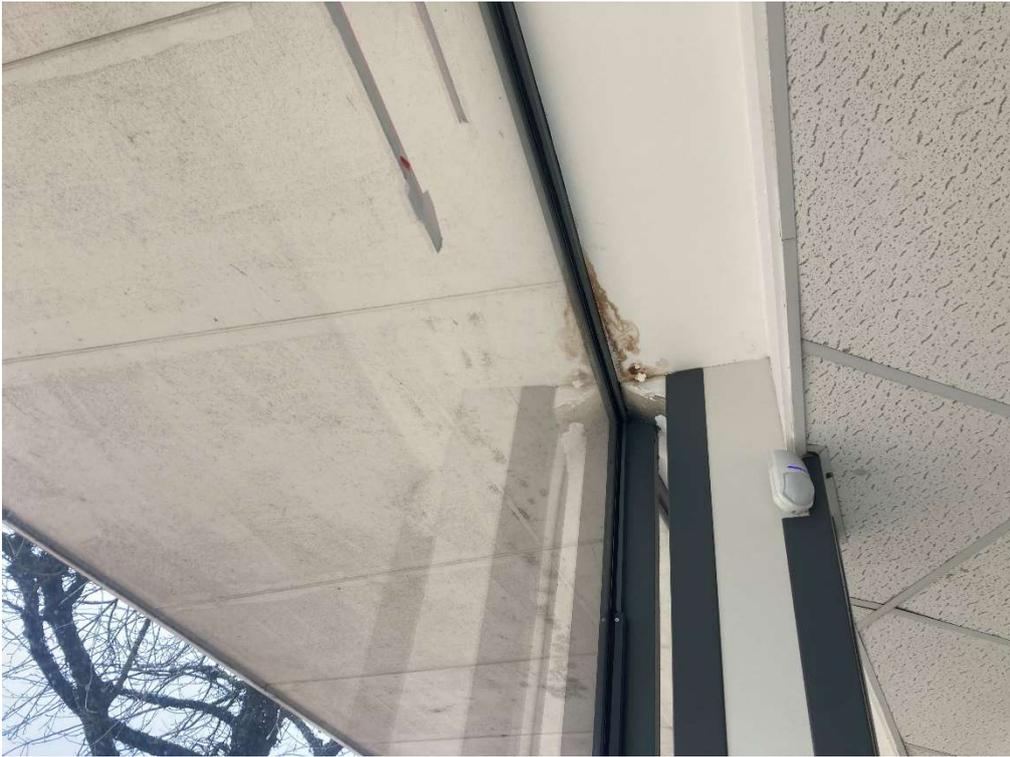
Photo 70 – Damp penetration internally due to canopy defects.

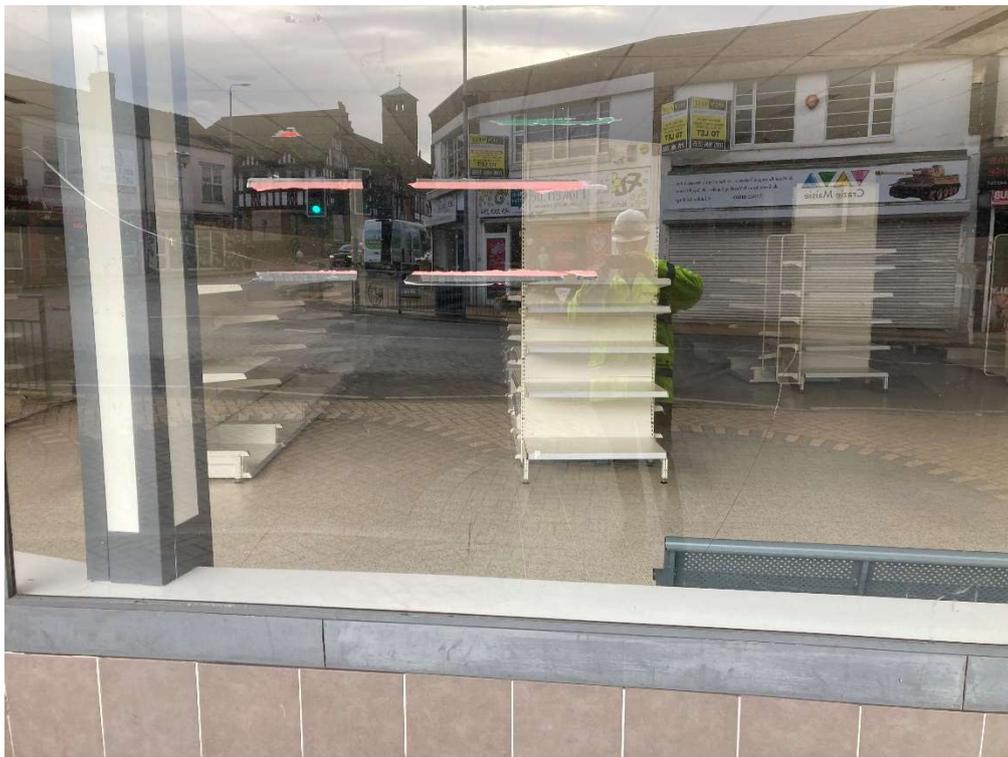
Photo 71 – Broken shop front window to LHS of entrance.

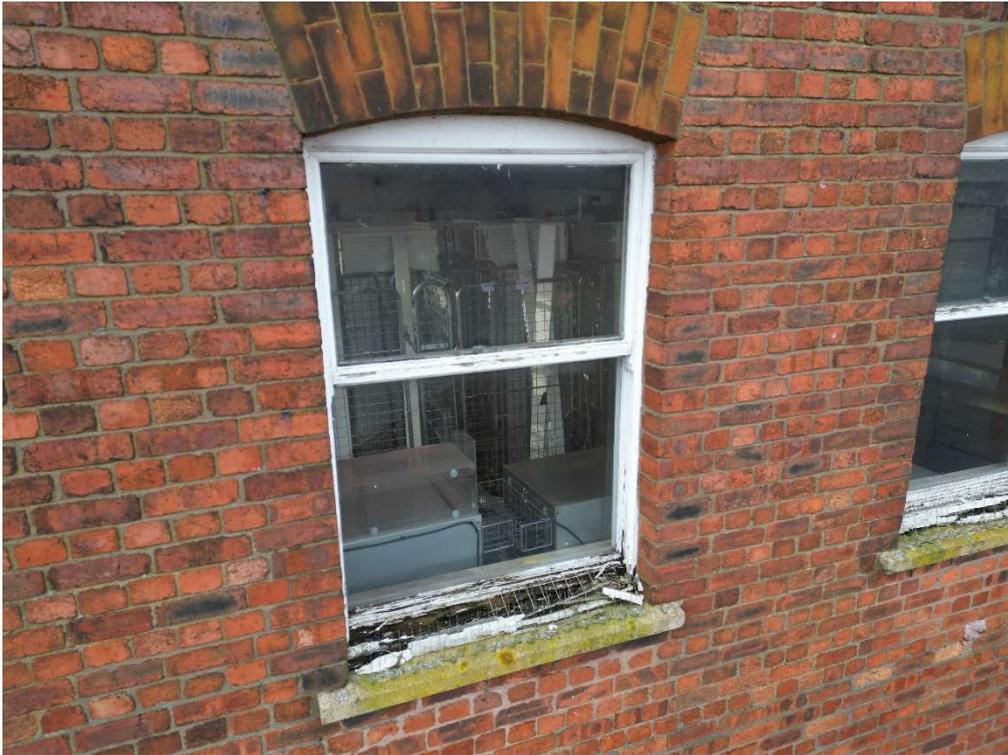
The remaining windows at first floor and second floor level are in very poor condition and require urgent replacement. Window frames are badly rotten allowing water to penetrate the building in multiple locations particularly around the first and second floor stock rooms. To the first floor western elevation of the original lift shaft a window frame has rotted to such an extent that glazing has dropped downwards by 25mm leaving a gap at the top of the window opening. There is a real risk that glazing could fall from the first and second floor windows in the eastern elevation into the alleyway below potentially resulting in injuries. The timber windows should be replaced as a matter of urgency (photos 72, 73, 74, 75 and 76).

Photo 72 – Example of rotten timber window frame, second floor western elevation.
