Building Survey Report

Address Wilkinsons
1-5 Outram Street
Sutton in Ashfield
NG17 4BX

Prepared for West Notts College
Derby Road
Mansfield
NG18 5BH

Condition Survey Report

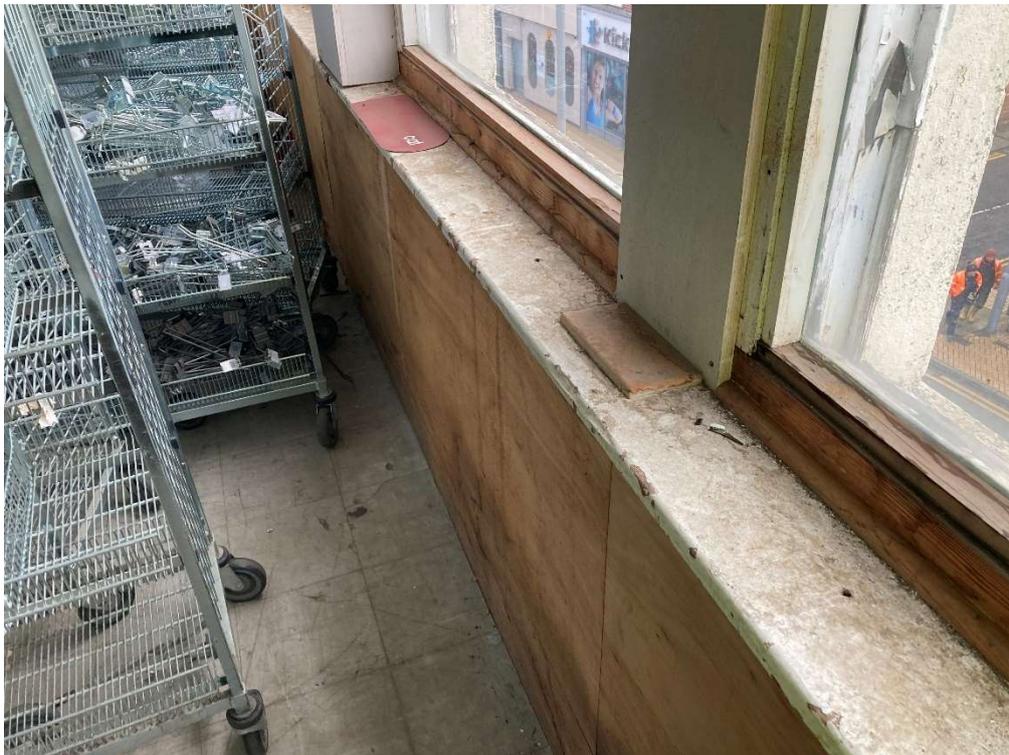
The remaining windows at first floor and second floor level are in very poor condition and require urgent replacement. Window frames are badly rotten allowing water to penetrate the building in multiple locations particularly around the first and second floor stock rooms. To the first floor western elevation of the original lift shaft a window frame has rotted to such an extent that glazing has dropped downwards by 25mm leaving a gap at the top of the window opening. There is a real risk that glazing could fall from the first and second floor windows in the eastern elevation into the alleyway below potentially resulting in injuries. The timber windows should be replaced as a matter of urgency (photos 72, 73, 74, 75 and 76).

Photo 76 – Further example, damp penetration due to condition of window frames.

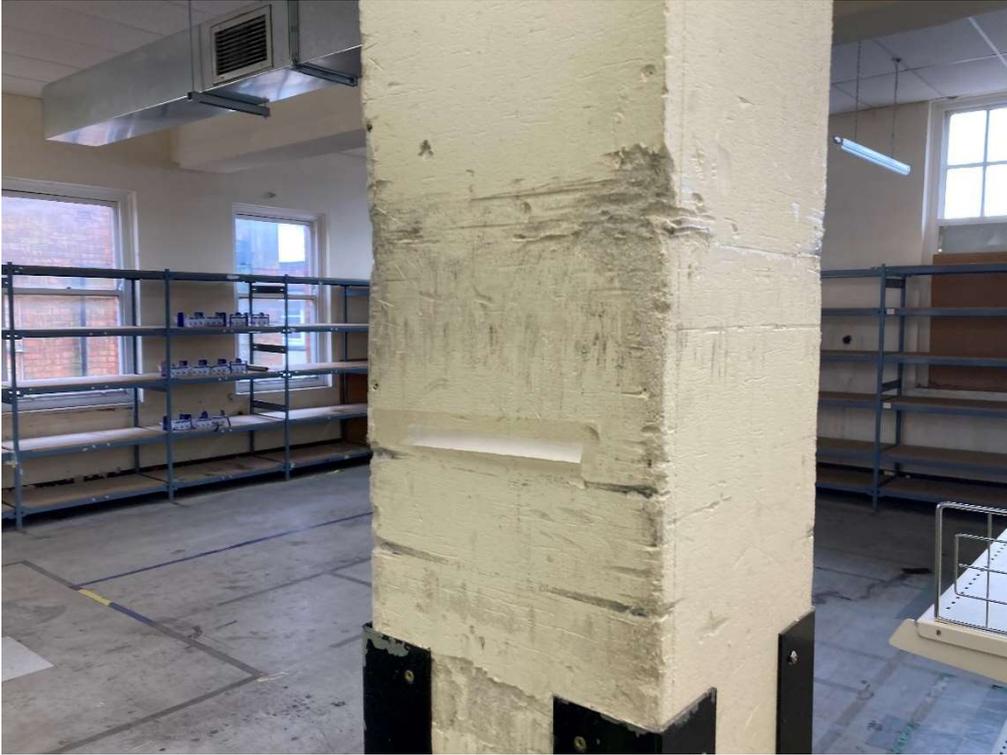
Photo 77 – Impact damage to structural columns.

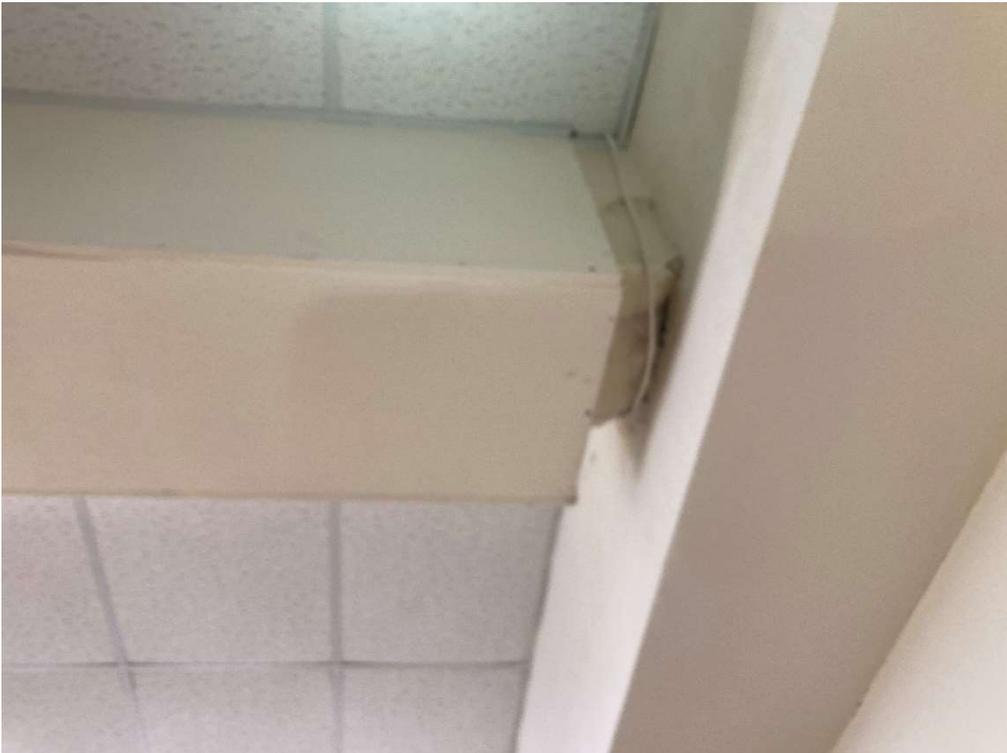
Photo 78 – suspected AIB boxing.

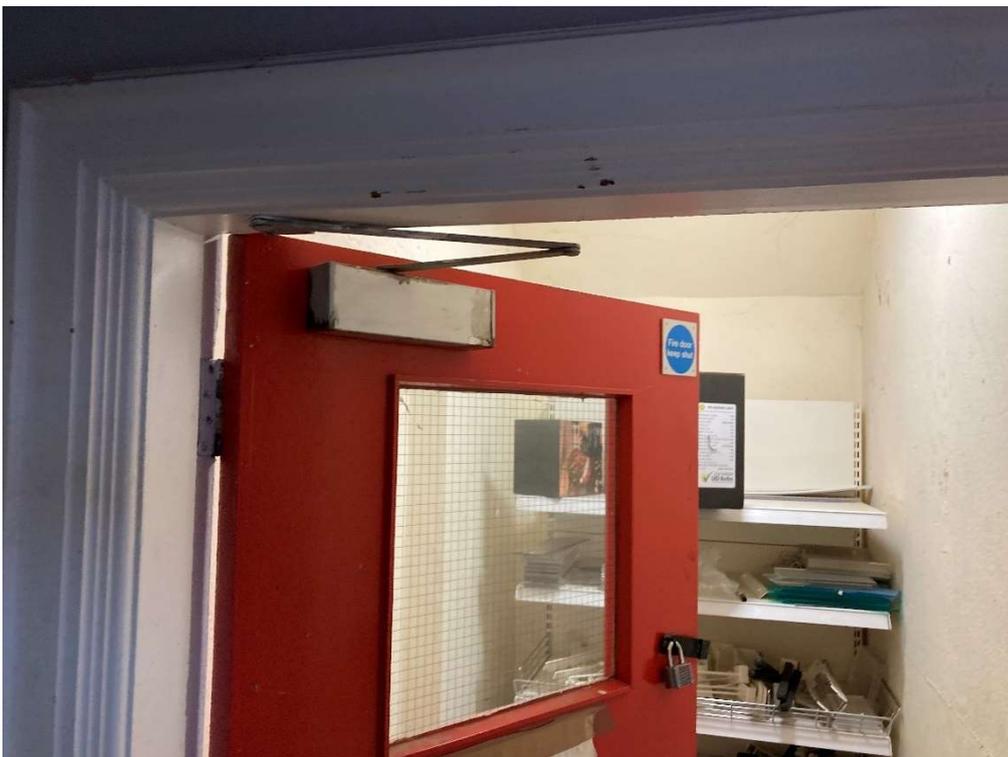
Photo 82 – Missing intumescent strips / smoke seals. First floor stock room.

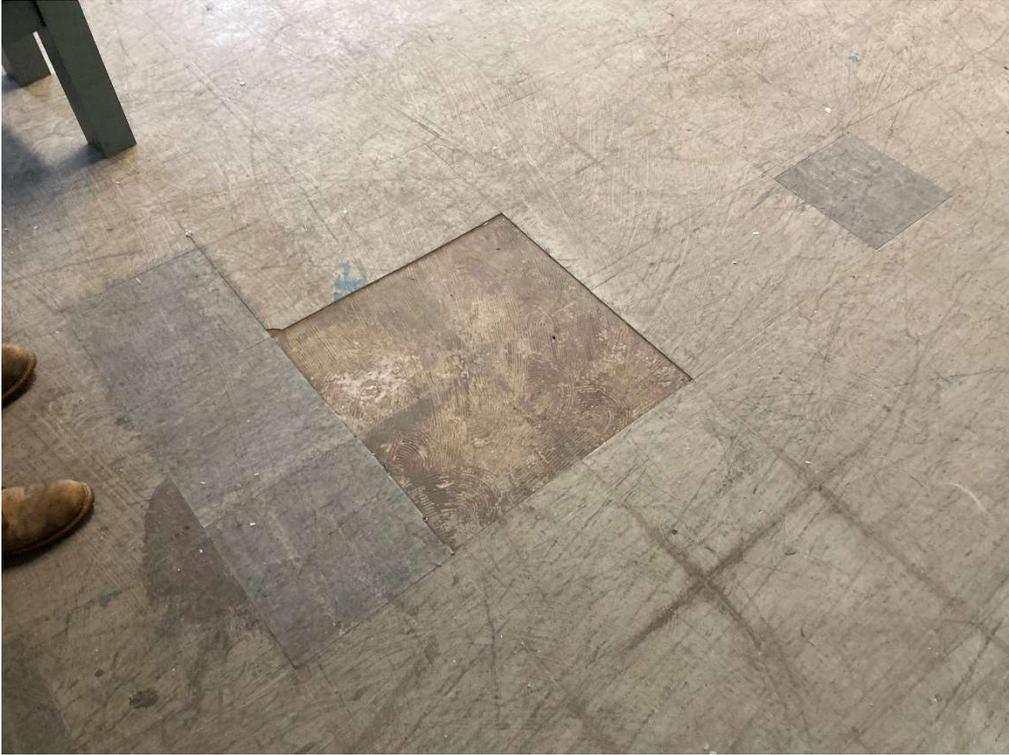
Photo 83 – Lifting tiles, 2nd floor stockroom. Note potential asbestos content.

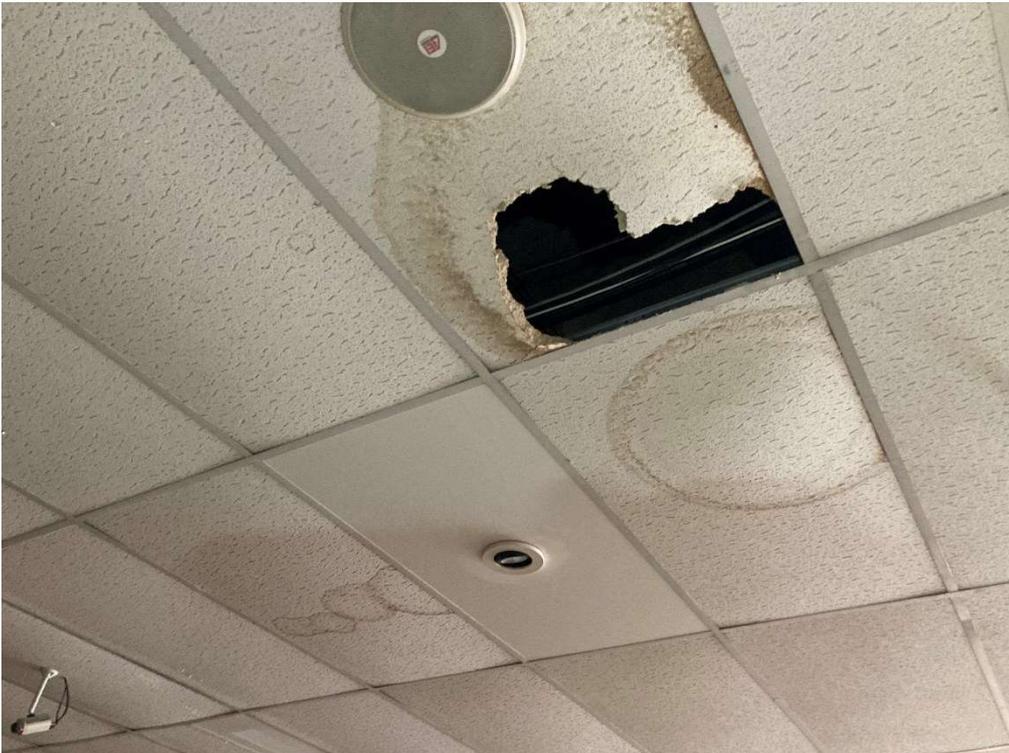
Photo 84 – Damage to shop floor ceiling due to leaking water pipe.

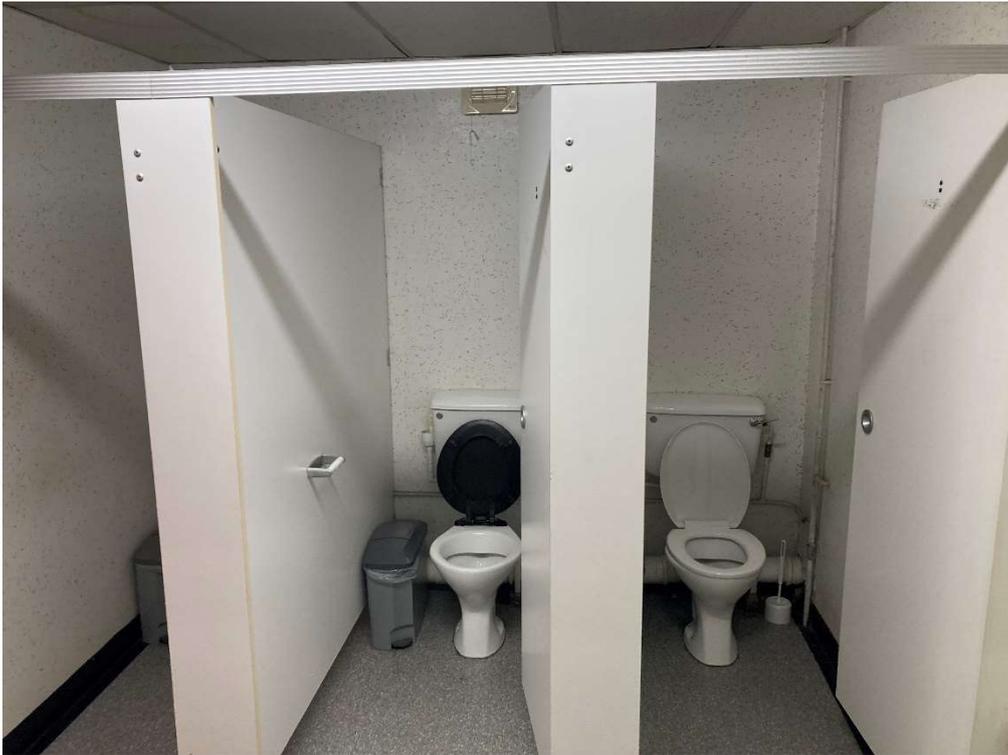
Photo 85 – Female WC, typical condition.

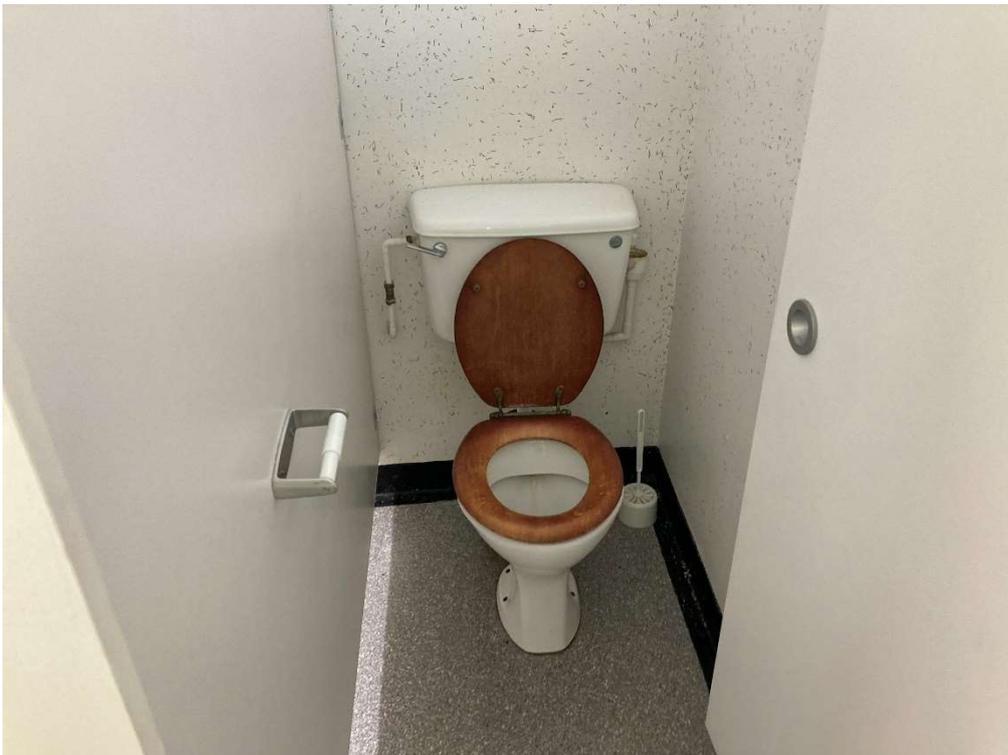
Photo 86 – Male WC, typical condition.

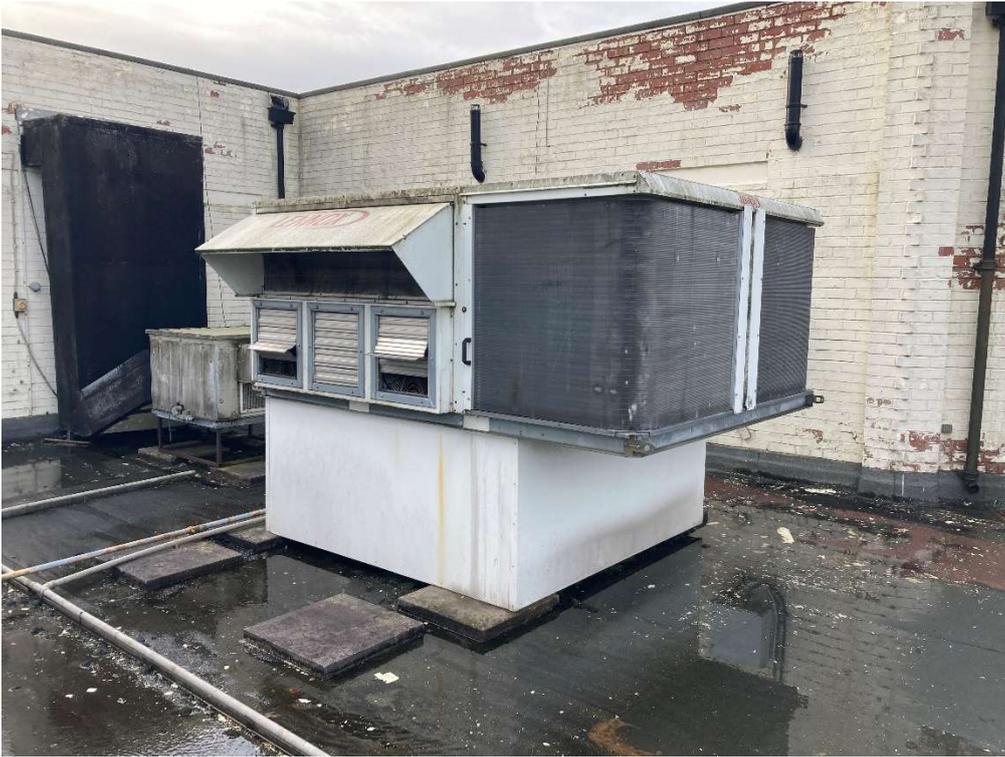
Photo 87 – Roof mounted HVAC with adjacent water tank.

Due to its age and complexity it is recommended that a full M&E inspection is undertaken by a qualified M&E engineer.

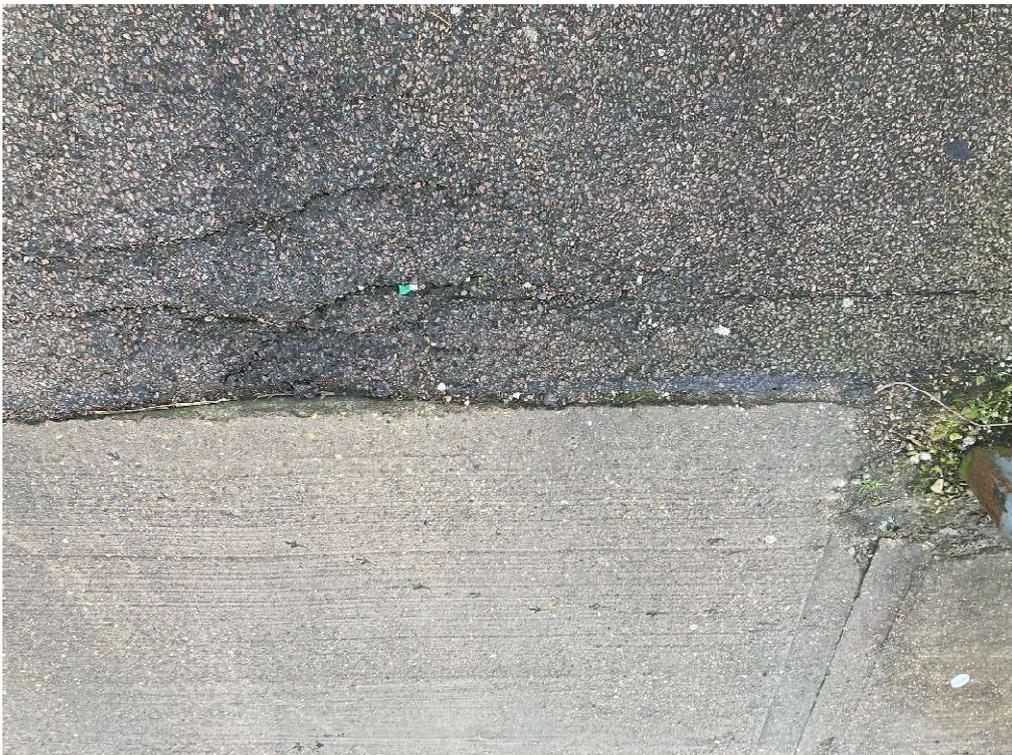
The service yard surface is formed from a mixture of tarmac and in-situ cast concrete. These are in fair condition other than a ridge at the service yard entrance gate (photo 97).

Photo 97 – Tripping hazard at entrance to service yard.
