BS5837:2012 Tree Survey Report

Proposed Construction of a New McDonald's Drive Thru Restaurant at:

Lane End, Kirkby in Ashfield, NG17 8AP

Revision B - 11th December 2024

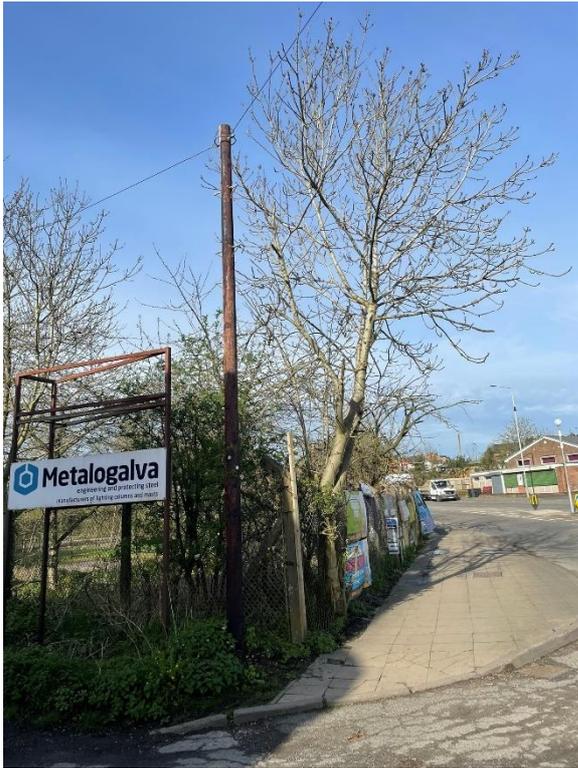
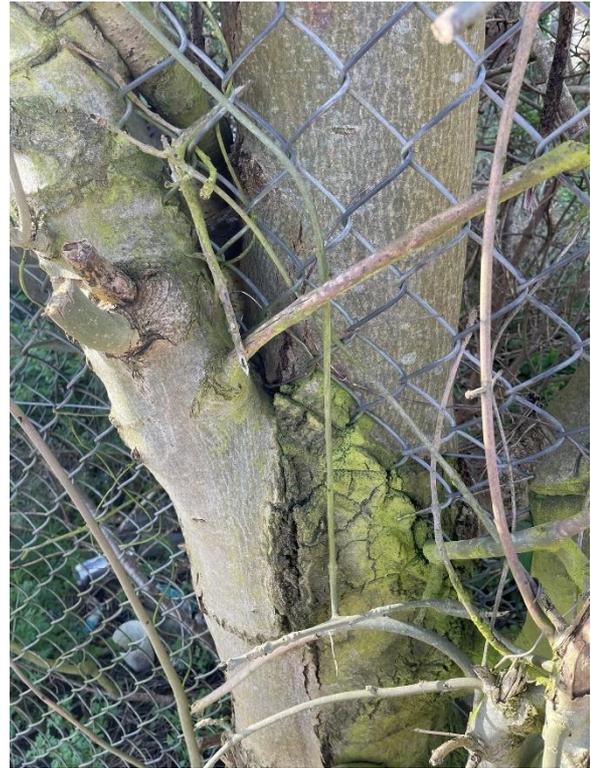
Photo 1 - View of T1

| Ref | Species | Height (m) | Stem Diameter (mm) | Branch spread (m) | | | | Height crown clearance (m) | Age class | Condition & Comments | Years left | Category grading | RPA (m ²) | RPA radius |
|---|---|---|---|---|---|---|---|---|---|--|---|---|---|---|
| T1 | Fraxinus excelsior (Ash) | 10 | 275 | 2.5 | 2.5 | 2.2 | 2.5 | 4 | EM | Poor. Trunk grown around chain link fencing and in poor condition. | <10 | U | 34 | 3.30 |

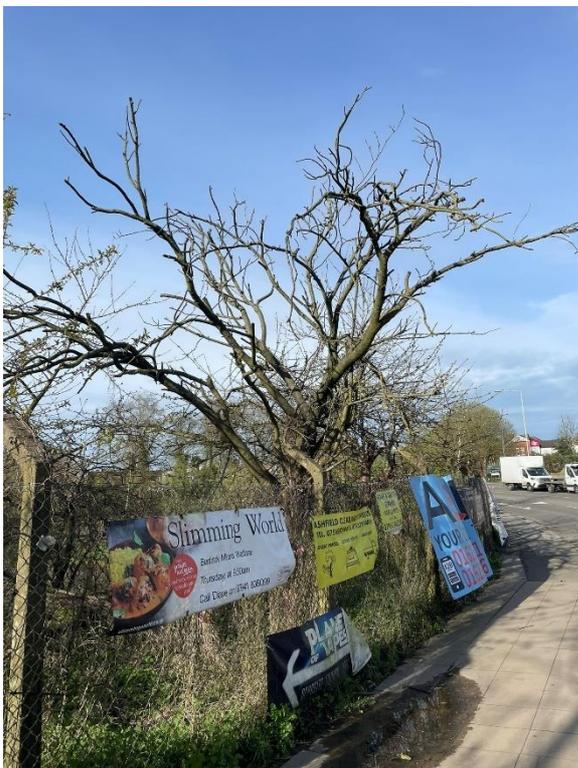
Photo 3 - View of T2

| Ref | Species | Height (m) | Stem Diameter (mm) | Branch spread (m) | | | | Height crown clearance (m) | Age class | Condition & Comments | Years left | Category grading | RPA (m ²) | RPA radius |
|---|---|---|---|---|---|---|---|---|---|--|---|---|---|---|
| T2 | Prunus avium (Cherry) | 6 | 295 | 5.0 | 5.0 | 5.0 | 5.0 | 2 | M | Poor. Some deadwood, very poor condition. | <10 | U | 39 | 3.54 |

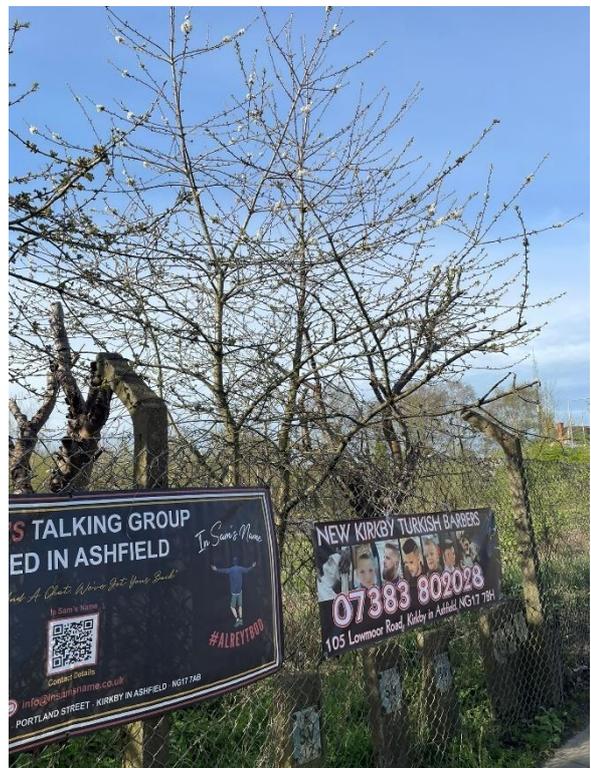
Photo 4 - View of T3

| Ref | Species | Height (m) | Stem Diameter (mm) | Branch spread (m) | | | | Height crown clearance (m) | Age class | Condition & Comments | Years left | Category grading | RPA (m ²) | RPA radius |
|---|---|---|---|---|---|---|---|---|---|--|---|---|---|---|
| T3 | Prunus avium (Cherry) | 7 | Multi | 2.0 | 2.0 | 2.0 | 2.0 | 1 | EM | Poor. Forks into 2 x 125mm stems at base. Poor condition. | <10 | U | 14 | 2.12 |

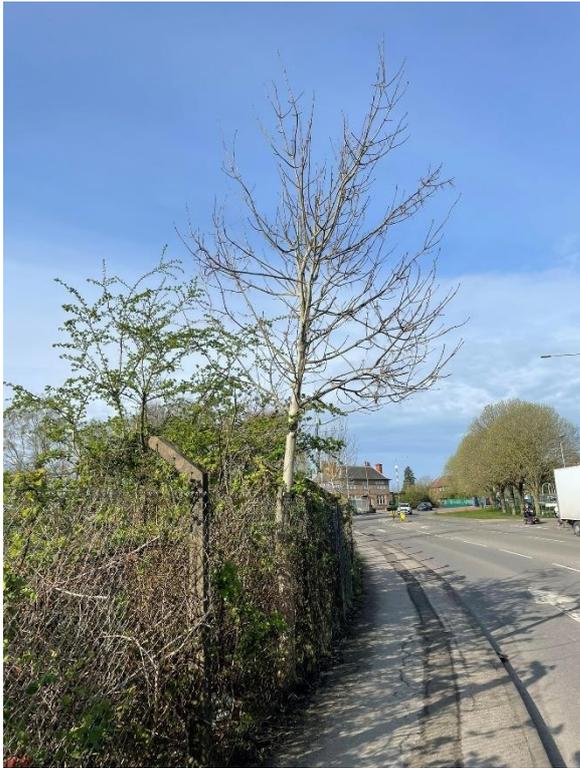
Photo 5 - View of T4

| Ref | Species | Height (m) | Stem Diameter (mm) | Branch spread (m) | | | | Height crown clearance (m) | Age class | Condition & Comments | Years left | Category grading | RPA (m ²) | RPA radius |
|---|---|---|---|---|---|---|---|---|---|--|---|---|---|---|
| T4 | Prunus avium (Cherry) | 5 | 295 | 3.0 | 3.0 | 3.0 | 3.0 | 2 | M | Poor. Severly coppiced, deadwood. Poor condition. | <10 | U | 39 | 3.54 |

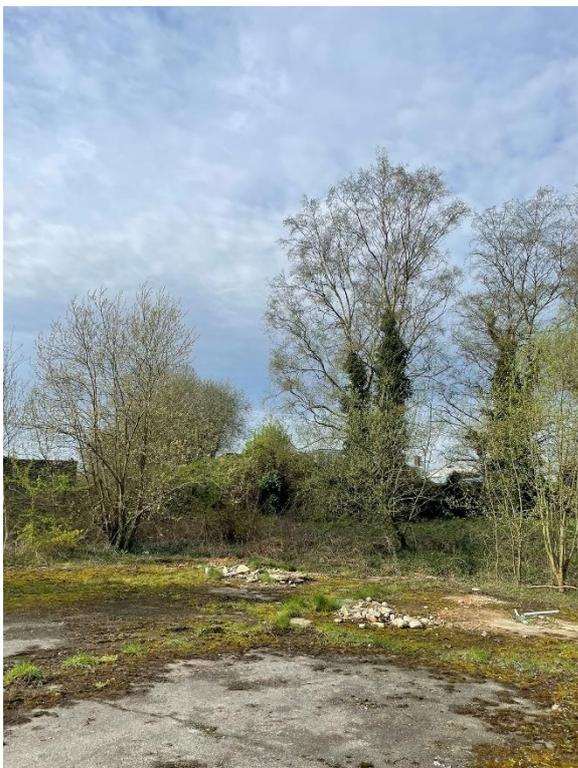
Photo 11 - View of T13

| Ref | Species | Height (m) | Stem Diameter (mm) | Branch spread (m) | | | | Height crown clearance (m) | Age class | Condition & Comments | Years left | Category grading | RPA (m ²) | RPA radius |
|---|---|---|---|---|---|---|---|---|---|--|---|---|---|---|
| T13 | Fraxinus excelsior (Ash) | 16 | Multi | 5.0 | 5.0 | 5.0 | 5.0 | 2 | OM | Fair. Forks into 2 large trunks: 2 x 300mm stems. Some deadwood and broken branches. | 20+ | B2 | 81 | 5.09 |

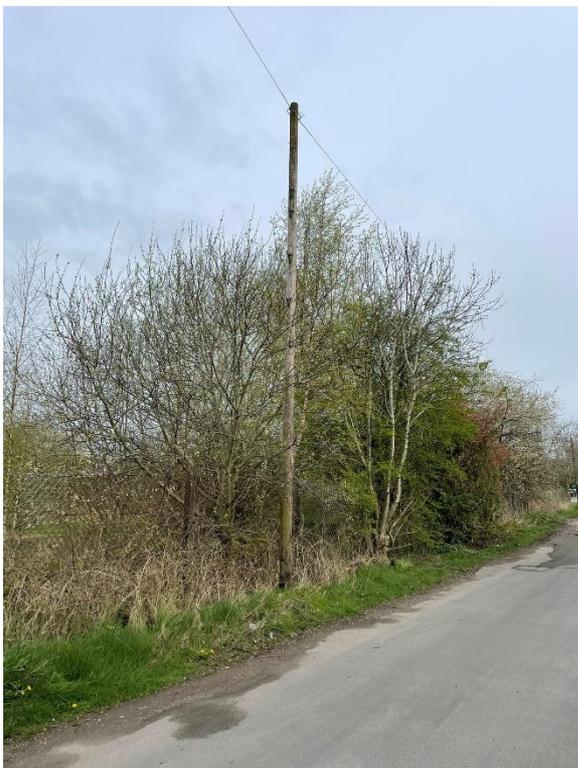
Photo 19 - View of G4

| Ref | Species | Height (m) | Stem Diameter (mm) | Branch spread (m) | | | | Height crown clearance (m) | Age class | Condition & Comments | Years left | Category grading | RPA (m ²) | RPA radius |
|---|--|---|---|---|---|---|---|---|---|--|---|---|---|---|
| G4 | Salix caprea (Goat Willow) Betula pendula (Silver Birch) Fraxinus excelsior (Ash) Crataegus monogyna (Hawthorn) Ribes sanguineum (Red-Flowering Currant) | 6-8 | <75 - 200 | 3.0 | 3.0 | 3.0 | 3.0 | 0 | SM-EM | Poor. Located along boundary lane within rubble/soil bund. Poor condition. Some growing through chain link fence. | <10 | U | 10 | 1.80 |

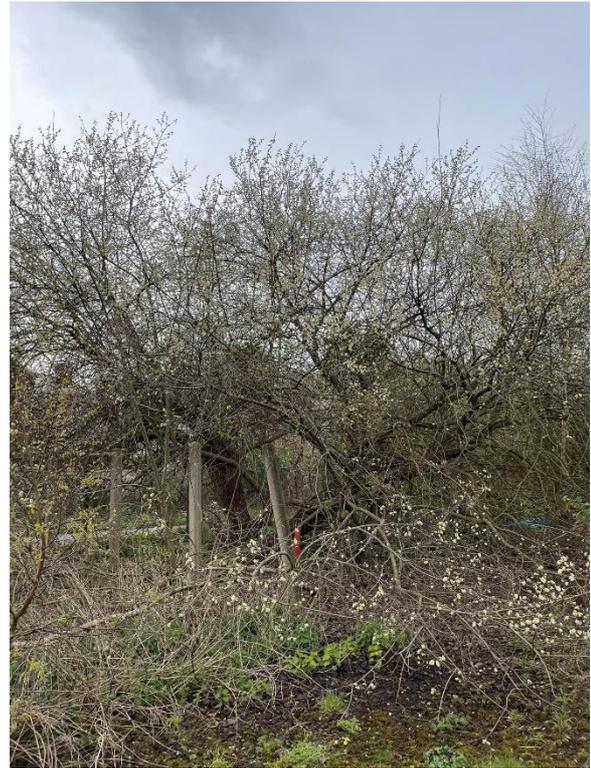
Photo 22 - View of T18

| Ref | Species | Height (m) | Stem Diameter (mm) | Branch spread (m) | | | | Height crown clearance (m) | Age class | Condition & Comments | Years left | Category grading | RPA (m ²) | RPA radius |
|---|--|---|---|---|---|---|---|---|---|--|---|---|---|---|
| T18 | Salix caprea (Goat Willow) | 7 | Multi | 6.0 | 6.0 | 6.0 | 6.0 | 0 | OM | Poor. Forks into 2 x 325mm trunks. Severe deadwood, broken branches. | <10 | U | 96 | 5.52 |

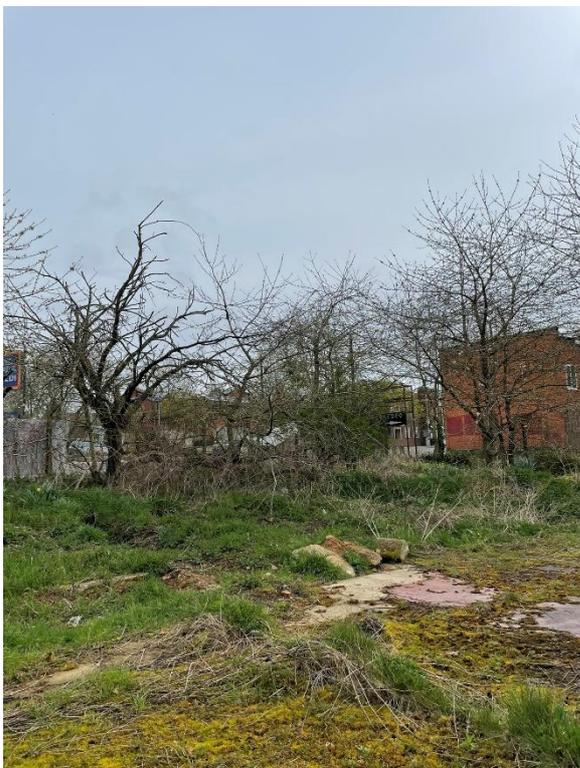
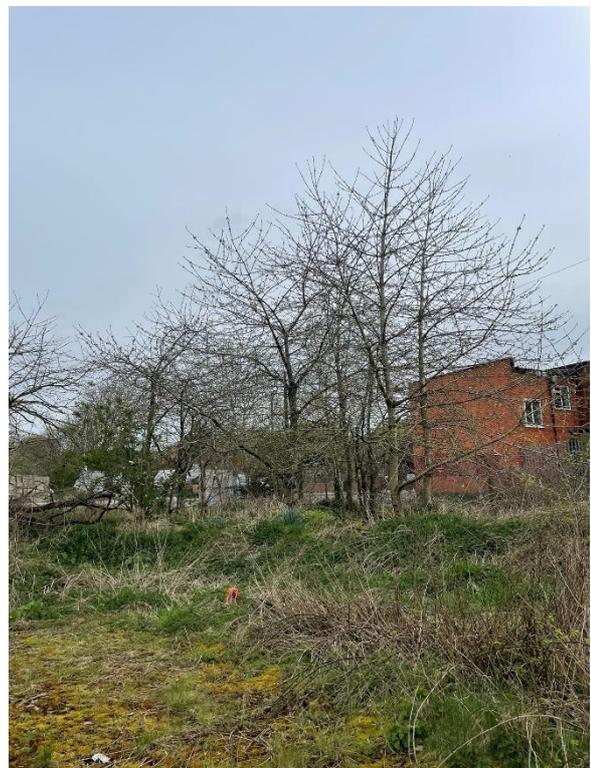
Photo 23 - View of G5

| Ref | Species | Height (m) | Stem Diameter (mm) | Branch spread (m) | | | | Height crown clearance (m) | Age class | Condition & Comments | Years left | Category grading | RPA (m ²) | RPA radius |
|---|--|---|---|---|---|---|---|---|---|--|---|---|---|---|
| G5 | Prunus avium (Cherry) | 6-10 | 100 - 200 | 3.0 | 3.0 | 3.0 | 3.0 | 1.5 | EM | Poor. Group of 5 Cherry trees in poor condition. | <10 | U | 18 | 1.80 |
