Arboricultural Impact Assessment

Fairhaven, Kirkby in Ashfield, Nottinghamshire

Report Reference: BG25.209

REV1 – August 2025

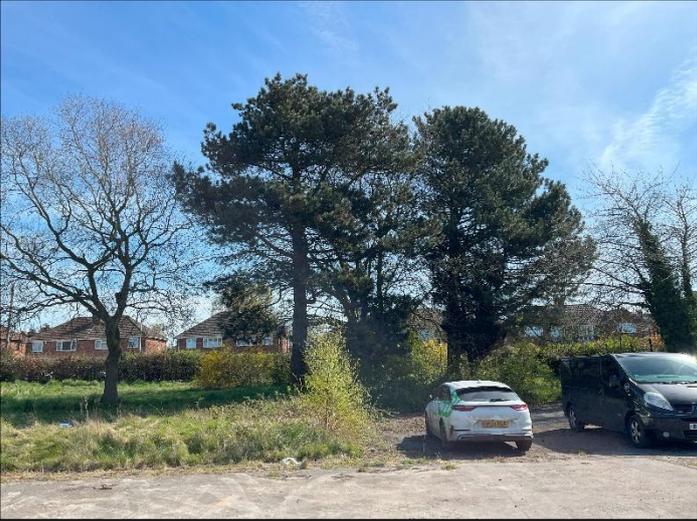
4.7.2 Due to the proximity of T1-T5 to plots 18 and 19, it is recommended that gutters and rainwater down pipes be fitted with mesh leaf guards, due to the potential for seasonal leaf litter.

<p>Trees T1-T6 at the south-eastern corner.</p>

- 4.9.1 A 2m clearance is required around the footprint of dwellings 18 and 19 to allow for installation of scaffolding. To allow this, a 2.5m crown reduction is required to the northern aspect of the crown of T4, and a 3m reduction is required to the western aspect of the crown of T5. Future crown reductions may be required after re-growth.
- 4.9.2 Reduction in the width of H3 and H5 is required to install tree protection fencing.
- 4.9.3 Any appointed contractor must carry out tree works according to BS 3998:2010 'Recommendations for Tree Work'.

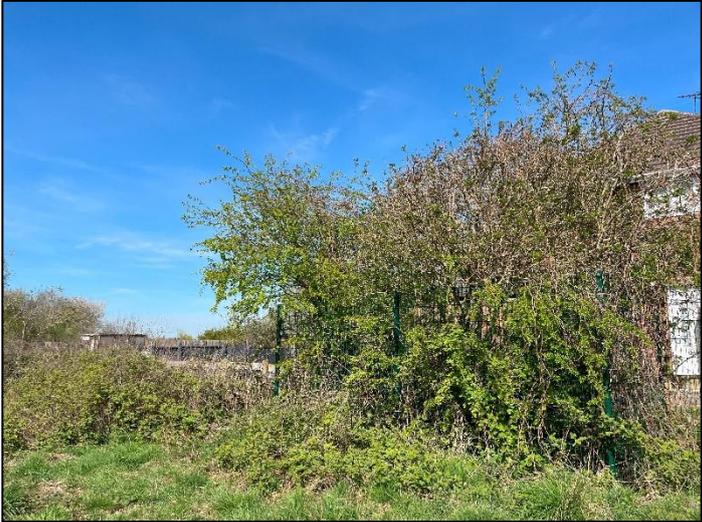
<p>T7, a Category C elder.</p>

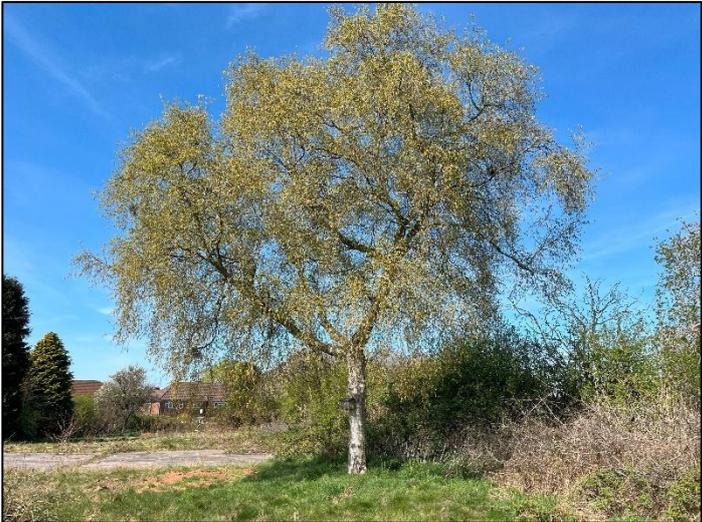
- New parking spaces for plots 9 and 10 are proposed within the notional RPA of T8, impacting approximately 20% of the RPA. This upper-limit RPA incursion necessitates the use of permanent ground protection and no-dig construction for the parking spaces.
- New hard surfacing is proposed within the notional RPA of T16, due to new parking spaces. Permanent ground protection is not recommended for these parking spaces, as root growth from T16 is likely skewed west, resulting from the mature ash T15 growing in the footprint of the proposed parking spaces.

<p>T8, a Category B silver birch.</p>

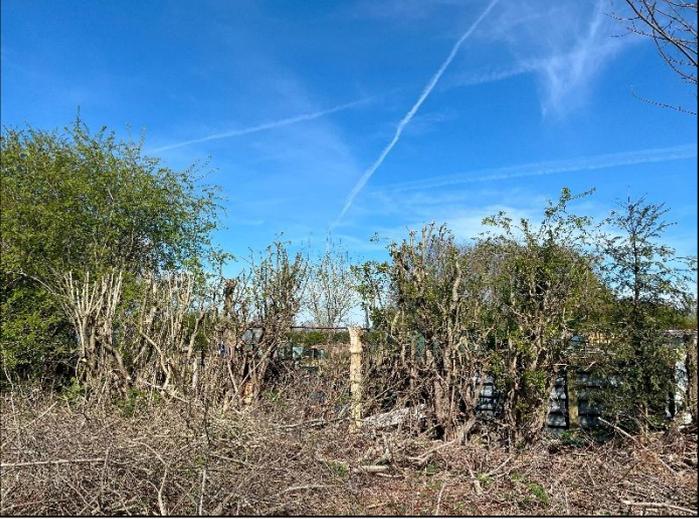
<p>Poor-quality hedgerow H3, on the northern boundary.</p>

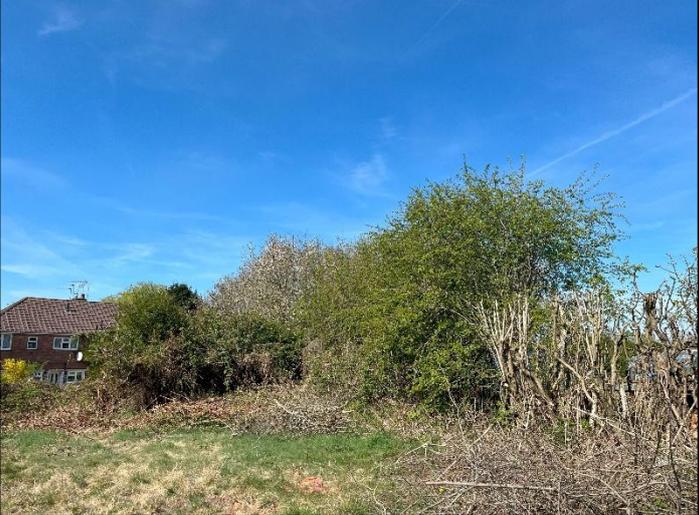
<p>H4 and T10, at the north-western corner of the site.</p>

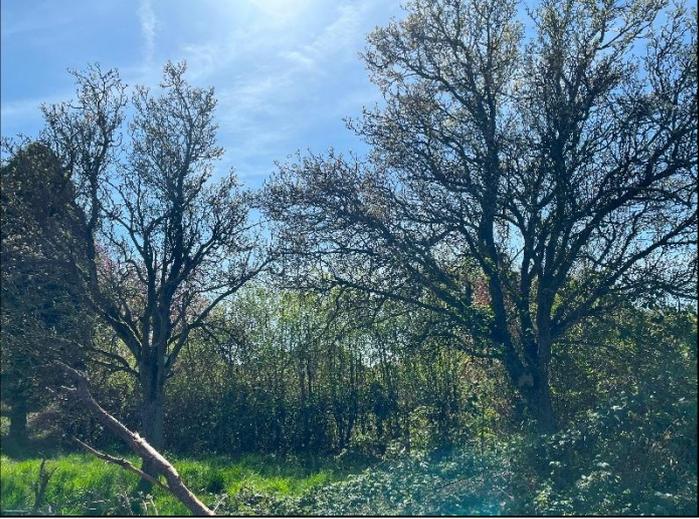
<p>T11 and T12, Category B and Category C pear trees.</p>

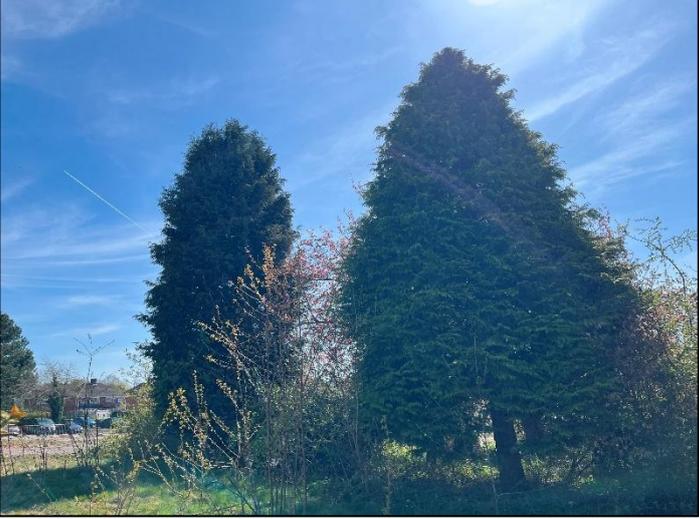
<p>T13 and T14, Category C Lawson and Leyland cypress.</p>

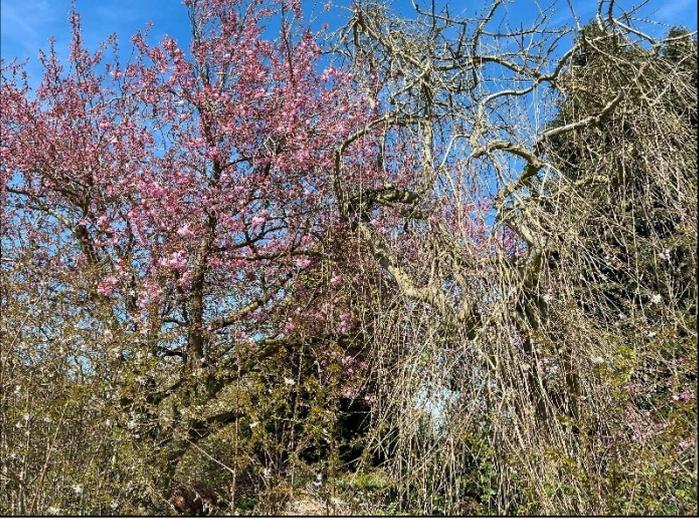
T15#	Common Ash	Semi-mature	9	1	475	5.7	102.1	2.5	3	3.5	3	6	2.5	0.5	0.5	Poor	Fair	Fair	U	<10 yrs	Decline	Fair to poor stem. Progressed ash dieback (ADB) with lesions to large limbs in crown. Upper crown dieback. ADB stage 3, with 50-75% crown dieback. Remove.
T16	Wild Cherry	Mature	11	1	570	6.8	147.0	7	7.5	4	6	1.5	1	5	3	Good	Fair	Fair	B2	20 to 40 yrs	Good	Large surface structural roots, some with damage. Extensive suckering from roots. Some marks consistent with chainsaw to lower limbs. Metal occluded to northern limbs at 2m. Diameter measured below 1.5m due to stem division at 1.5m, some with bark-inclusions. Lots of self-set wild cherry surrounding.
T17	Rowan	Semi-mature	7	1	250	3.0	28.3	1	2.5	2	2	4	3.5	3	3.5	Poor	Poor	Fair	C1	10 to 20 yrs	Poor	Crown in decline with branch dieback. Branch failures with decay to stems. Low quality, remove.
T18	Rowan	Semi-mature	8.5	1	315	3.8	44.9	2	3	3	2.5	2.5	3	2.5	3	Fair	Fair	Fair	C1	10 to 20 yrs	Fair	Fair condition, some areas of decay at former branch attachments to stem and in crown. Unremarkable.

<p>T15, a Category U weeping ash, and T16, a Category B wild cherry.</p>

- 1.3.1 T6, T7 and T10-T15 are required for removal to facilitate the development. Partial removal is also required from H1. A tree protection plan, complete with removal recommendations and mitigation measures has been proposed for the development. **The proposed mitigation will be**

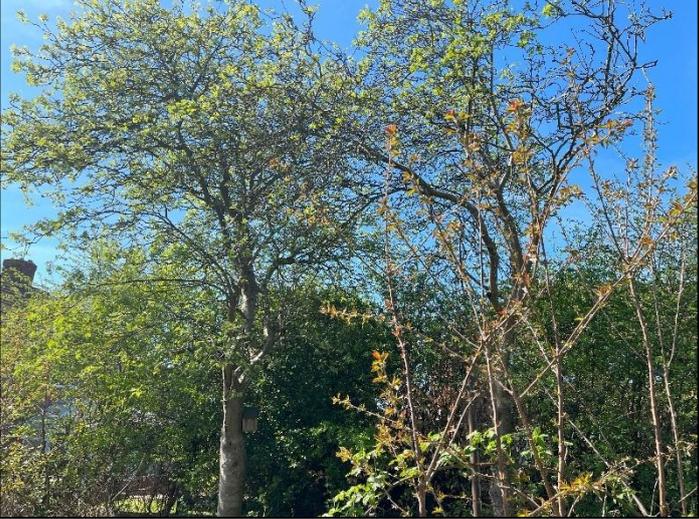
<p>T17 and T18, Category C rowan.</p>

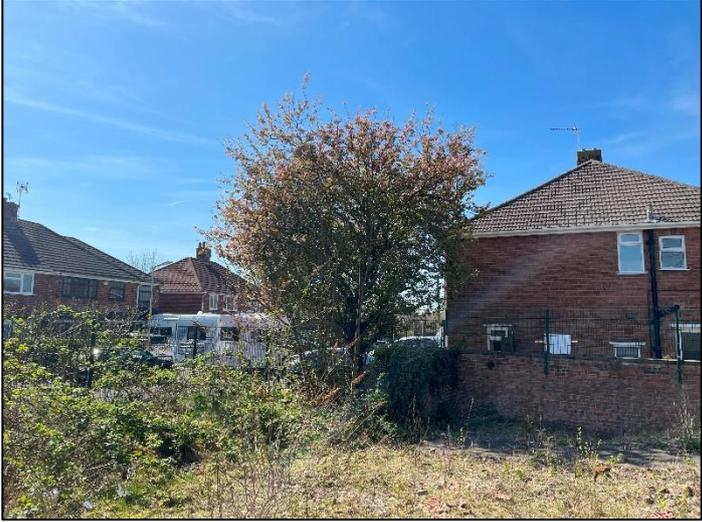
T19, a Category C apple.
