Geo-Environmental Investigation  
Project: Fairhaven, Kirkby-in-Ashfield  
Project No: EGE-24-07-07-01  
Client: Lindum BMS

<b>Project Name</b>	Fairhaven, Kirkby-in-Ashfield
<b>Client</b>	Lindum BMS
<b>Service</b>	Geo-Environmental Investigation (GI)
<b>Date of Issue</b>	2 <sup>nd</sup> May 2025
<b>Project number</b>	EGE-24-07-07-01

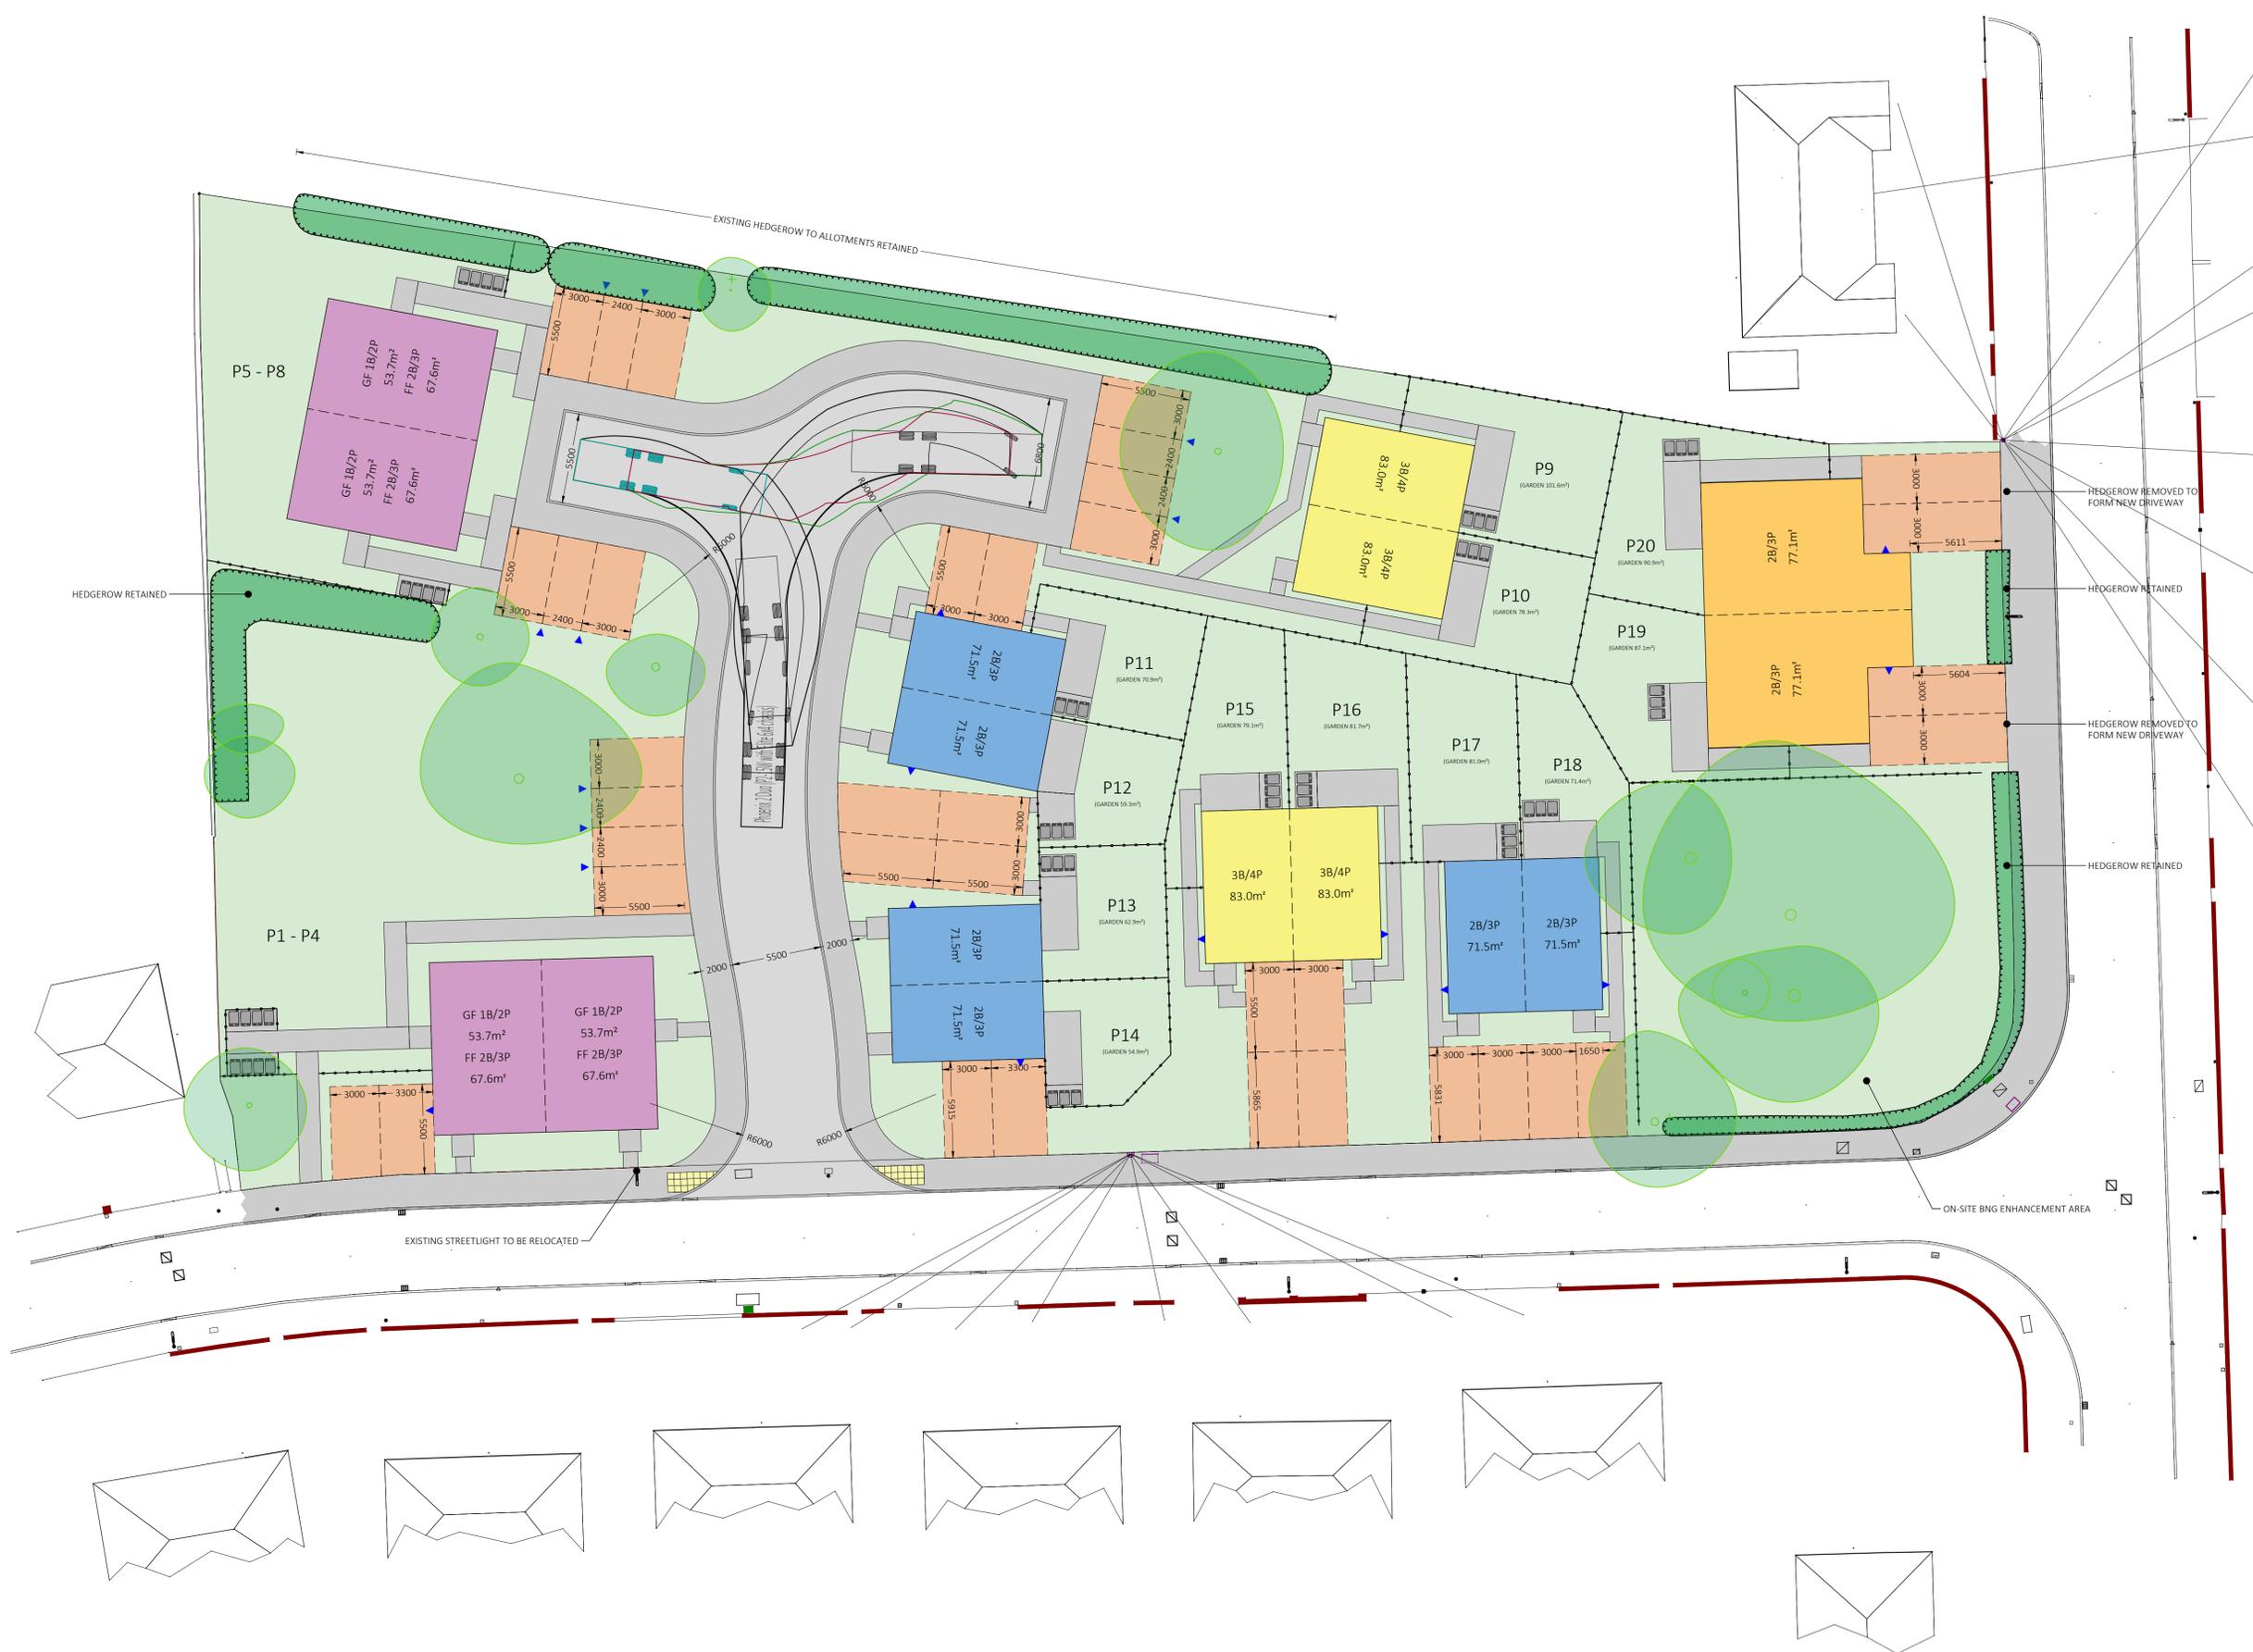
## Drawing II - Proposed Development Plan

Revision	Date	Details	Revised By
D	12.05.2025	LAYOUT REVISED	SR
C	29.04.2025	LAYOUT REVISED	SR
B	28.04.2025	LAYOUT REVISED	SR
A	20.11.2024	BUNGALOWS ADDED	SR

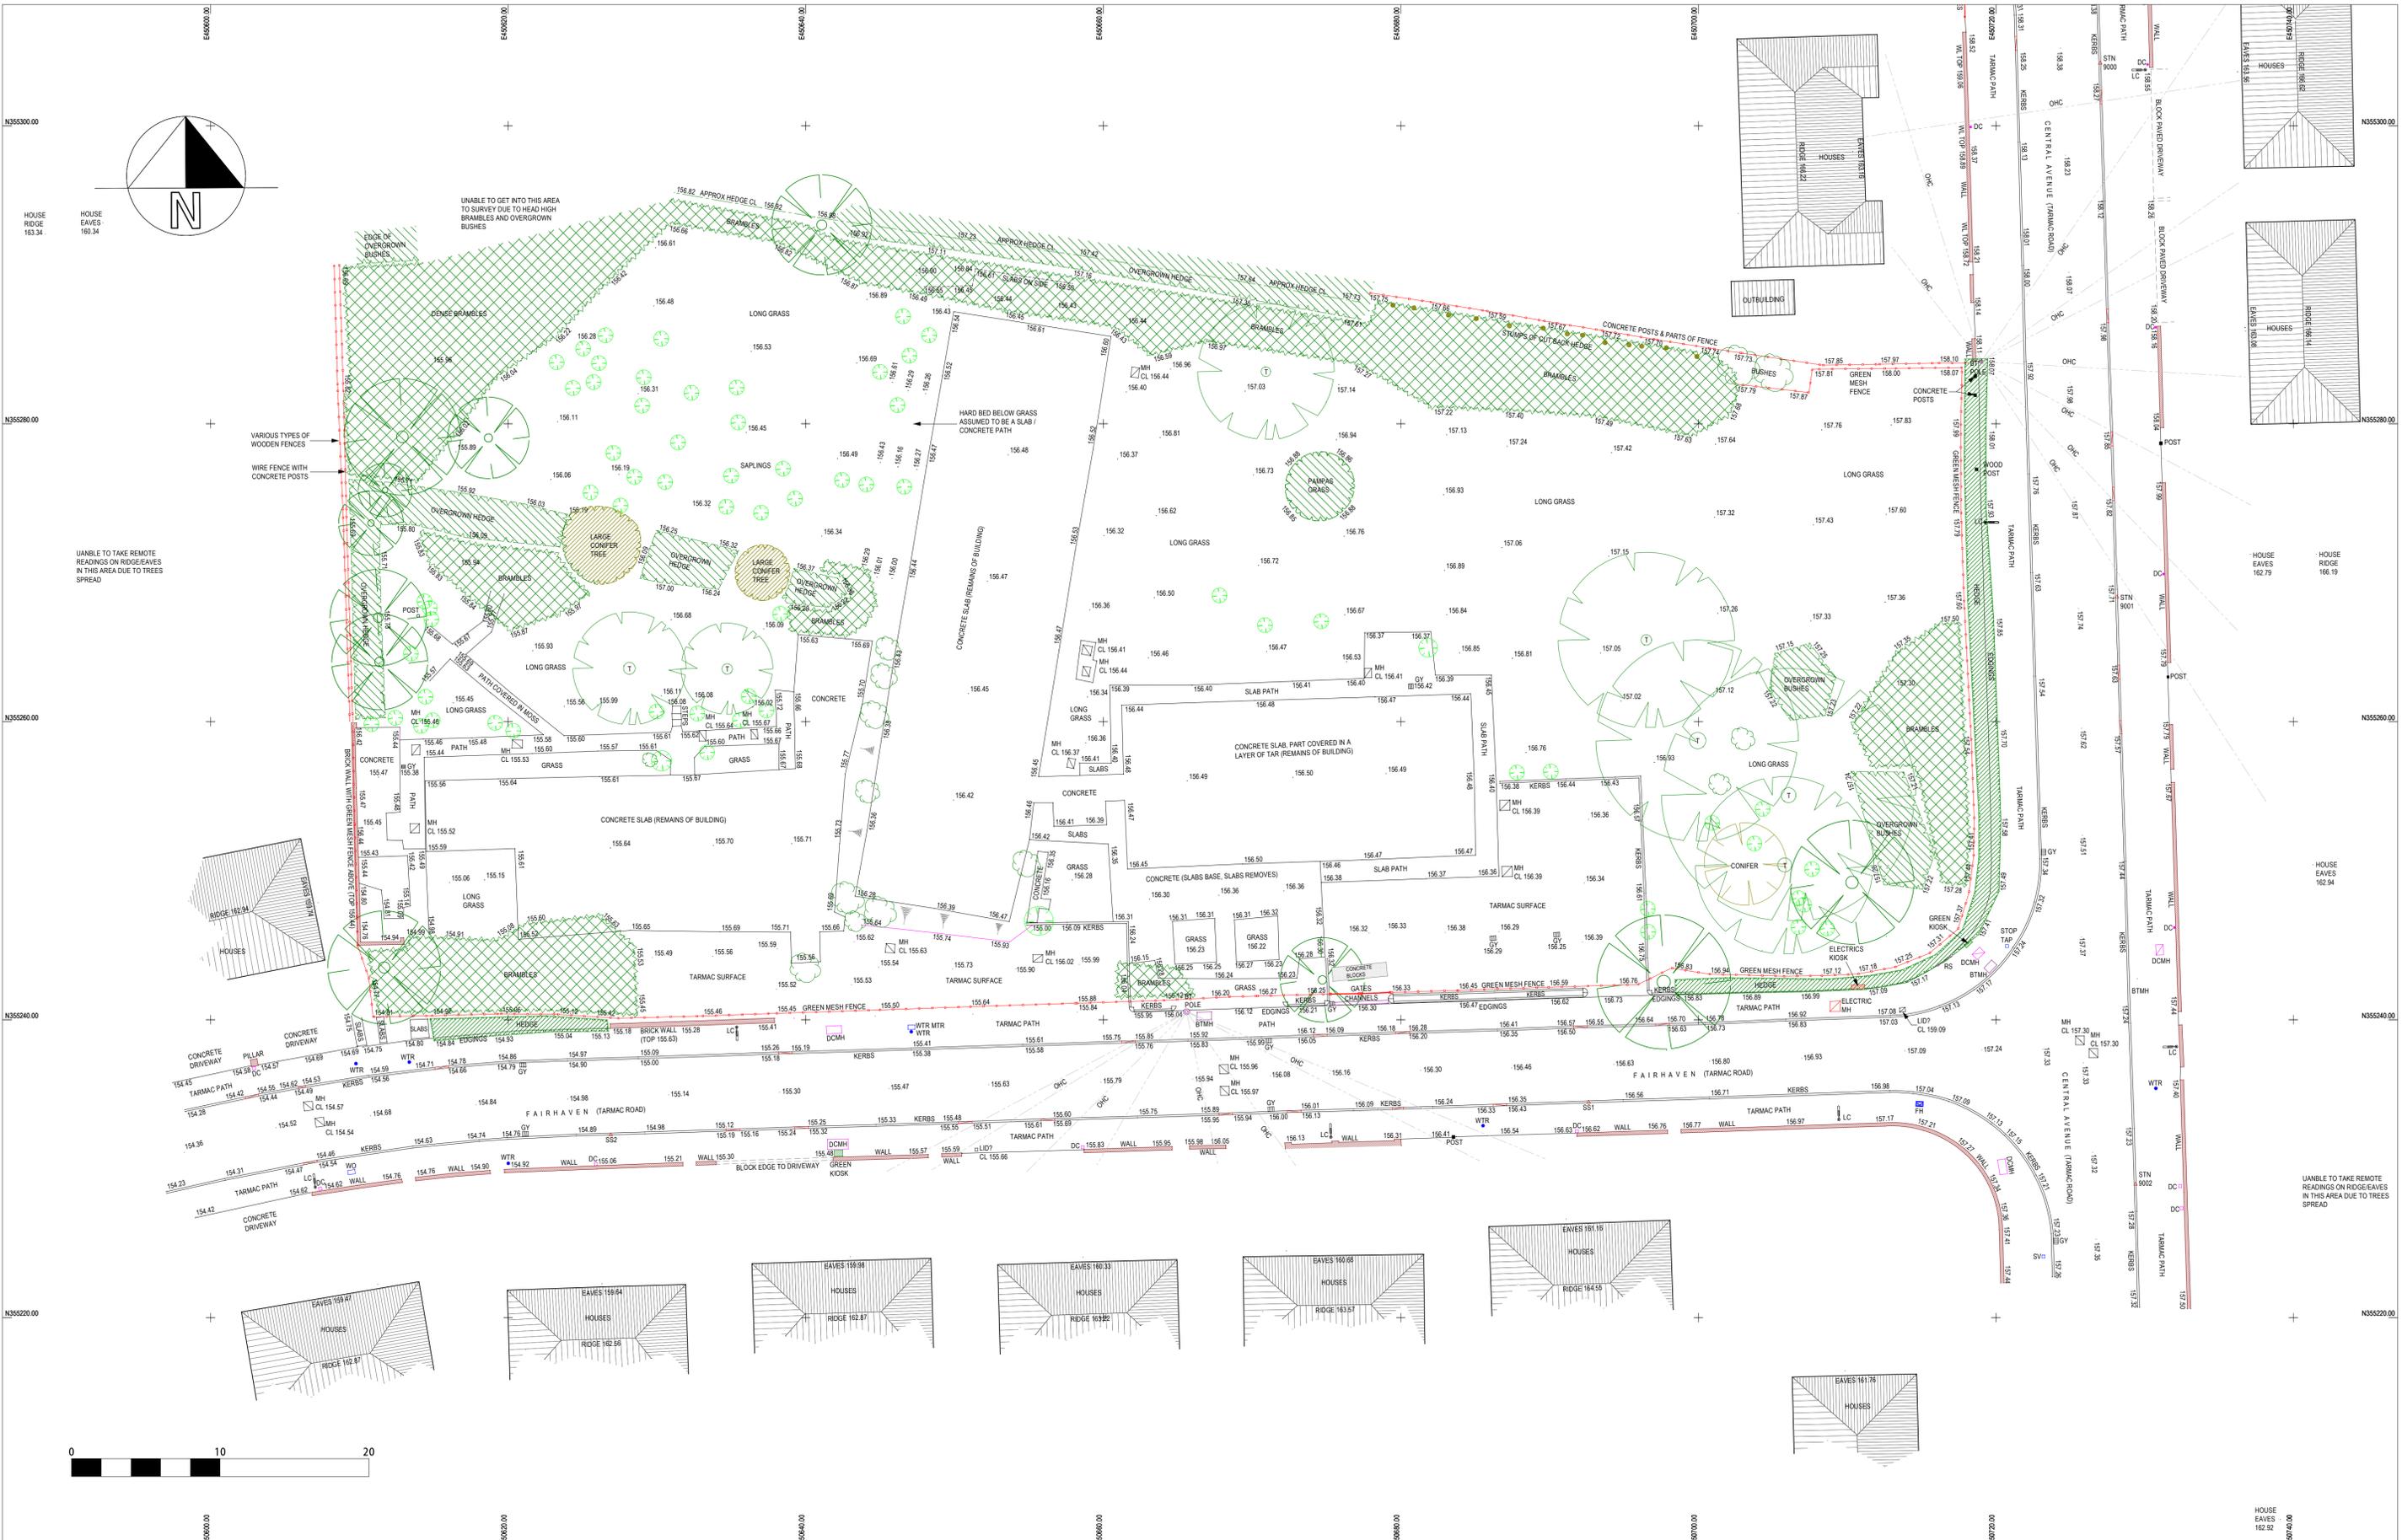
## Drawing III - Topographical Survey

The topography of the Site is noted to fall from a high point in the north-east (approximately 158.0 m AOD) to a low, located in the south-west (approximately 155.0 m AOD). As such, it is anticipated that a degree of earthworks is required as part of the proposed development. This may include the use of the existing Made Ground and Lenton Sandstone Formation soils. However, no volumes or models have been provided to EGE at this stage.

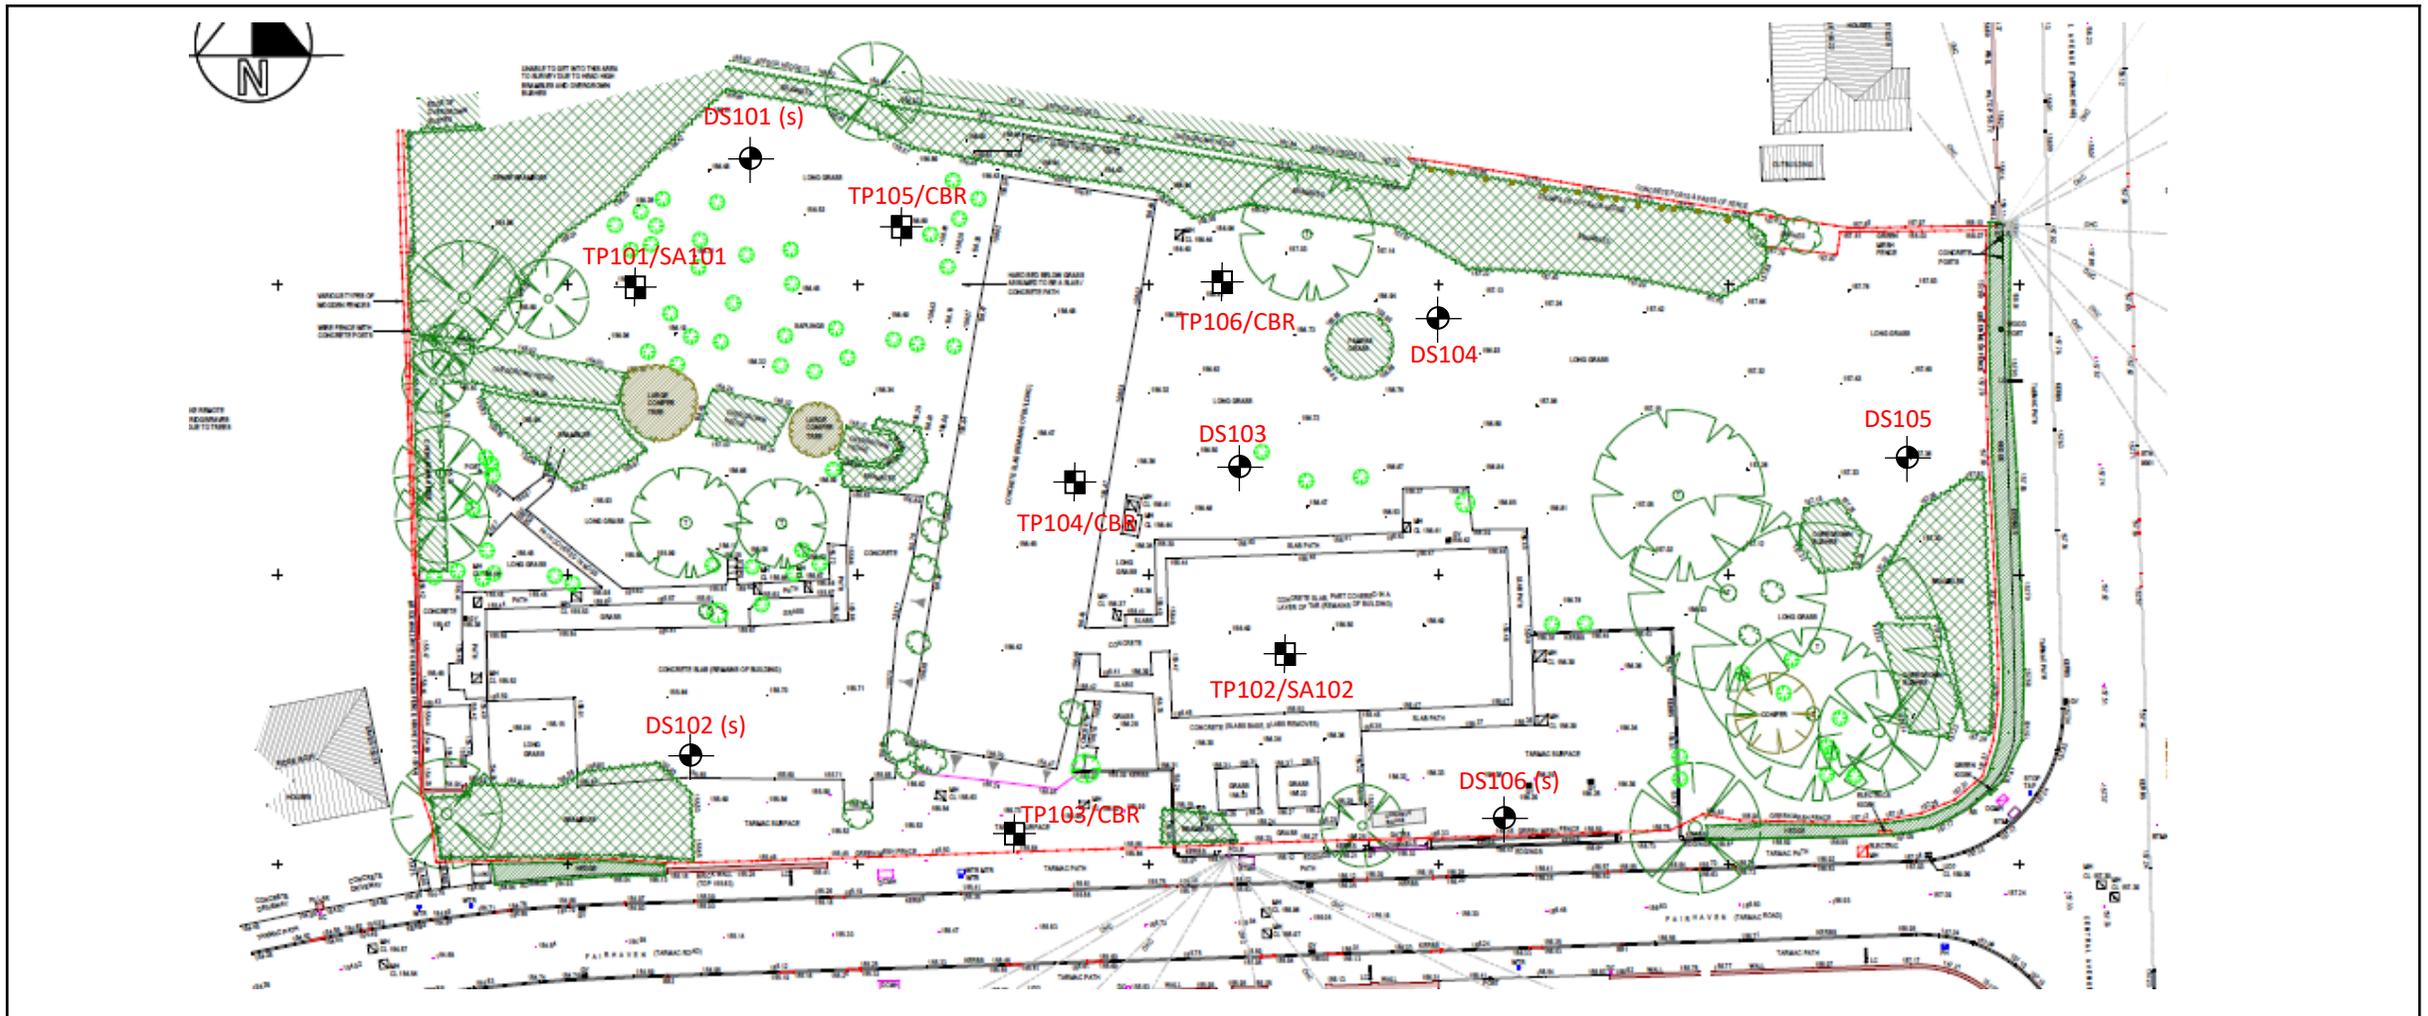
Figure III - Approximate Intrusive location Plan

Figure No. and Title	Figure III - Approximate Intrusive Location Plan	
Project Name	Fairhaven, Kirkby in Ashfield	
Client	Lindum BMS	
Service	Geo-Environmental Investigation	
Date of Issue	May 2025	
Project number	EGE-24-07-07-01

Ground conditions at the Site comprised Topsoil or Made Ground, over the Lenton Sandstone Formation, in all locations.

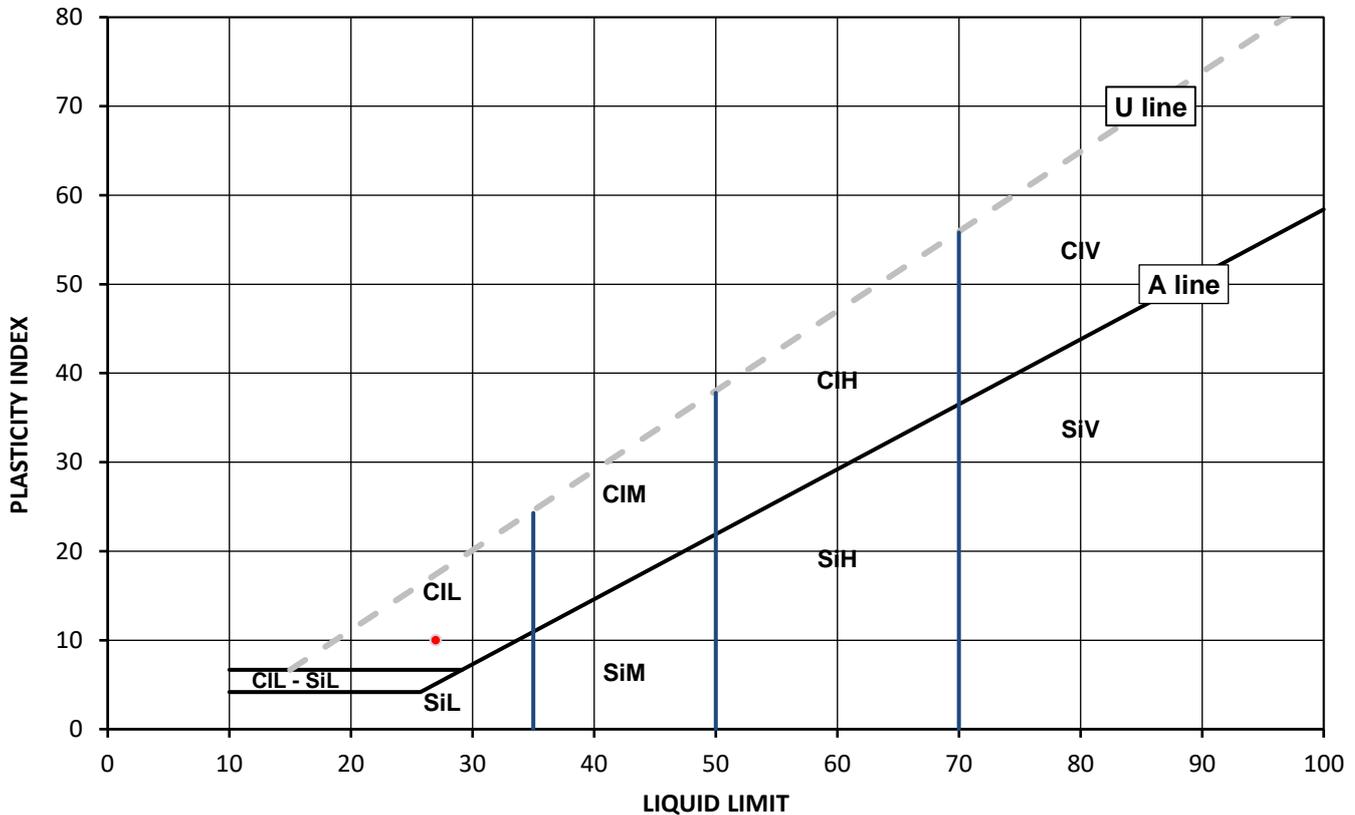
As Received Water Content [W] %	Liquid Limit [WL] %	Plastic Limit [Wp] %	Plasticity Index [Ip] %	Liquidity Index [IL] % #	Consistency Index [IC] % #	% Passing 425µm BS Test Sieve
20.3	27	17	10	0.30	0.70	100

Part 5.1.13 of Nottinghamshire County Council Materials Specification recommends that for design purposes equilibrium CBR is designed from plasticity index. A shallow plasticity index test was undertaken at 0.80 m in DS106 and required a plasticity index of 10 %.

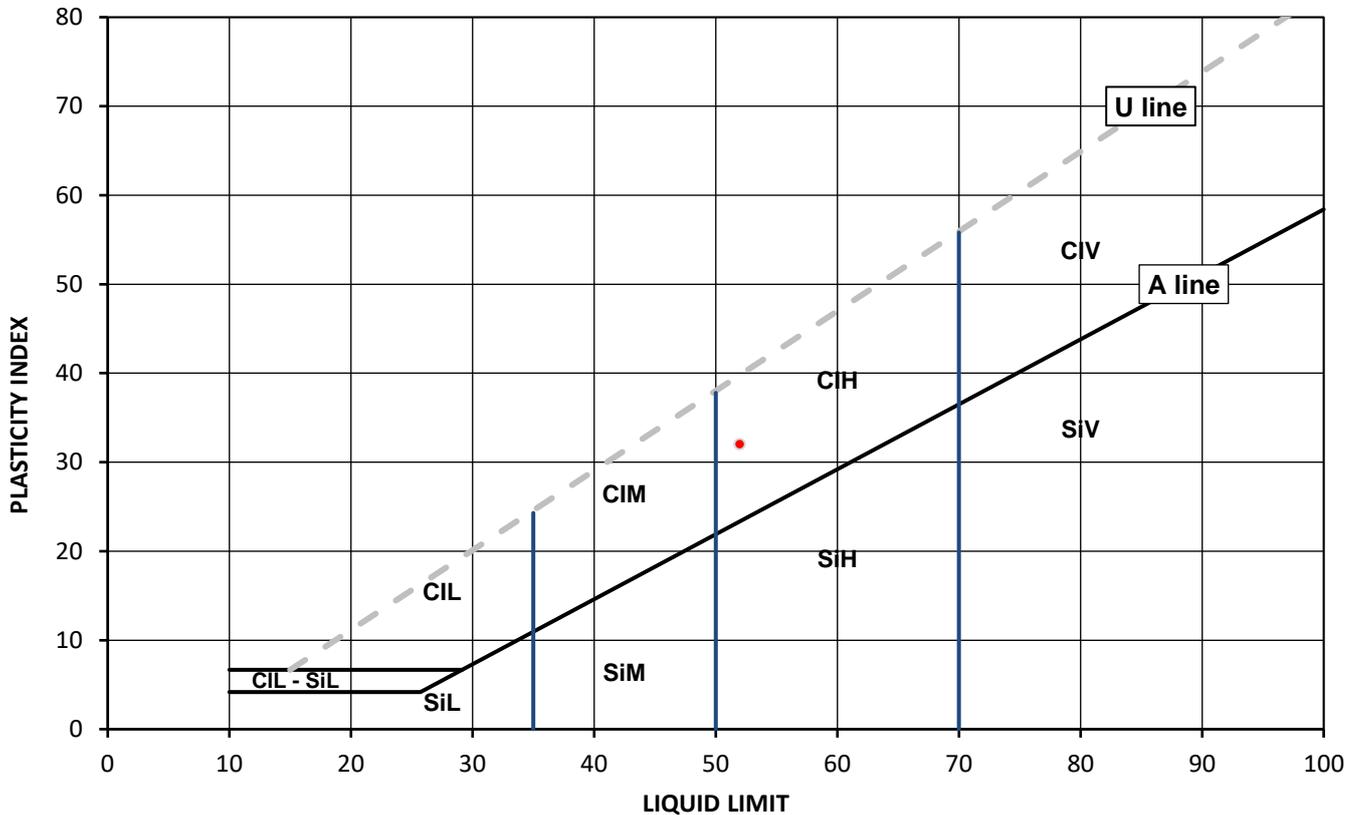
As Received Water Content [W] %	Liquid Limit [WL] %	Plastic Limit [Wp] %	Plasticity Index [Ip] %	Liquidity Index [IL] % #	Consistency Index [IC] % #	% Passing 425µm BS Test Sieve
18.3	52	20	32	-0.06	1.06	100

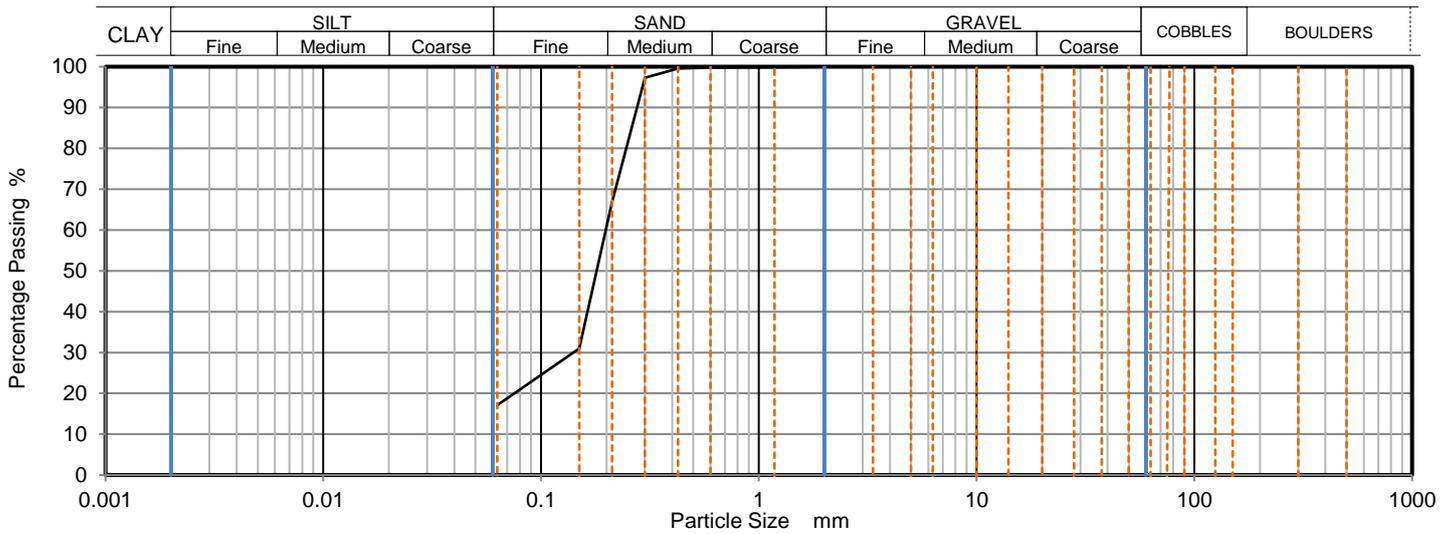
Laboratory Reference: 489082  
Hole No.: DS102  
Sample Reference: Not Given  
Sample Description: Orangish brown clayey SAND  
Sample Preparation: Sample was quartered, oven dried at 107.2 °C and broken down by hand.

Sieving		Sedimentation	
Particle Size mm	% Passing	Particle Size mm	% Passing
500	100		
300	100		
150	100		
125	100		
90	100		
75	100		
63	100		
50	100		
37.5	100		
28	100		
20	100		
14	100		
10	100		
6.3	100		
5	100		
3.35	100		
2	100		
1.18	100		
0.6	100		
0.425	100		
0.3	97		
0.212	67		
0.15	31		
0.063	17

Sample Proportions	% dry mass
Very coarse	0
Gravel	0
Sand	83
Fines <0.063 mm	17

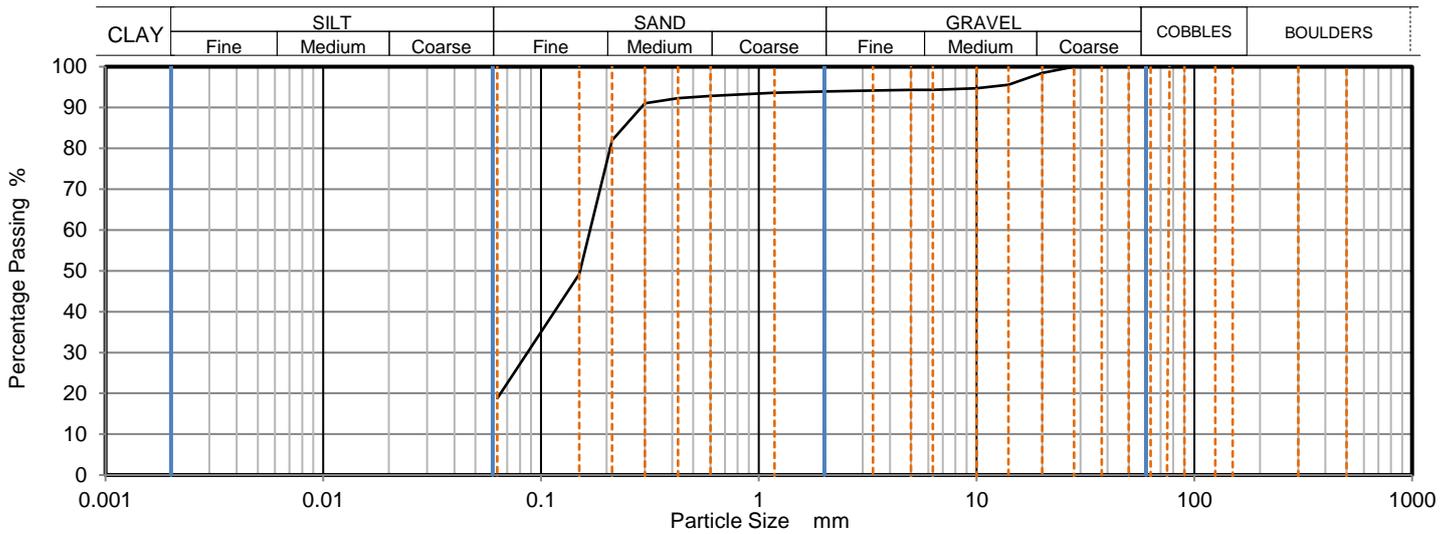
Laboratory Reference: 489083  
Hole No.: DS103  
Sample Reference: Not Given  
Sample Description: Orangish brown gravelly clayey SAND  
Sample Preparation: Sample was quartered, oven dried at 107.2 °C and broken down by hand.

Sieving		Sedimentation	
Particle Size mm	% Passing	Particle Size mm	% Passing
500	100		
300	100		
150	100		
125	100		
90	100		
75	100		
63	100		
50	100		
37.5	100		
28	100		
20	99		
14	96		
10	95		
6.3	94		
5	94		
3.35	94		
2	94		
1.18	94		
0.6	93		
0.425	92		
0.3	91		
0.212	82		
0.15	49		
0.063	19

Sample Proportions	% dry mass
Very coarse	0
Gravel	6
Sand	75
Fines <0.063 mm	19

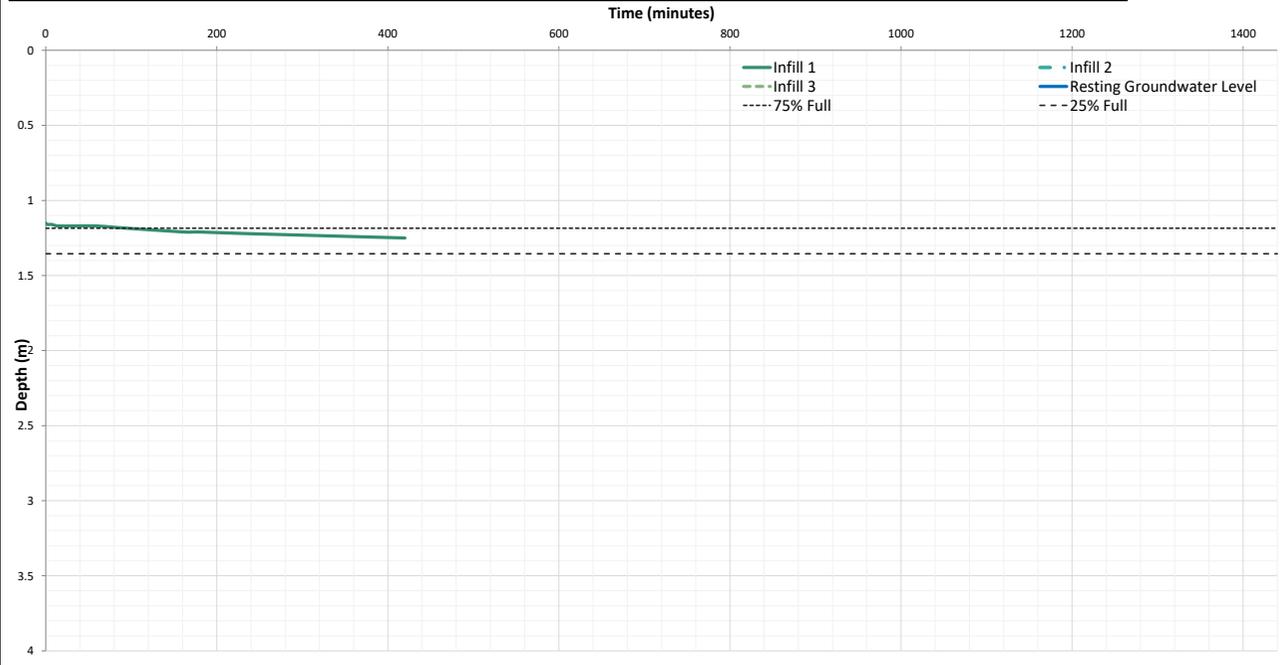
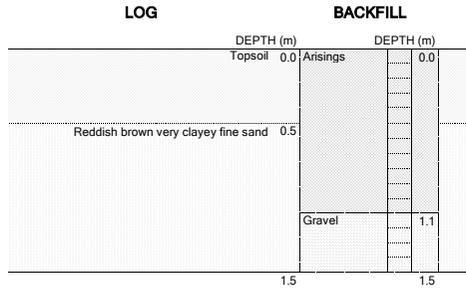
<b>TITLE:</b> Soakaway Test Results Fairhaven, Kirkby in Ashfield Lindum Group	<i>In general accordance with BRE Digest 365 (2016)</i>	<b>DRAWN BY:</b> PH	<b>SCALE:</b> Not to Scale	<b>PROJECT NUMBER:</b> EGE-24-07-01
			<b>CHECKED BY:</b> PB	<b>REVISION:</b> 1	<b>SOAKAWAY NUMBER:</b> TP101/SA101
			<b>DATE:</b> 19/03/2025

units	Infill 1	Infill 2	Infill 3
Length	m		1.60	
Width	m		0.60	
Depth	m		1.45	
Gravel type		20mm single size		
Voids ratio		0.40		
Resting groundwater level at time of testing	m	5.00		
Depth of first reading	m	0.98	1.06	1.10
Depth of final reading	m	1.44	1.45	1.45
Did soakage test reach 25% of maximum fill depth?		Yes	Yes	Yes
Did soakage test reach near empty?		Yes	Yes	Yes
Depth at 75% full/effective depth	m	1.10	1.16	1.19
Depth at 25% full/effective depth	m	1.33	1.35	1.36
Time at 75% full/effective depth	mins	4.87	14.50	20.63
Time at 25% full/effective depth	mins	49.50	71.62	70.00
Vp75 - 25 (volume outflowing between 75% and 25% full/effective depth)	m <sup>3</sup>	0.09	0.07	0.07
Mean surface area for outflow (50% full/effective depth)	m <sup>2</sup>	1.99	1.82	1.73
tp75 (time for the water level to fall from 75% to 25% full/effective depth)	mins	44.63	57.12	49.38
Soil infiltration rate, f =	m/s	0.00001690	0.00001202	0.00001311

Recommended soil infiltration rate	
1.2E-05	m/s

Infiltration testing in general accordance BRE365 methodology was undertaken within two (2 no.) locations; SA101 and SA102, the results of which are included as Appendix VI and discussed in Section 6.10 of this Report.

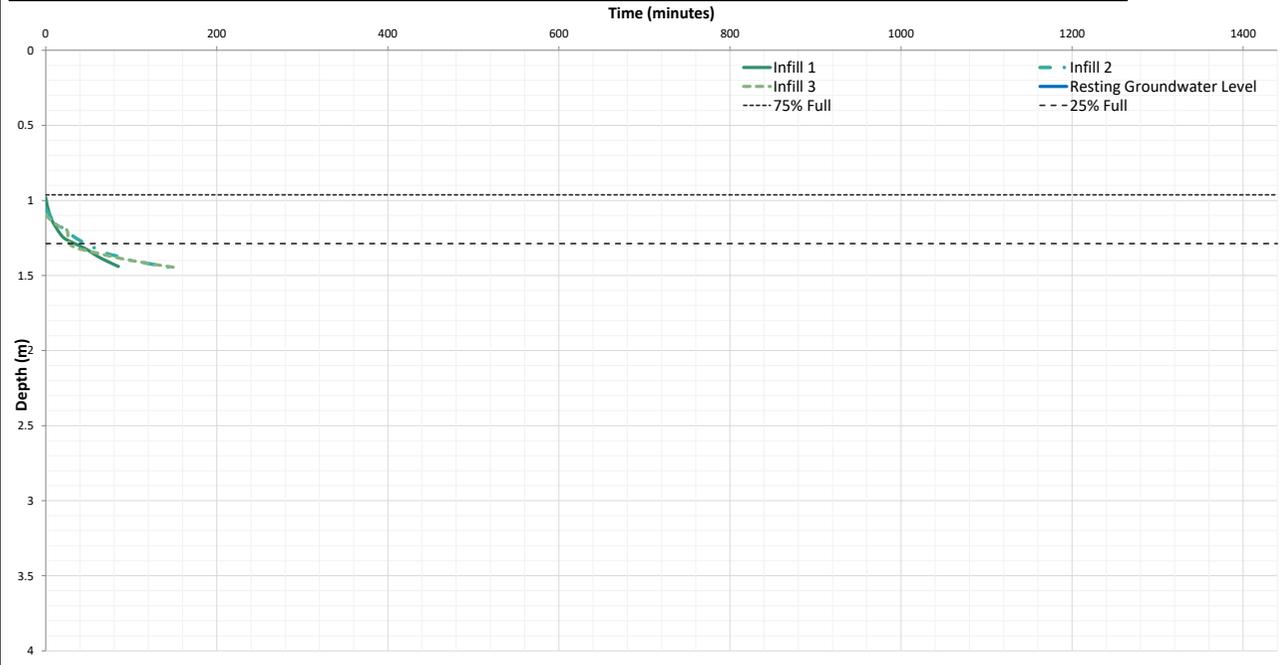
LOG		BACKFILL	
DEPTH (m)		DEPTH (m)	
0.0	Concrete	0.0	Arisings
0.3	Gravel	0.8	Gravel
0.7	Gravelly sand		
1.5		1.5

<b>TITLE:</b> Soakaway Test Results Fairhaven, Kirkby in Ashfield Lindum Group	<i>In general accordance with BRE Digest 365 (2016)</i>	DRAWN BY: PH	SCALE: Not to Scale	PROJECT NUMBER: <b>EGE-24-07-01</b>
			CHECKED BY: PB	REVISION: 1	SOAKAWAY NUMBER: <b>TP102/SA102</b>
			DATE: 19/03/2025
