RE: Hucknall Town Football Club – Additional Soakaways and Groundwater Monitoring

Remada Ltd was commissioned by Lidl (hereafter ‘the Client’) to undertake additional soakaways and groundwater monitoring at Hucknall Town Football Club, Watnall Road, NG15 6EY.

Project Title
Hucknall Town Football Club

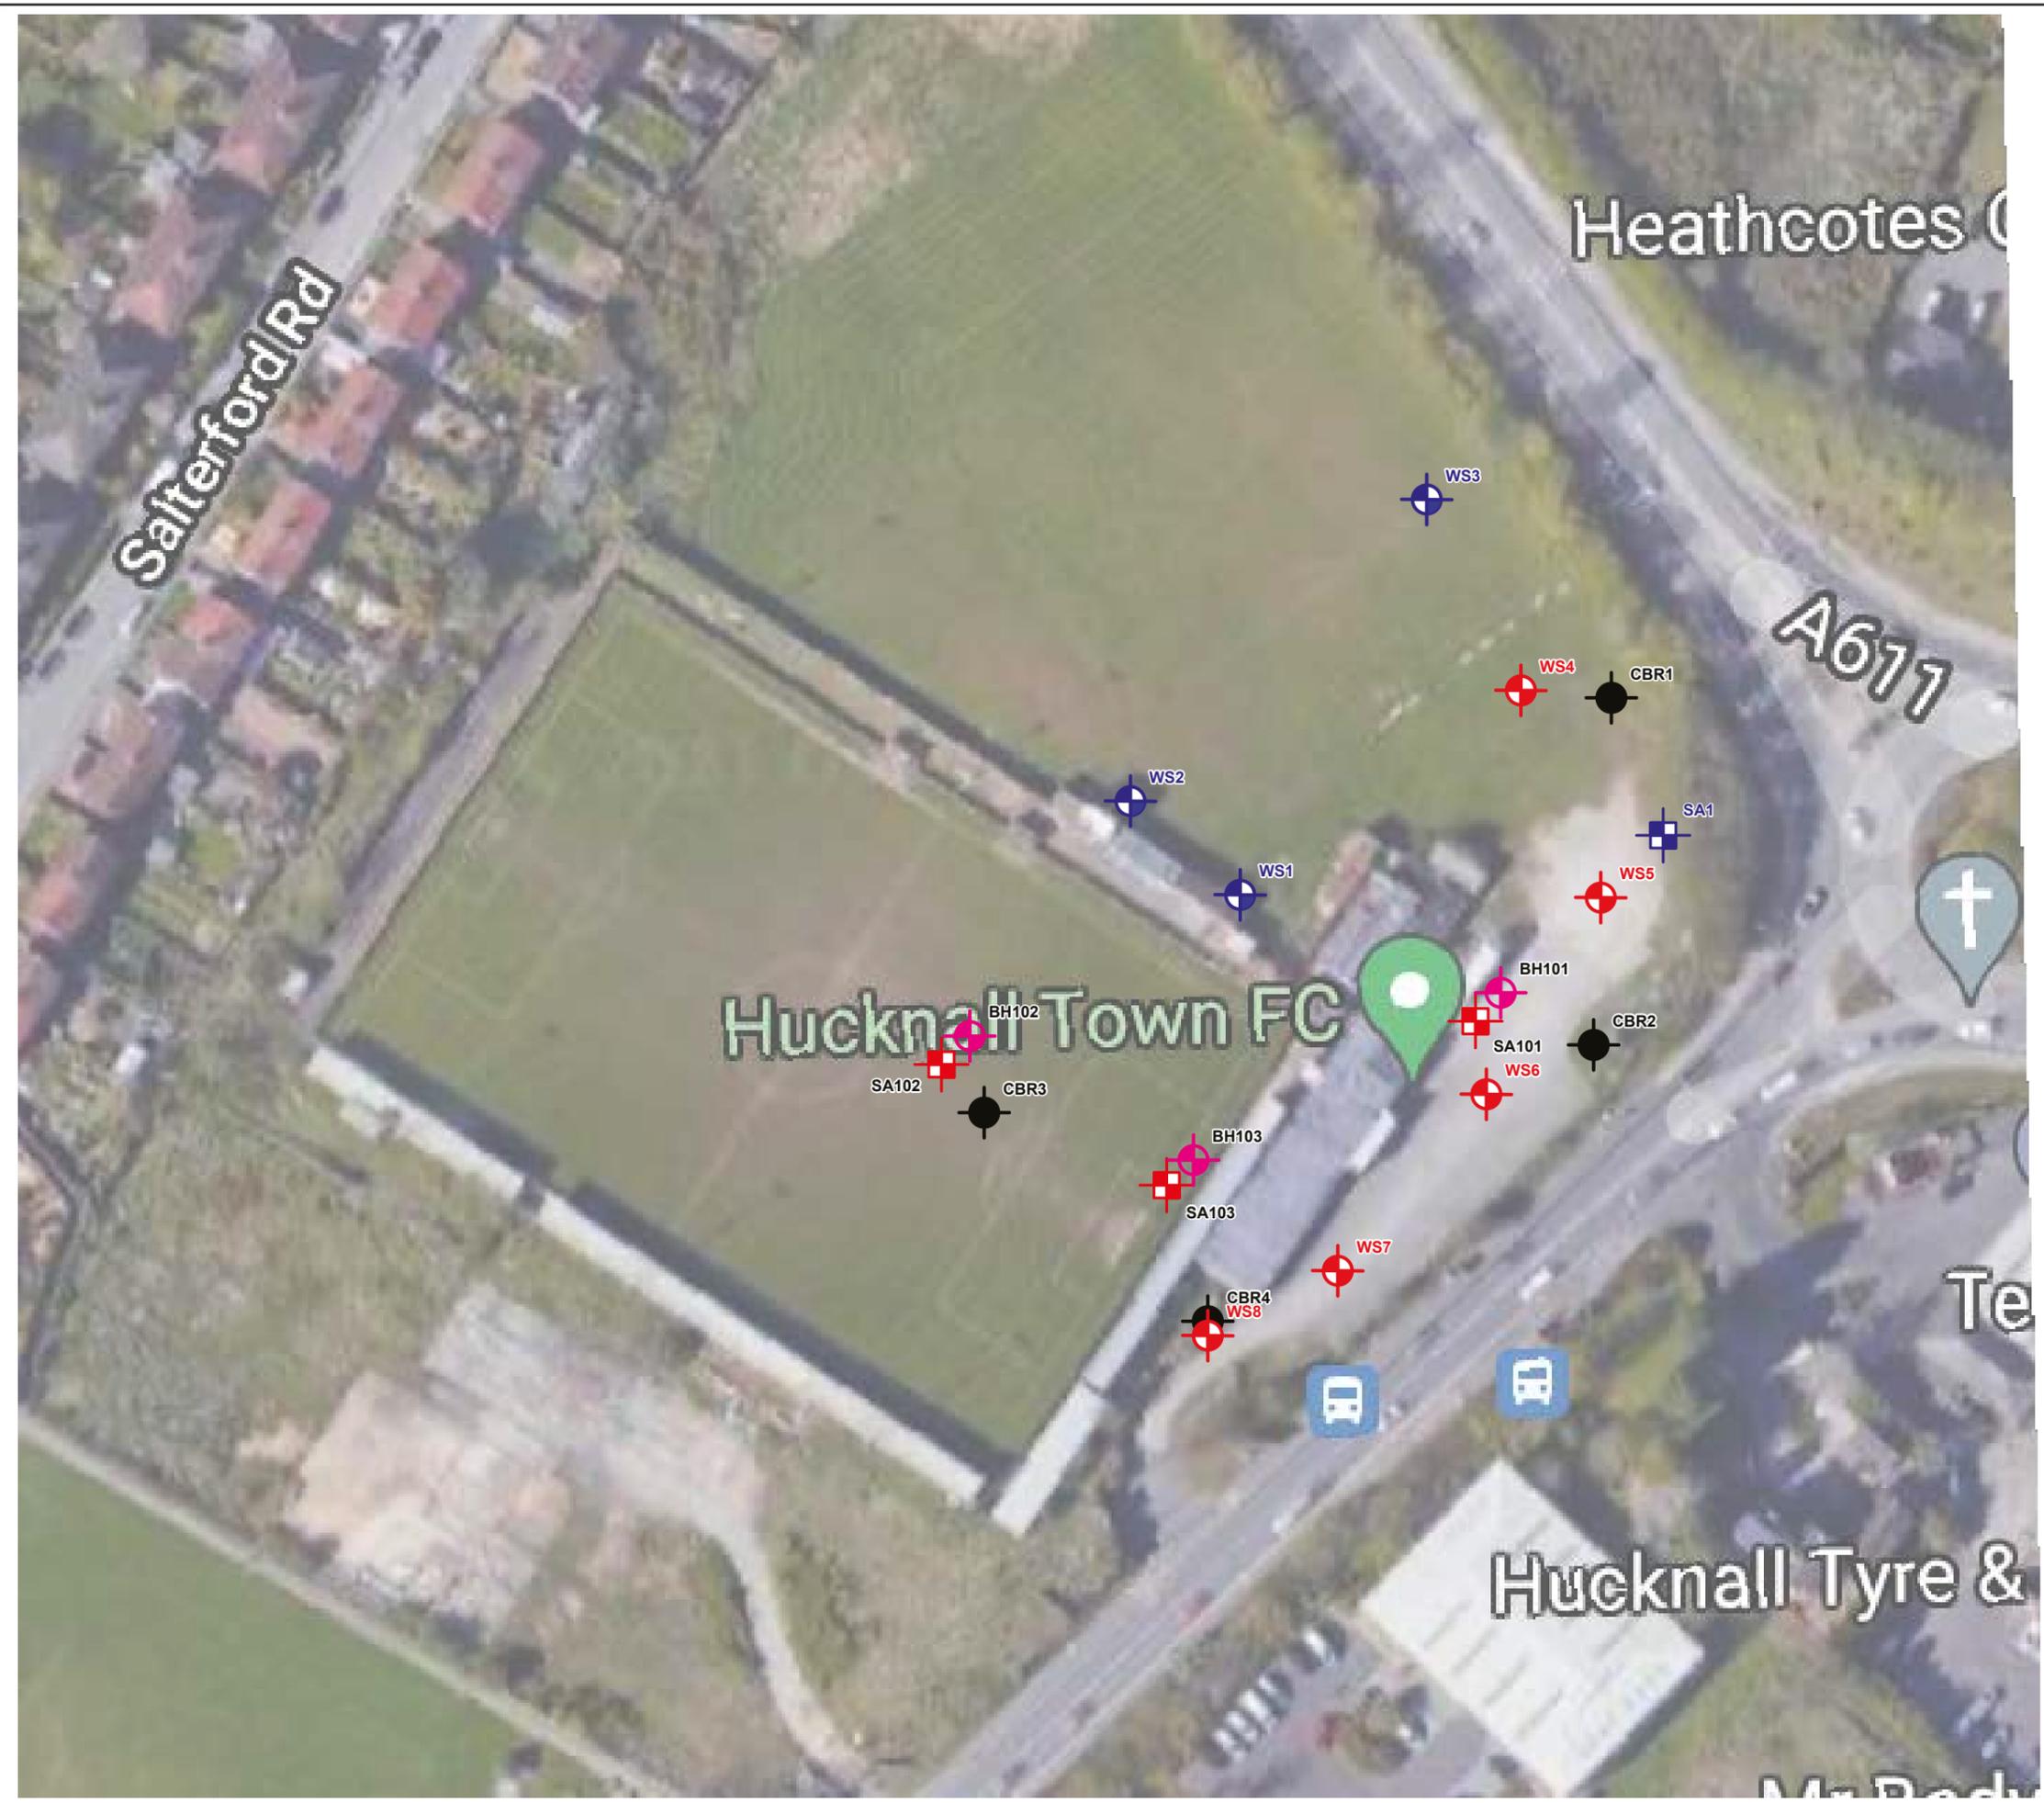
Drawing Title
Figure 1 - Site Location and Exploratory Hole Plan

Legend
2021 Ground Investigation

SA1 Soakaway Test

2022 Ground Investigation

SA101 Soakaway Test
-

BH101 Borehole

Remada attended site on 19th December 2022 to undertake the scope of works as described above, the exploratory hole locations are shown on **Figure 1**. A total of three trial pits were excavated and three boreholes were bored at the site.

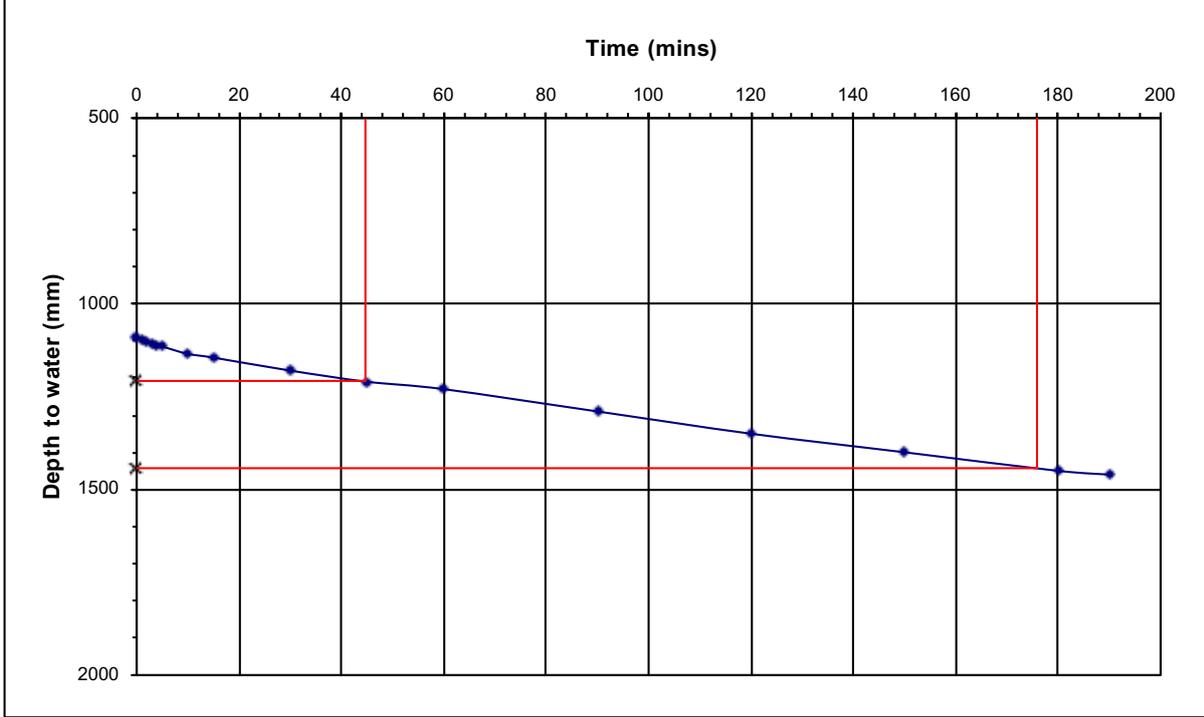
Base area of pit	=	1.365
a_{p50} - 50% internal surface area inc. base	=	2.658
V_{p75-25} - Volume 75 - 25%	=	0.321

t_{p75} (min) = (Read from graph)	44
t_{p25} (min) = (Read from graph)	176
t_p values extrapolated from graph data =	132
t_p value (seconds) =	7920

Soil infiltration rate, f , (m/s) = **1.52E-05** **(normal test)**

Location	Basal Depth at beginning of test (m bgl)	Test	Infiltration Rate (m/s)
SA101	1.6	1	2.04x10 ⁻⁵
	1.53 (due to silting)	2	1.72x10 ⁻⁵
SA102	1.6	1	4.36x10 ⁻⁵
	1.55 (due to silting)	2	3.97x10 ⁻⁵
	1.52 (due to silting)	3	4.73x10 ⁻⁵
SA103	1.6	1	1.65x10 ⁻⁵
	1.56 (due to silting)	2	1.52x10 ⁻⁵
