KE/DN/46924-004

29 July 2022

**Newark Road, Sutton-in-Ashfield**

## **Hydrogeological Review and Groundwater Piling Assessment**

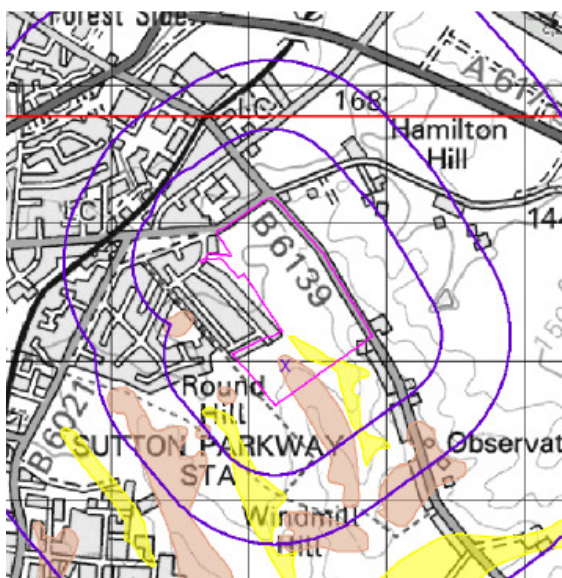
*Extract showing the superficial deposits  
(where present) Secondary A aquifer  
(brown) and Secondary Undifferentiated  
aquifer (yellow) below the site and below  
wider surrounding area.*

The solid bedrock is classified as a Principal Aquifer. The superficial glaciofluvial deposits are classified as a Secondary A Aquifer. The superficial Head deposits are classified as a Secondary Undifferentiated Aquifer.
