Building Survey Report

Address Wilkinsons
1-5 Outram Street
Sutton in Ashfield
NG17 4BX

Prepared for West Notts College
Derby Road
Mansfield
NG18 5BH

Condition Survey Report

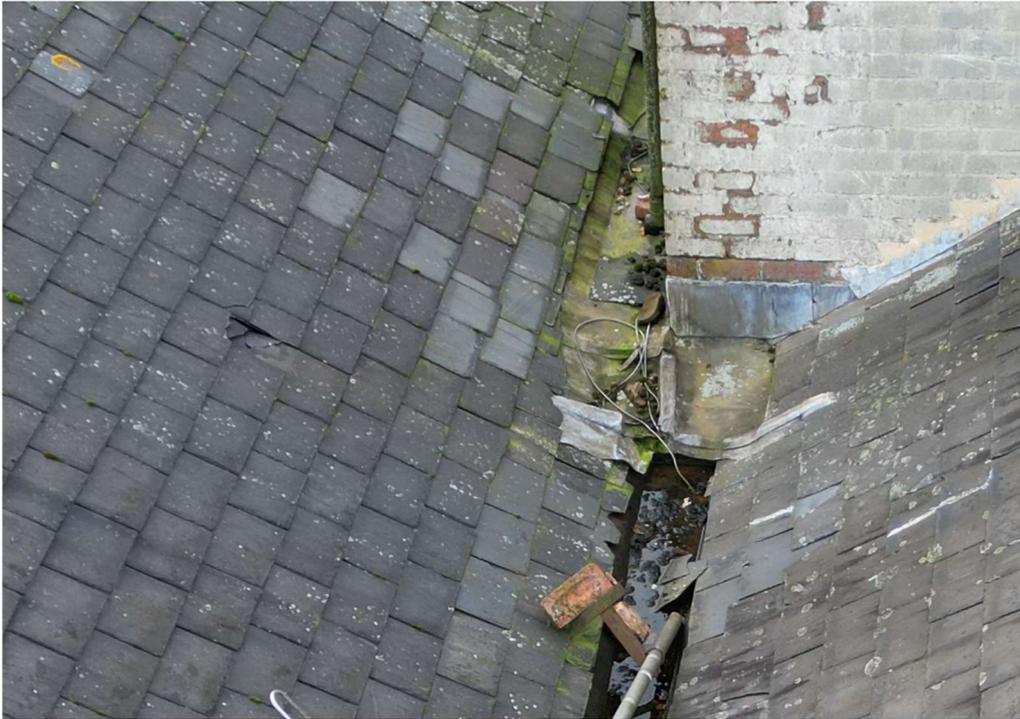
Photo 5 – Hole in roof, slipped slates resting in valley, northern elevation.

Immediate actions include renewing pitched roof coverings to prevent water ingress in second floor stock rooms and eastern stairwell. Urgently replacing all timber windows to eliminate potential safety hazards and prevent water ingress through the defective window frames. Stripping and renewing the flat roof canopy to prevent further damage to the canopy structure and building fabric. Removing and making safe defective concrete cladding panels to southern elevation. Reinstating missing brickwork to southern external wall of original lift shaft.

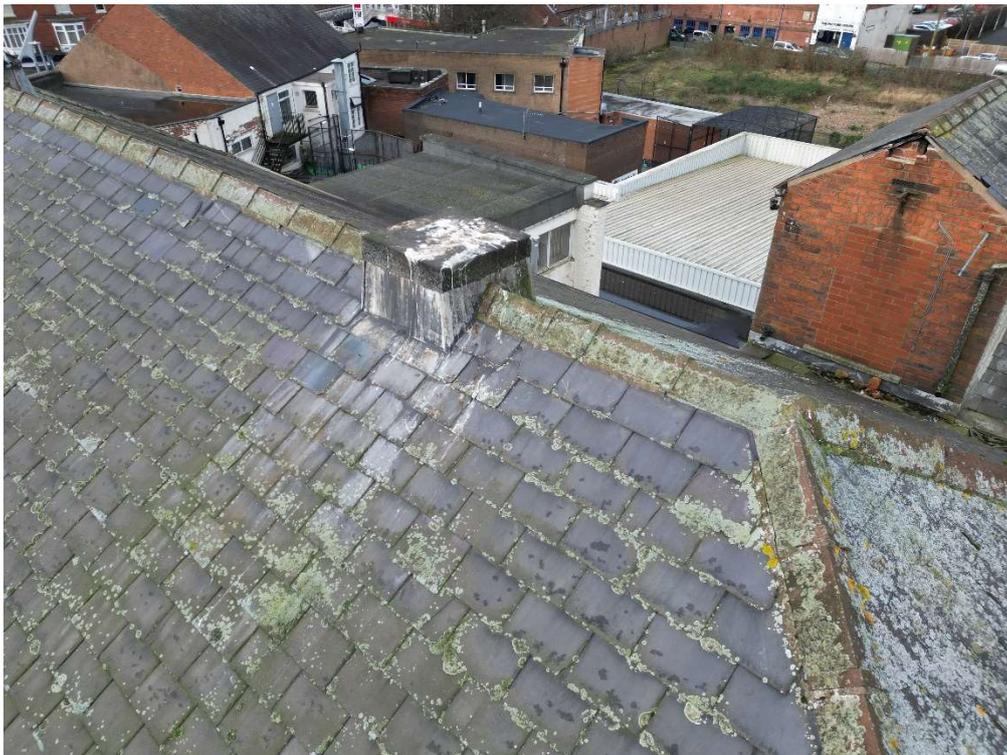
Photo 6 - Capped off roof vent, eastern end of main roof pitch.

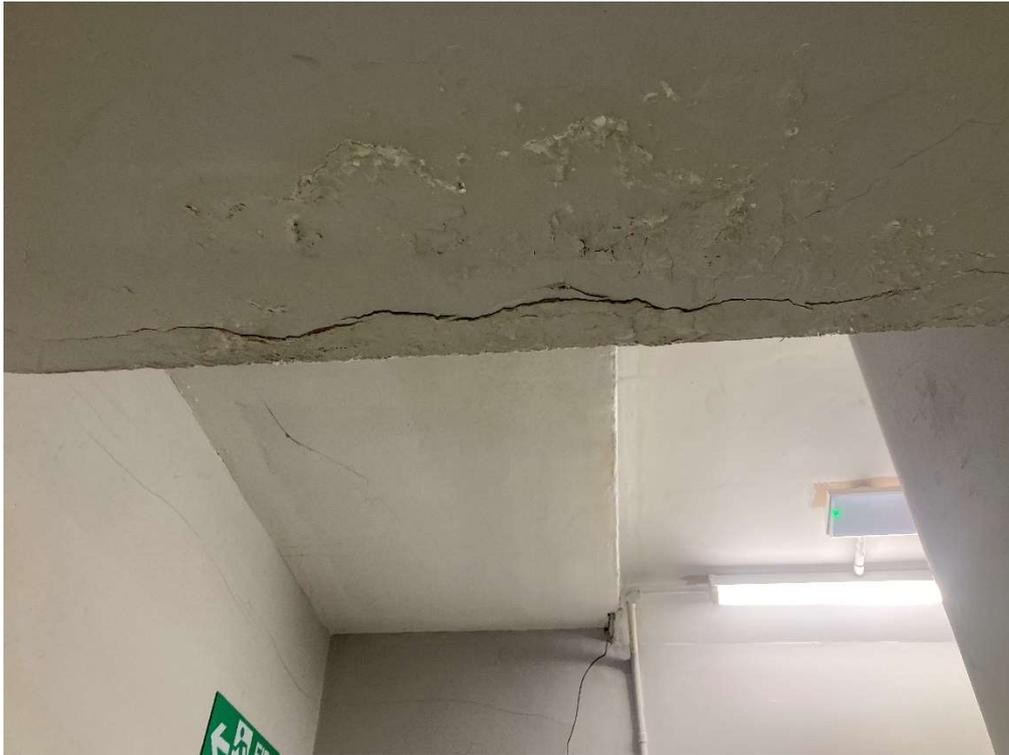
Photo 11 – Water penetration, eastern stairwell.

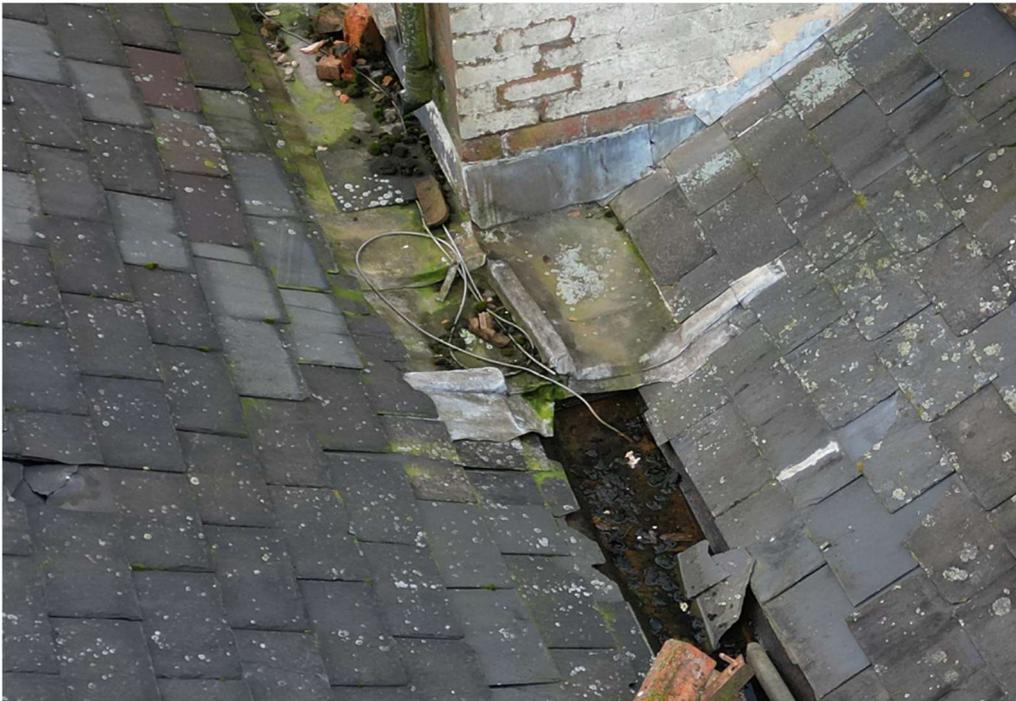
Photo 12 – Standing water and debris, valley between main roof and eastern stairwell.

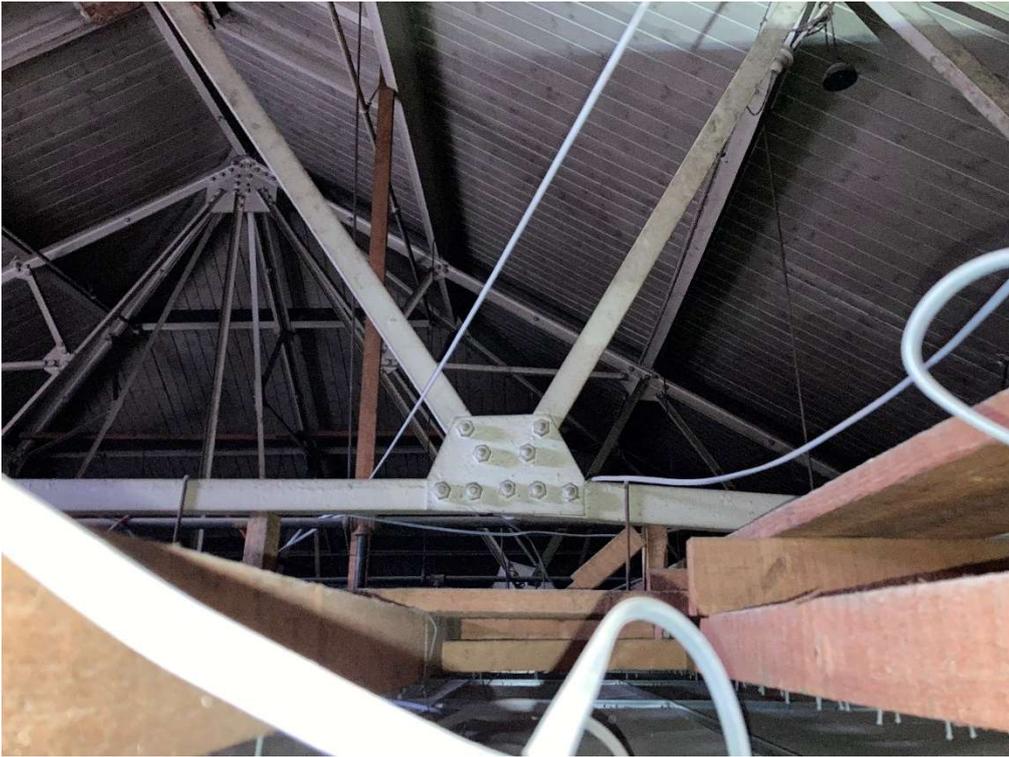
Photo 16 – View inside roof structure.

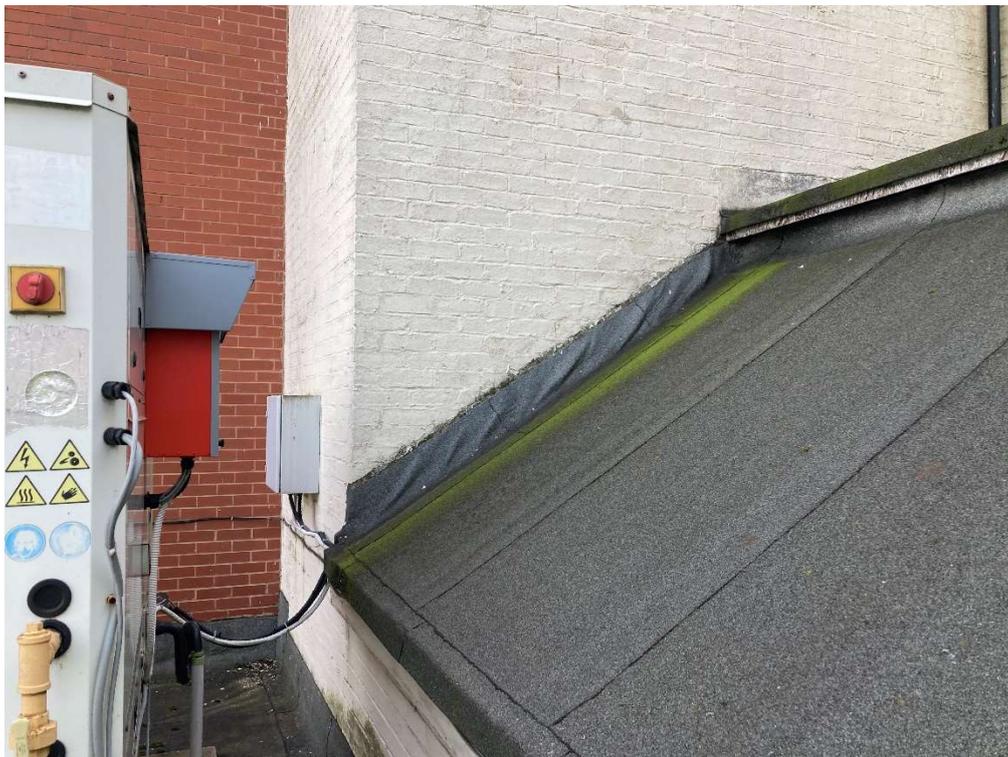
Extensive patch and flash band repairs have been undertaken beneath an external escape stair from a neighbouring property. These repairs indicate past roof defects and water ingress (photo 18). The bitumen felt roof covering is bubbled and ridged in a number of areas. Around the upstands and northern valley gutters these ridges are soft / spongy indicating water ingress between the roof covering and roof deck (photo 19). Evidence of water ingress to the rear of an upstand is also evident at the change in roof level between the original lift shaft and stairwell (photo 20).

Photo 20 – Water ingress to rear of upstand.

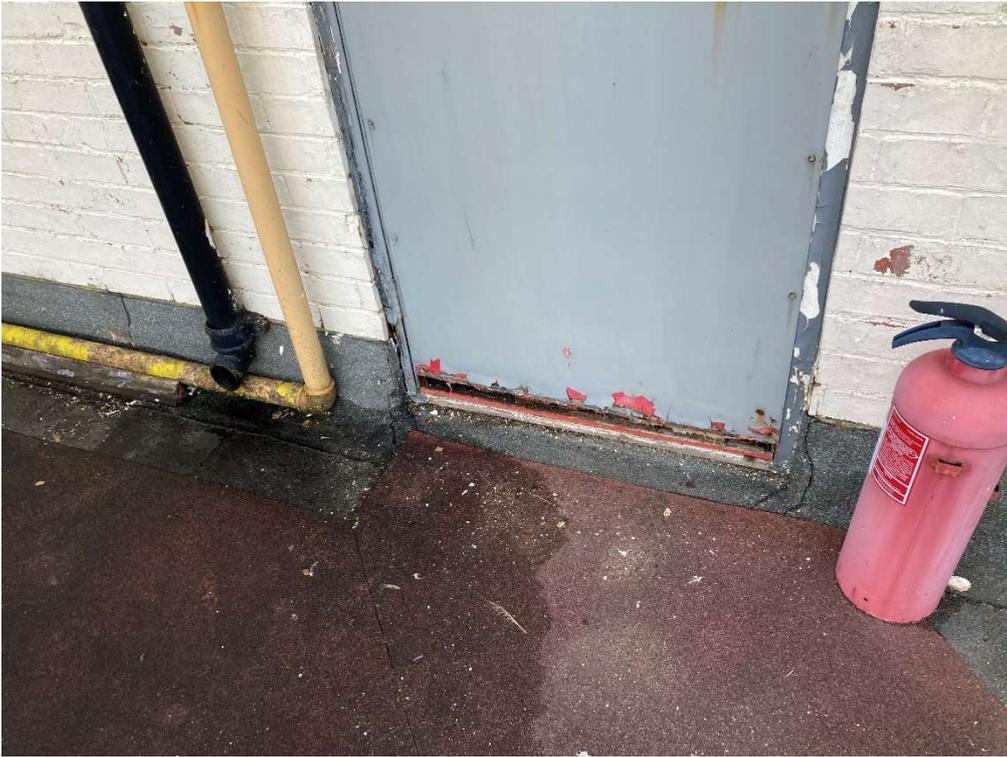
Fire exits from the first floor offices exit on to this flat roof. The upstand at the base of the fire doors is less than 150mm in height and doors / frames are severely rotten. The low upstand height and condition of the fire exit doors / frames will be allowing water to penetrate the building fabric (photo 21).

Photo 21 – Upstands at base of fire exit doors.

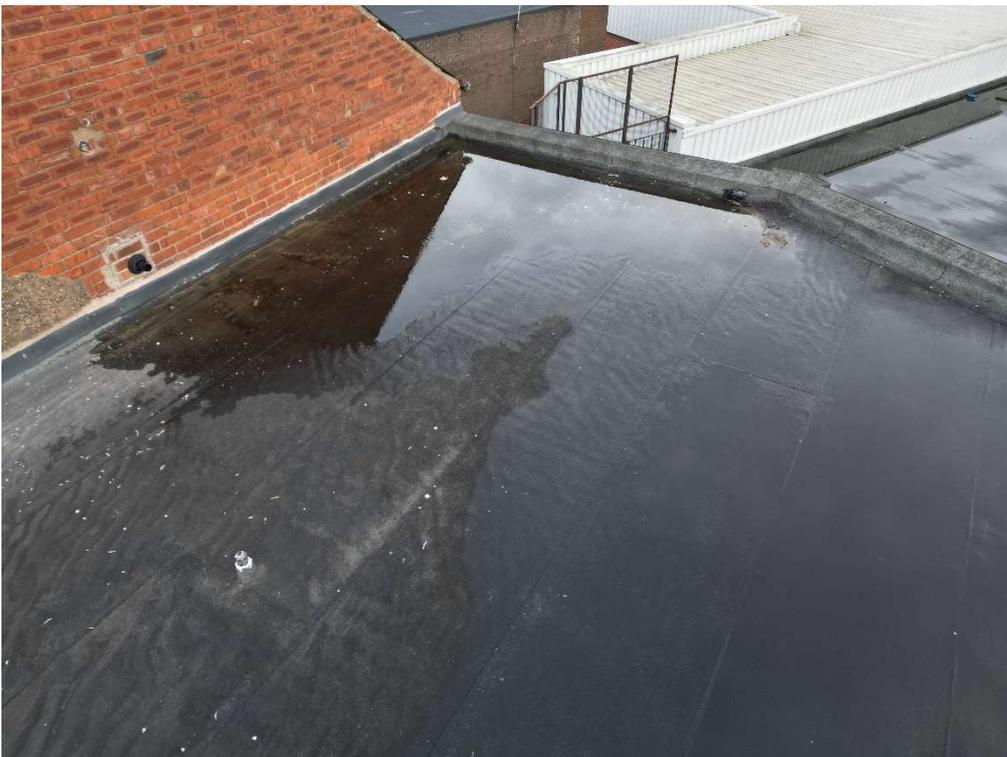
The first floor flat roof is also reaching the end of its service life. Standing water is present indicating insufficient falls. Ridging is present indicating water penetration between roof deck and roof covering (photo 22). The mortar fillet to the upstand at the eastern end of the roof is beginning to break up and should be replaced with a suitable material (photo 23). Damp penetration in the confectionary and fixtures store appears to be due to these upstand defects.

Photo 22 – First Floor flat roof, standing water.

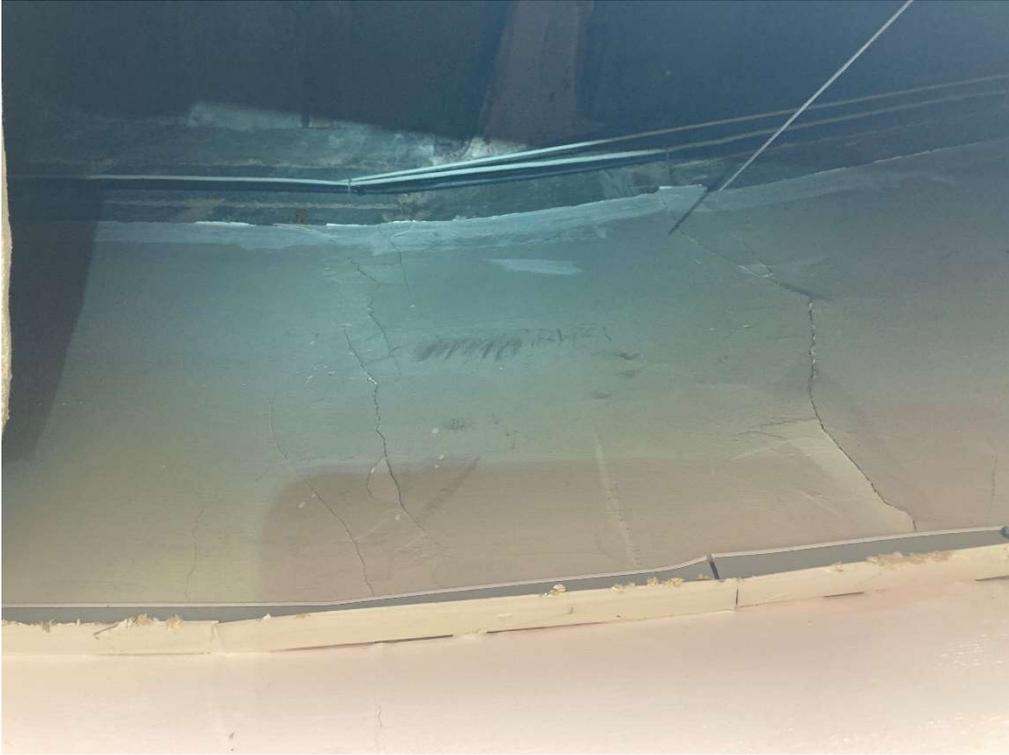
The internal wall plaster finish is beginning to blow around the steel columns in the training room and managers office (photo 25 and 26). There is a gap in the concrete copings at the column heads, the coping gap has been covered with lapped felt to prevent water ingress. The felt lapping is unlikely to fully prevent water ingress and the plaster disturbance around the columns indicates that this detail has failed in the past (photo 28). The mortar joint beneath the copings has failed in a number of areas and should be replaced (photo 27). Water ingress in the cash admin office is likely to be a result of these defects (photo 29).

Photo 25 – Blowing plaster around steel column (training room).

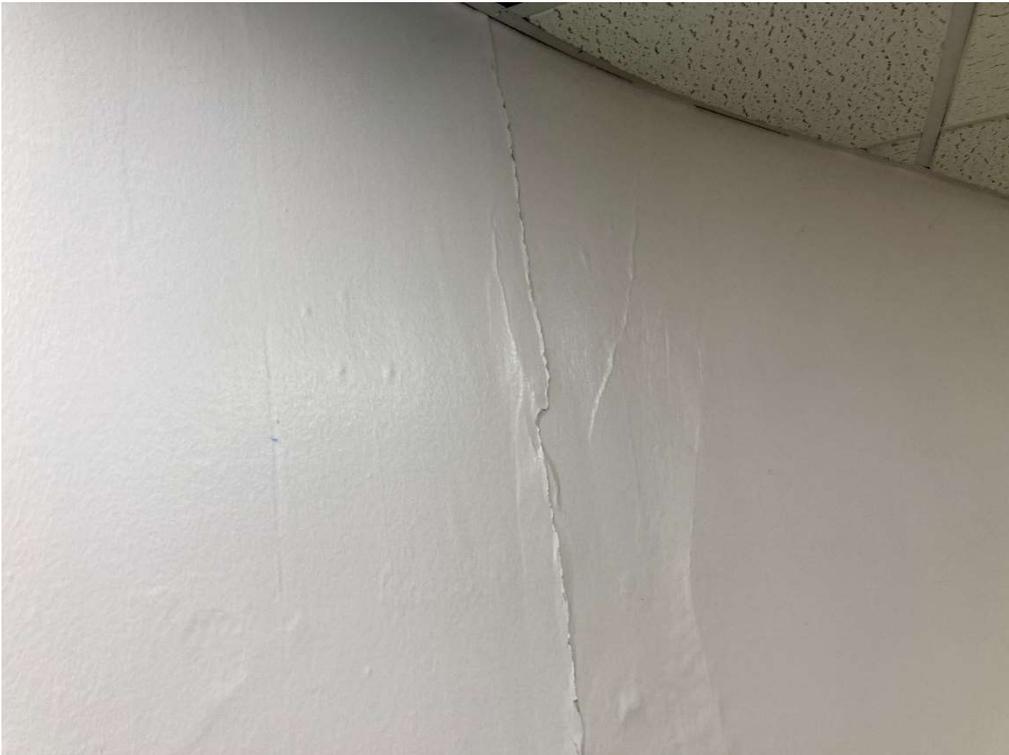
Photo 26 – Blowing plaster around steel column (training room).

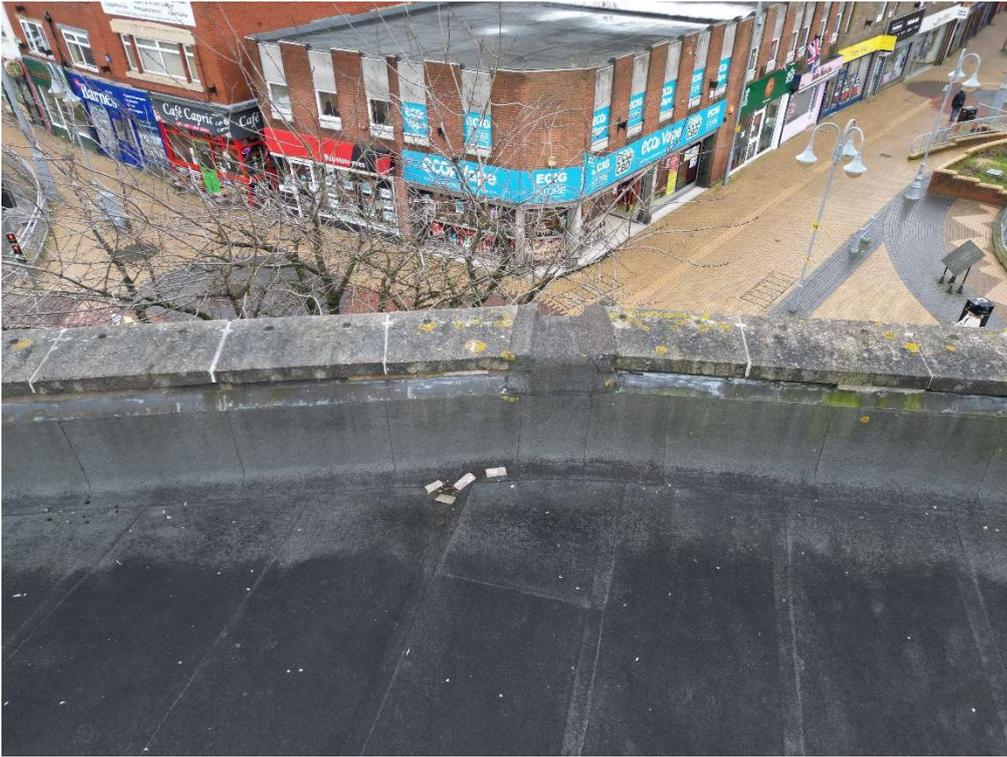
Photo 27 – lapped felt at column heads.

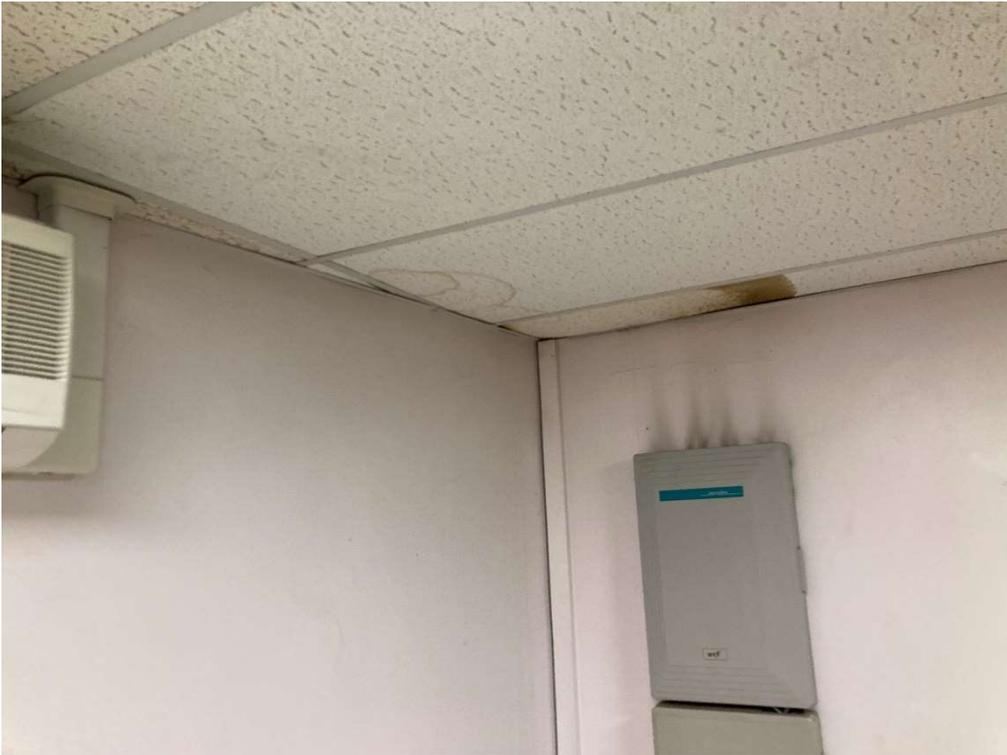
Photo 29 – Water ingress in cash admin office.

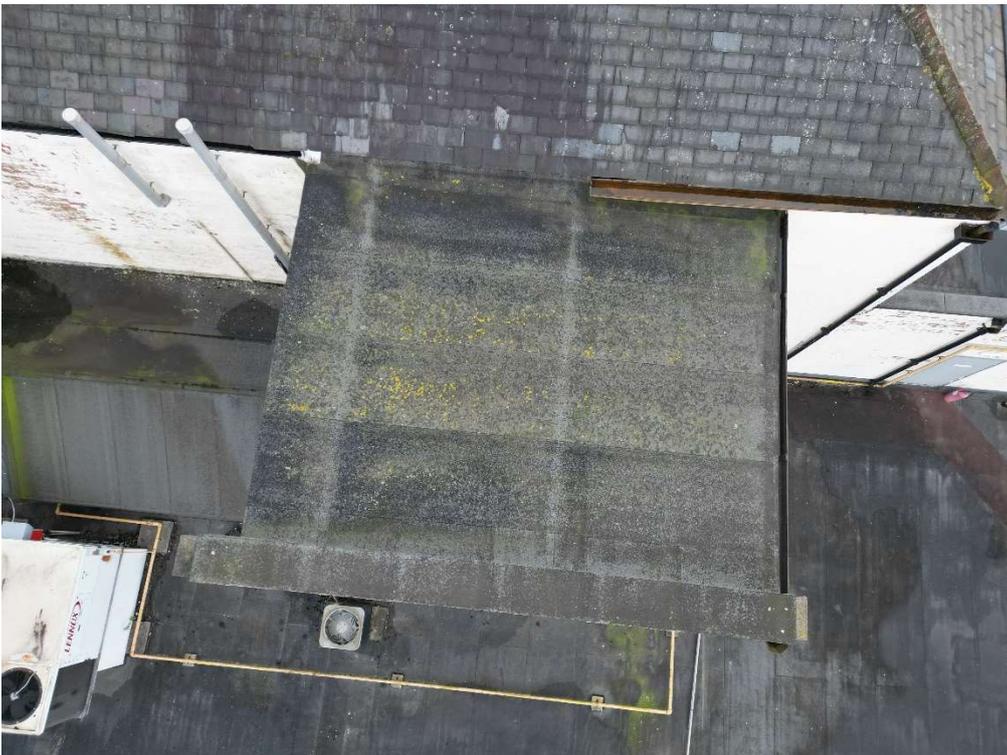
As with other flat roof areas, the flat roof above the main stairwell is showing evidence of deterioration due to age and should be replaced (photo 30).

Photo 30 – Flat roof above main stairwell.

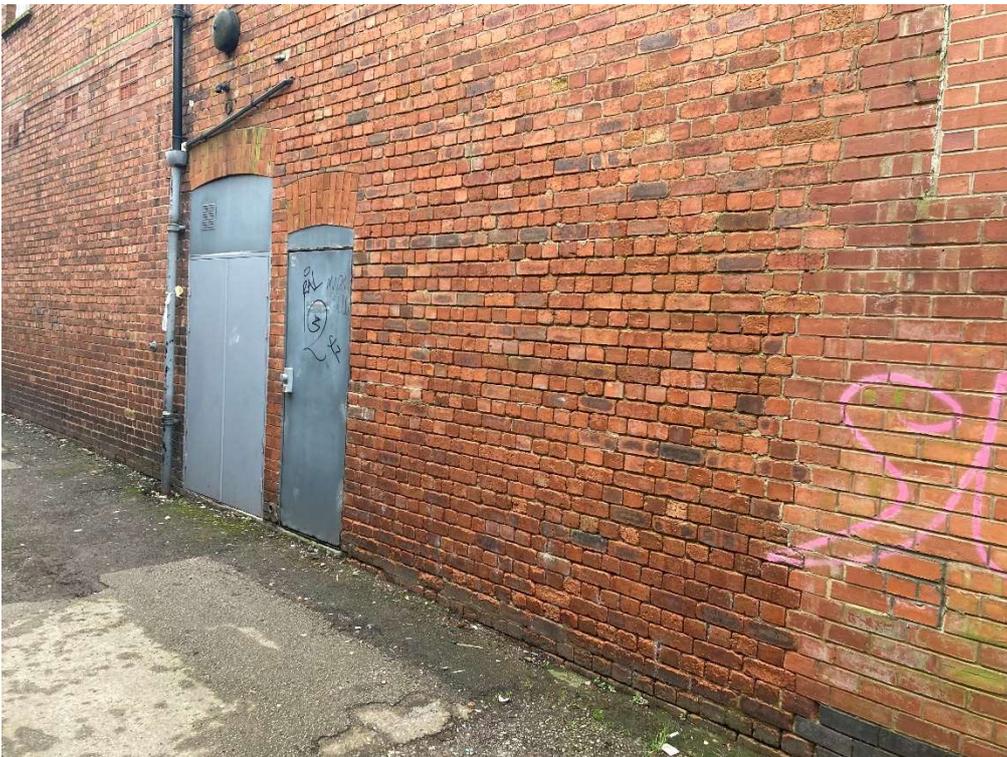
Extensive deep open joints are evident to the original section of wall open up to 50mm totalling an area of approximately 60%. The mortar joints in this wall should be raked out and repointed with appropriate mortar (photo 38).

Photo 38 – Deep open joints to eastern external wall.

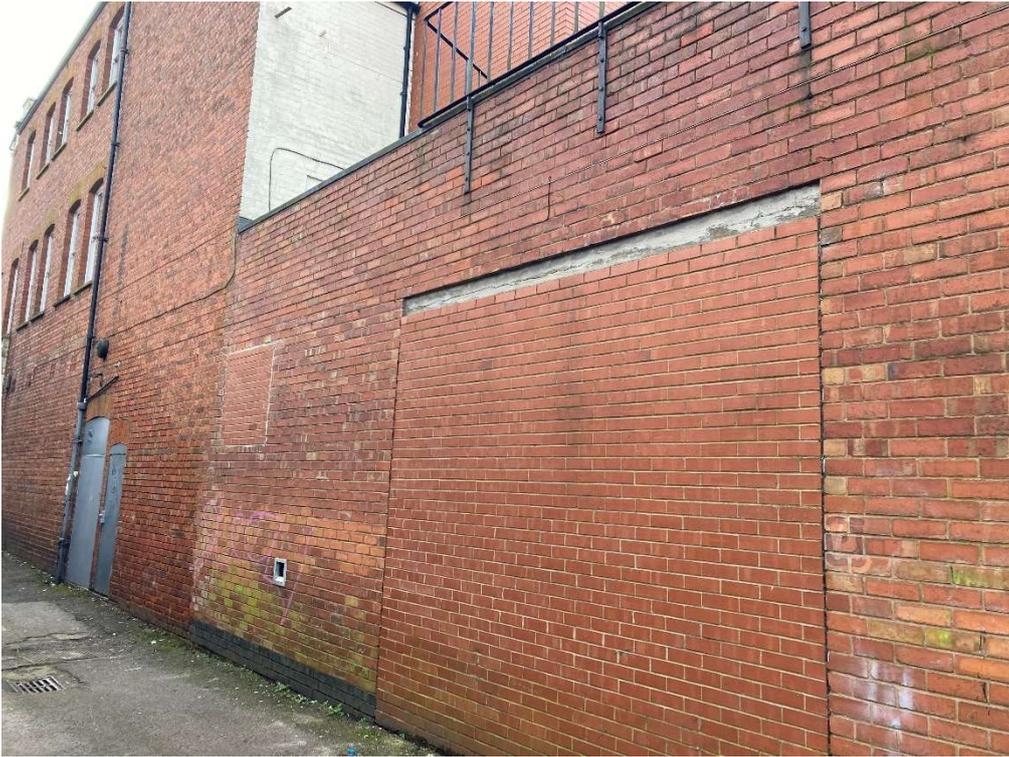
Photo 39 – Infilled opening.

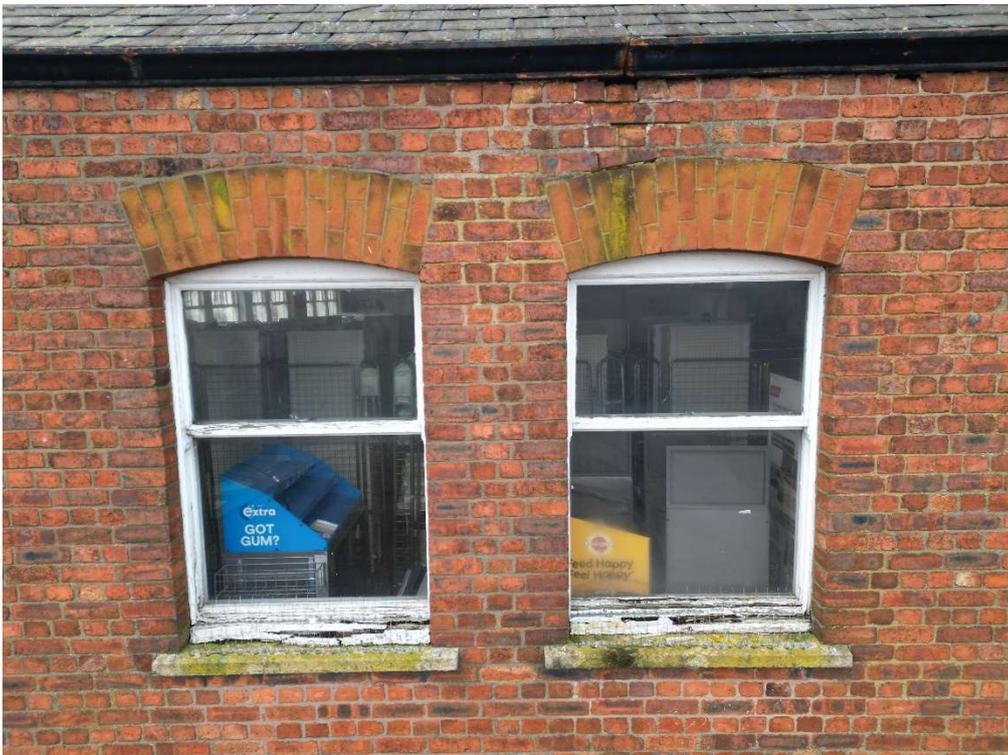
The remaining windows at first floor and second floor level are in very poor condition and require urgent replacement. Window frames are badly rotten allowing water to penetrate the building in multiple locations particularly around the first and second floor stock rooms. To the first floor western elevation of the original lift shaft a window frame has rotted to such an extent that glazing has dropped downwards by 25mm leaving a gap at the top of the window opening. There is a real risk that glazing could fall from the first and second floor windows in the eastern elevation into the alleyway below potentially resulting in injuries. The timber windows should be replaced as a matter of urgency (photos 72, 73, 74, 75 and 76).

Photo 73 – Further example of rotten windows, second floor western elevation.

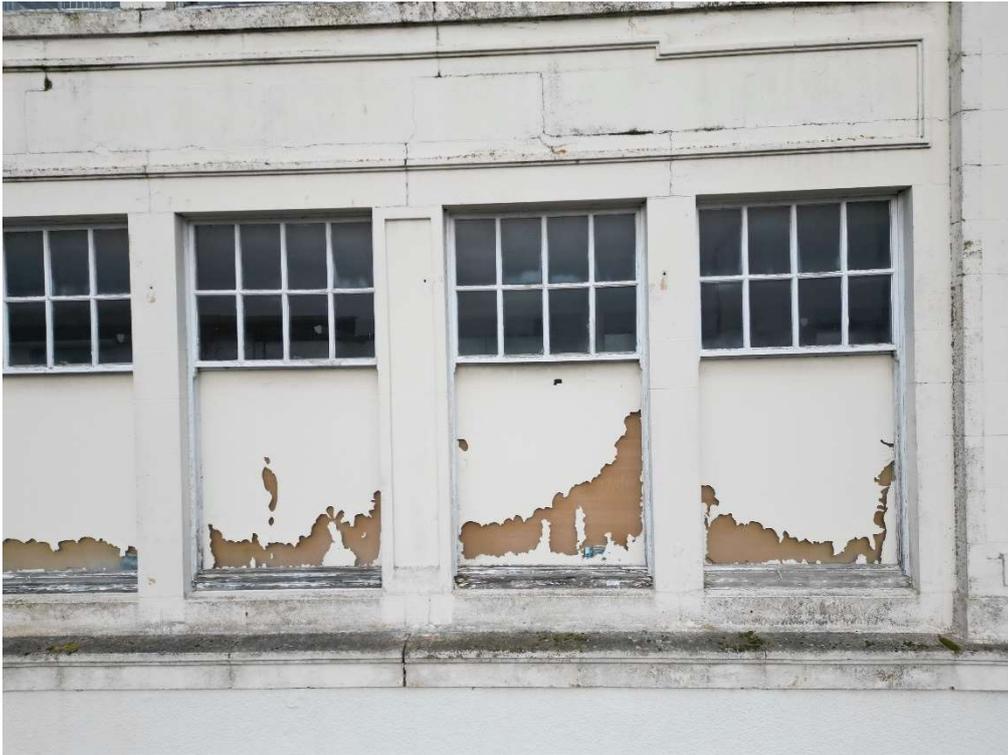
Photo 74 – Example rotten windows, southern façade.

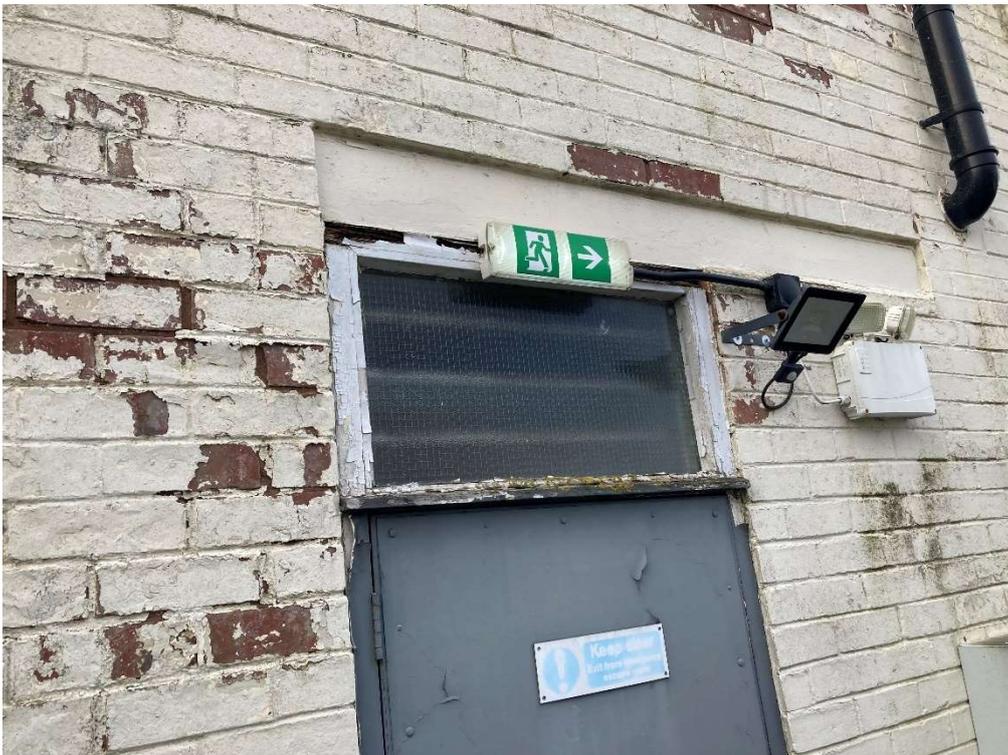
Photo 75 – Rotten window, northern elevation first floor.

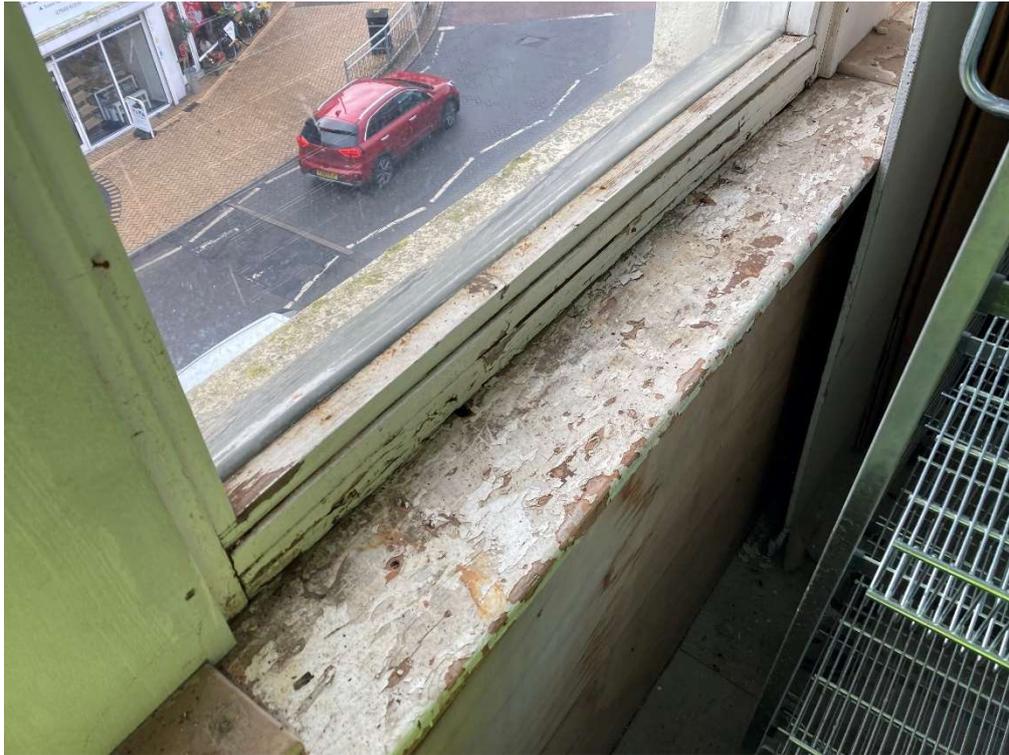
Photo 75 – Example, internal damp penetration due to rotten window frames.

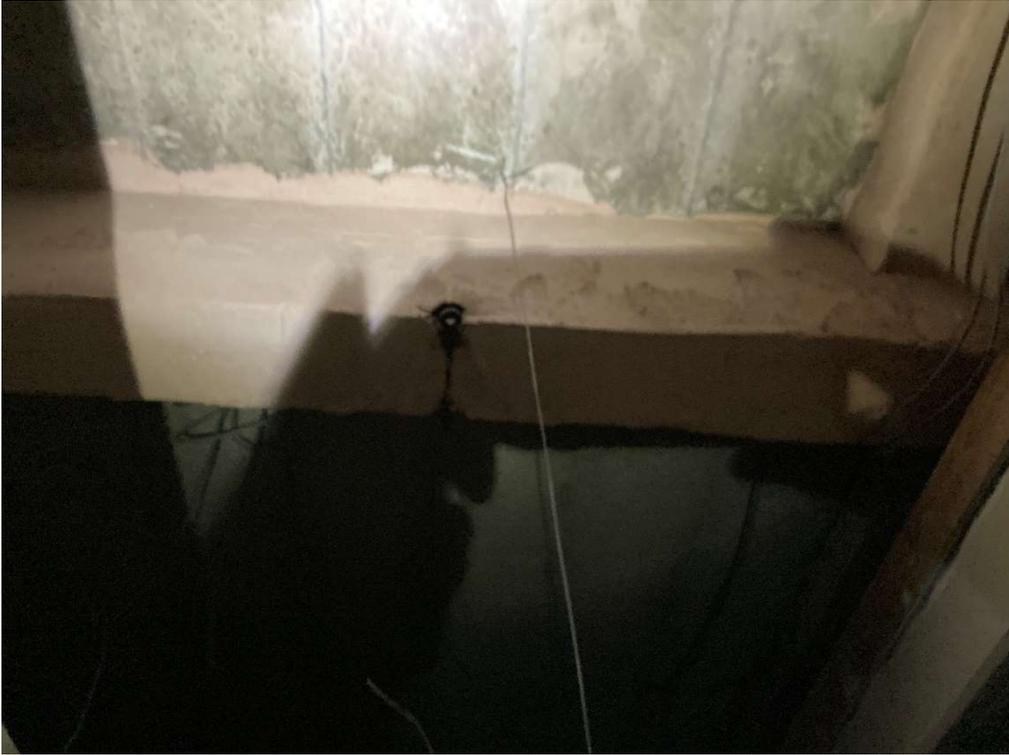
Above ceilings most of the visible structural beams have been covered with a plaster type material. It is assumed this is some form of intumescent coating for fire resistance (photo 79 and 80). The presence of this coating limits inspection of the beams and makes it impossible to tell if any historic fire proofing (e.g asbestos) remains beneath the coating.

Photo 79 – Coating to beam in ceiling void.

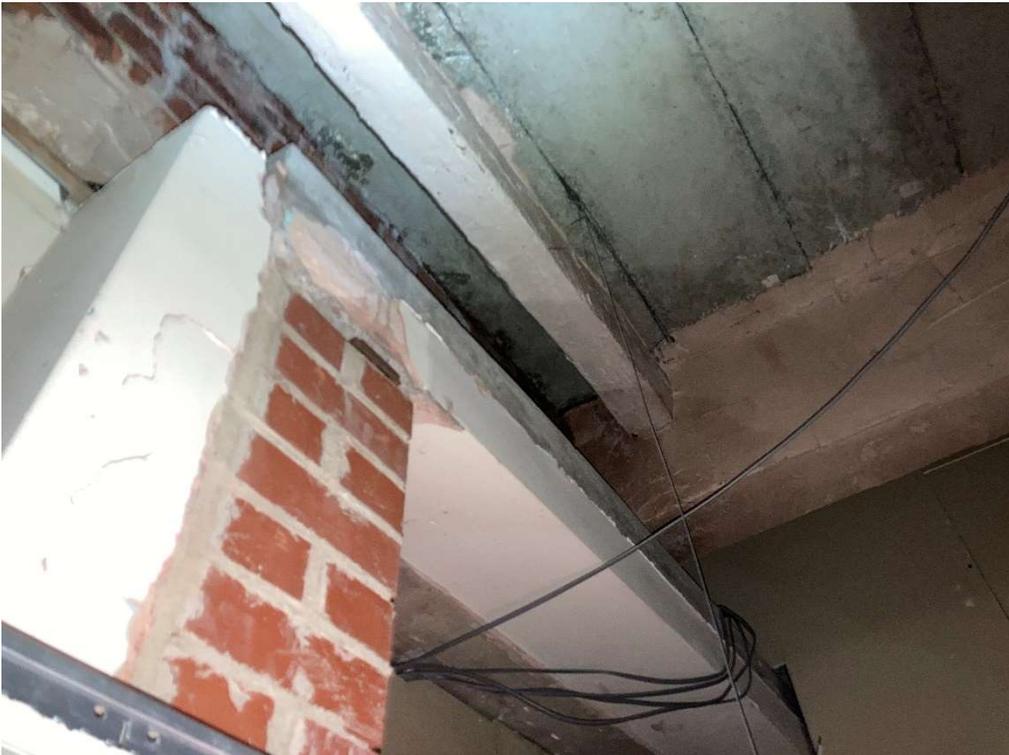
Photo 80 – Coating to beam in ceiling void.

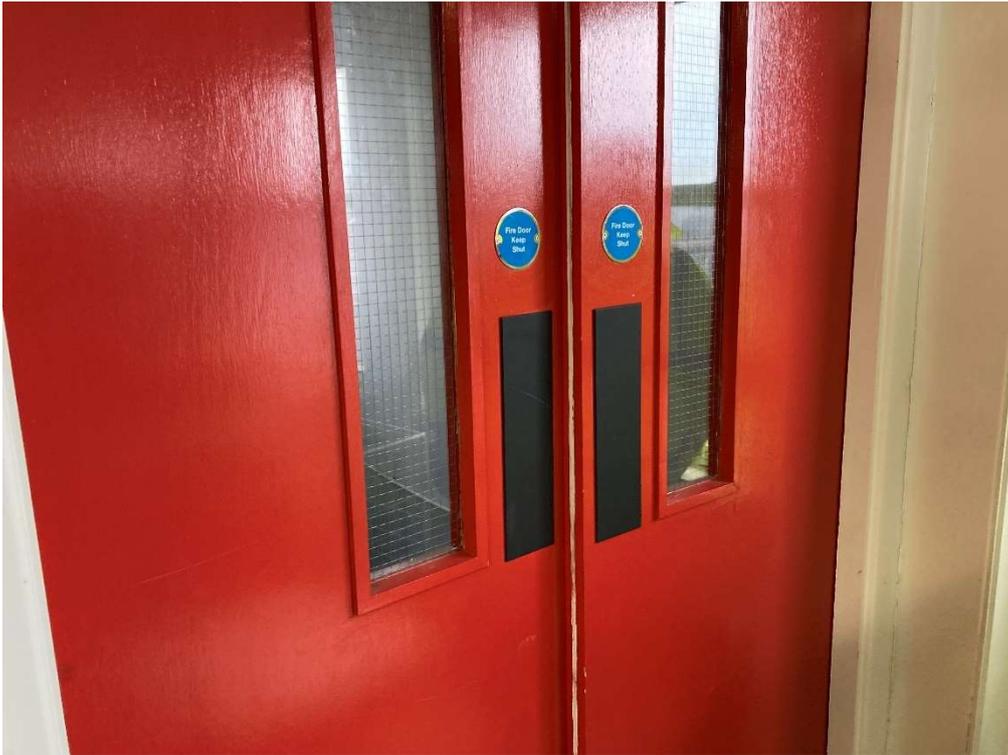
Whilst all internal doors are functional and in generally good condition significant deficiencies were observed with the fire compartmentation arrangements. None of the internal fire doors are compliant with modern standards for fire doors, all are missing intumescent strips and smoke seals. A number do not shut properly due to being poorly fitted in the frames or due to defective self closers (photo 81 and 82). The fire doors should be replaced with compliant FD30 door sets.

Photo 81 – Poorly fitted fire doors, first floor stock room.

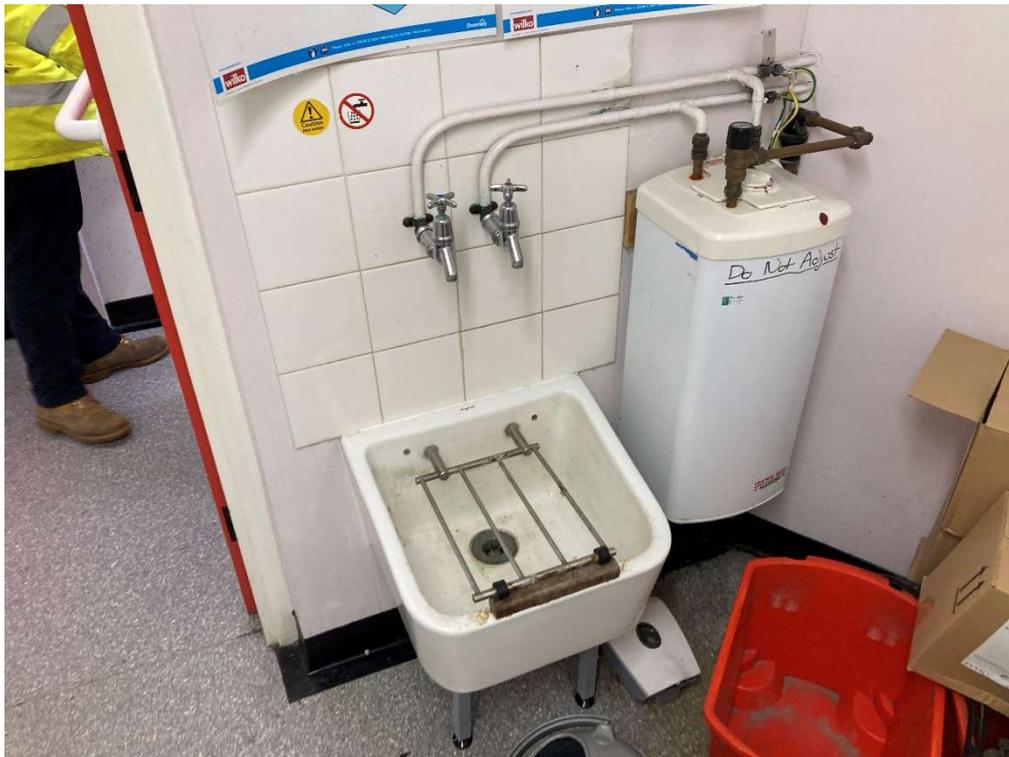
Photo 88 – Typical point of use water heater.

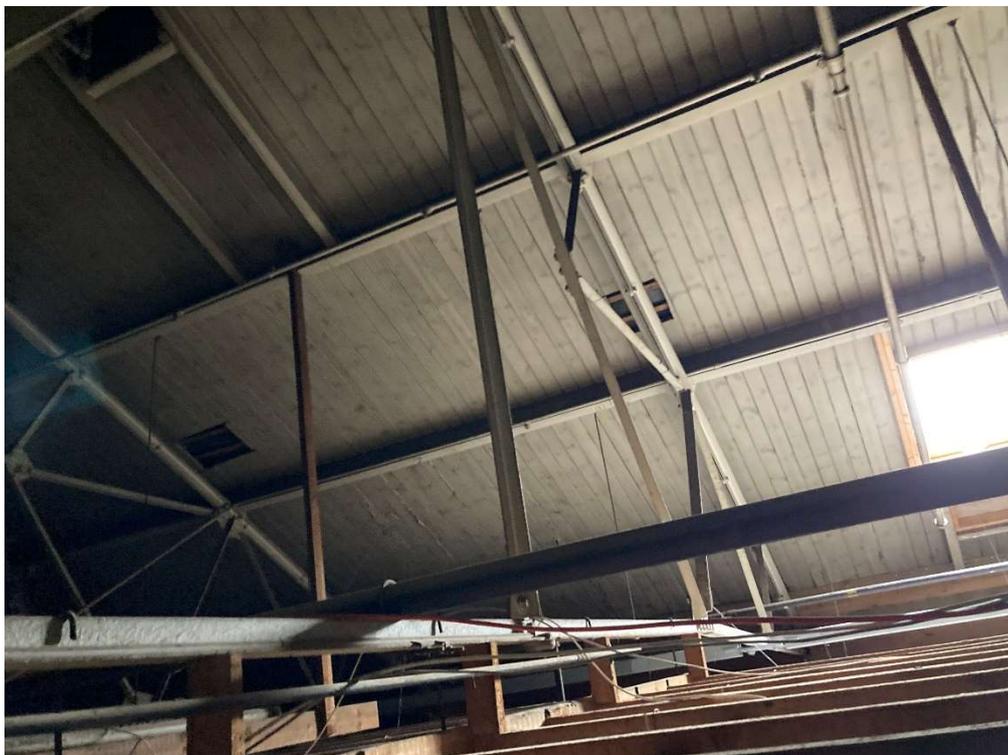
Photo 90 – Remains of sprinkler system.

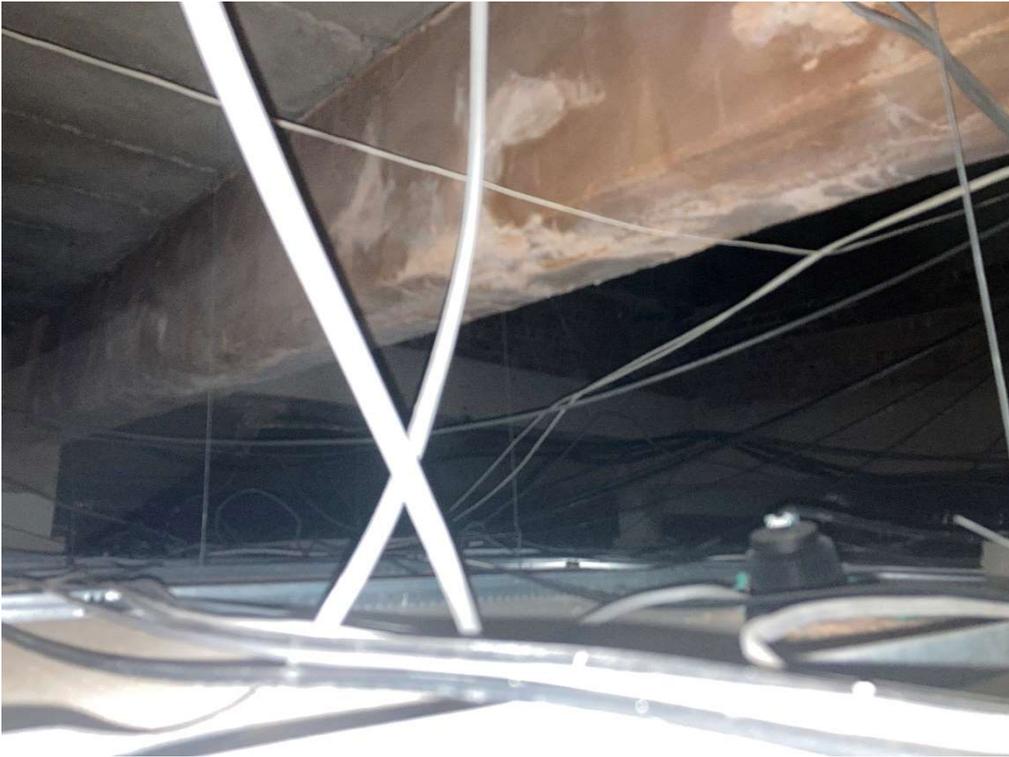
Photo 91 – Untidy wiring above ceiling void.

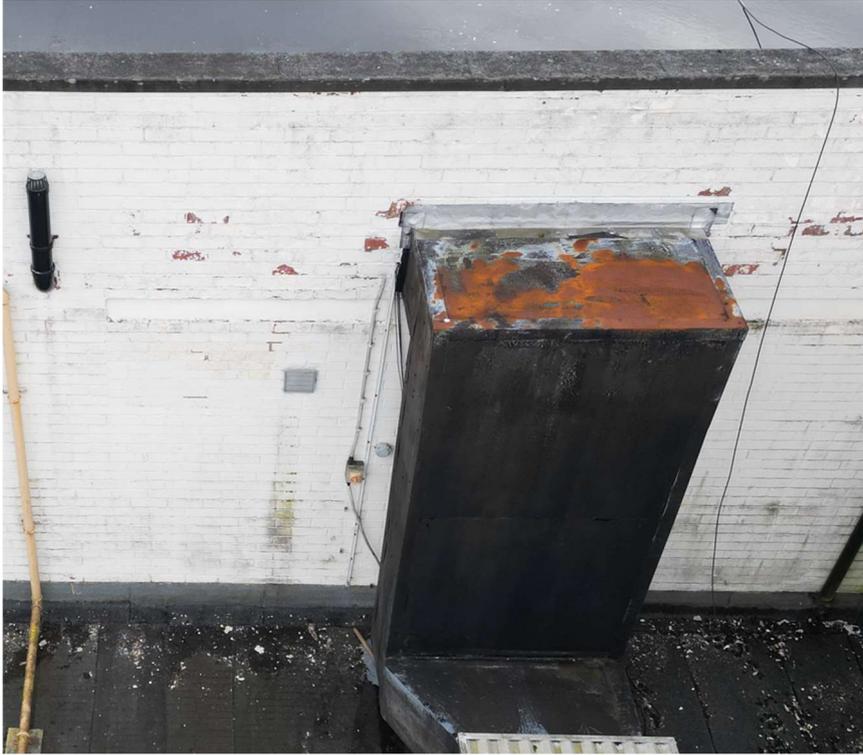
Heating and ventilation ducts are poorly sealed with flash band tape where they enter the building (photo 93).

Photo 94 – Poorly sealed heating / ventilation duct penetration.

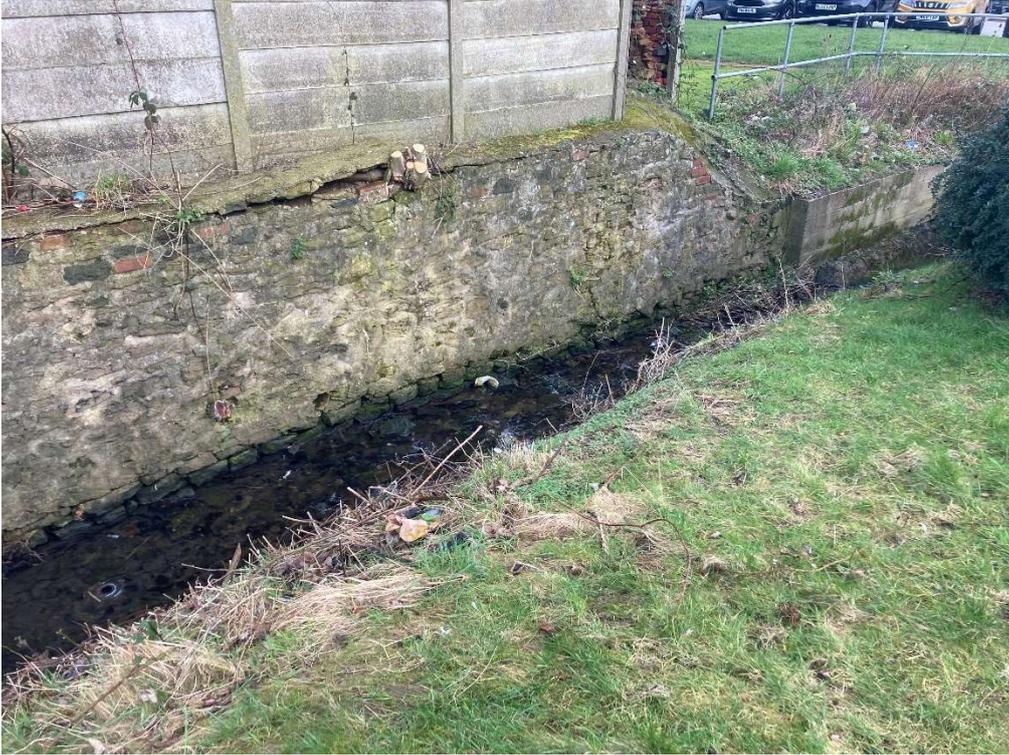
A culverted water course runs to the northern side of the service yard. This water course is not protected by any fencing. If a public right of way does exist across the service yard the risk posed by this water course / lack of fencing should be consider in terms of the Occupiers Liability Act (photo 96).

Photo 96 – Culverted water course.
